**GEOLOGIC MAP
LEGEND**

FIGURE 3.5-1

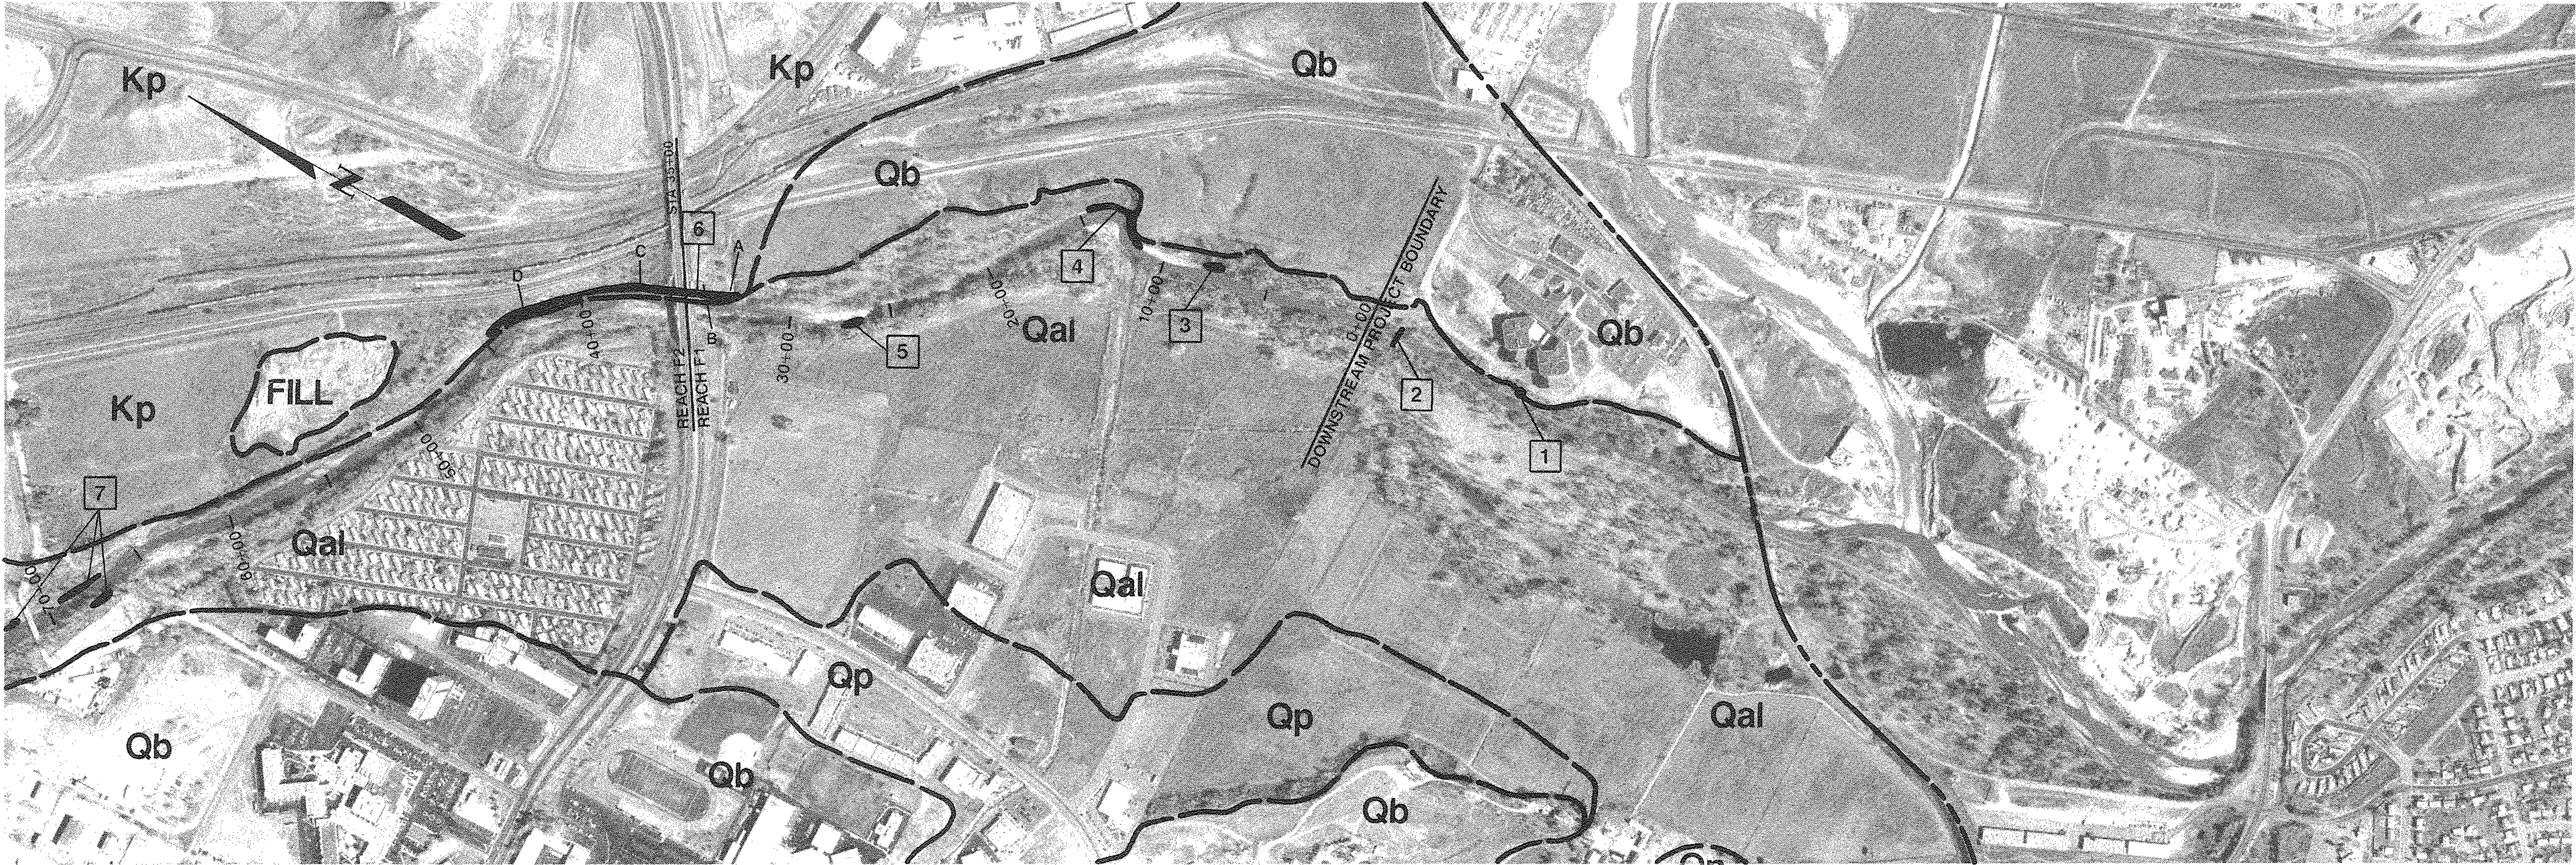
- 1 SOME EROSION OF WEST BANK DOWNSTREAM OF THIS POINT.
- 2 DROP STRUCTURE, PROBABLE SEWER OR OTHER UTILITY CROSSING.
- 3 DOWNED TREE, PIERRE SHALE EXPOSED AT BASE OF ERODING BANK. 6-INCH DIAMETER CONCRETE PIPE ENTERS CREEK JUST UPSTREAM, FLOWING SLIGHTLY.
- 4 PIERRE SHALE EXPOSED IN ERODING CUT BANK. OUT CROP RESULTS IN BEND IN CREEK. UPSTREAM OF THIS POINT BOTH SIDES OF BANK ERODING (ABOUT 5- FEET HIGH BANKS). DOWNSTREAM TO ABOUT POINT 1, EAST BANK MAINLY ERODING.
- 5 ERODING BANK AT SLIGHT BEND IN CREEK. UNDERCUT TREES, AND BIG TREE IN MIDDLE OF CHANNEL.

- 6 CIRCLE DRIVE CROSSING. PIERRE SHALE AT BASE OF BANK FROM ABOUT 300- FEET DOWNSTREAM TO ABOUT 900- FEET UPSTREAM OF CIRCLE DRIVE, CONCENTRATED EROSION ALONG THIS STRETCH, EAST BANK.
 - A. 300± SOUTH, UNDERMINING AT CHANNEL OUTFALL.
 - B. EAST SIDE DOWNSTREAM ABUTMENT FAILED GABION WALL, "Fix" ALSO ERODING.
 - C. UPSTREAM ABUTMENT O.K. BUT SEVERE EROSION AT BASE OF SLOPE JUST UPSTREAM.
 - D. PIERRE SHALE UPSTREAM OF GABION SLOPE AND WALL ERODING.
 - E. UPSTREAM OF CIRCLE DRIVE, MAINLY EROSION OF EAST BANK TO POINT 8.
- 7 PIERRE SHALE EXPOSED IN BANKS.

DOWNSTREAM END TO SPRING CREEK, STREAM BOTTOM MATERIALS CONSIST OF FINE TO COARSE GRAVELLY TO COBBLEY SAND, WITH SCATTERED BOULDERS. SIDE BANKS VARY FROM SAME, TO FINE GRAINED SILTY SAND, TO EXPOSED SHALE.

DOWNSTREAM OF HIGHWAY 24 BYPASS CROSSING, STREAM BANKS GENERALLY HEAVILY VEGETATED WITH GRASSES, WILLOWS AND COTTONWOOD TREES. EXCEPT FOR CIRCLE DRIVE AREA, EAST SIDE OF CREEK LARGELY NATURAL FLOOD PLAIN. UPSTREAM OF CIRCLE DRIVE, SOME FILL ENCROACHMENT ON WEST SIDE OF CHANNEL (TRAILER PARK BERM AND COMMERCIAL DEVELOPMENT).
