FIGURE 3.5-1

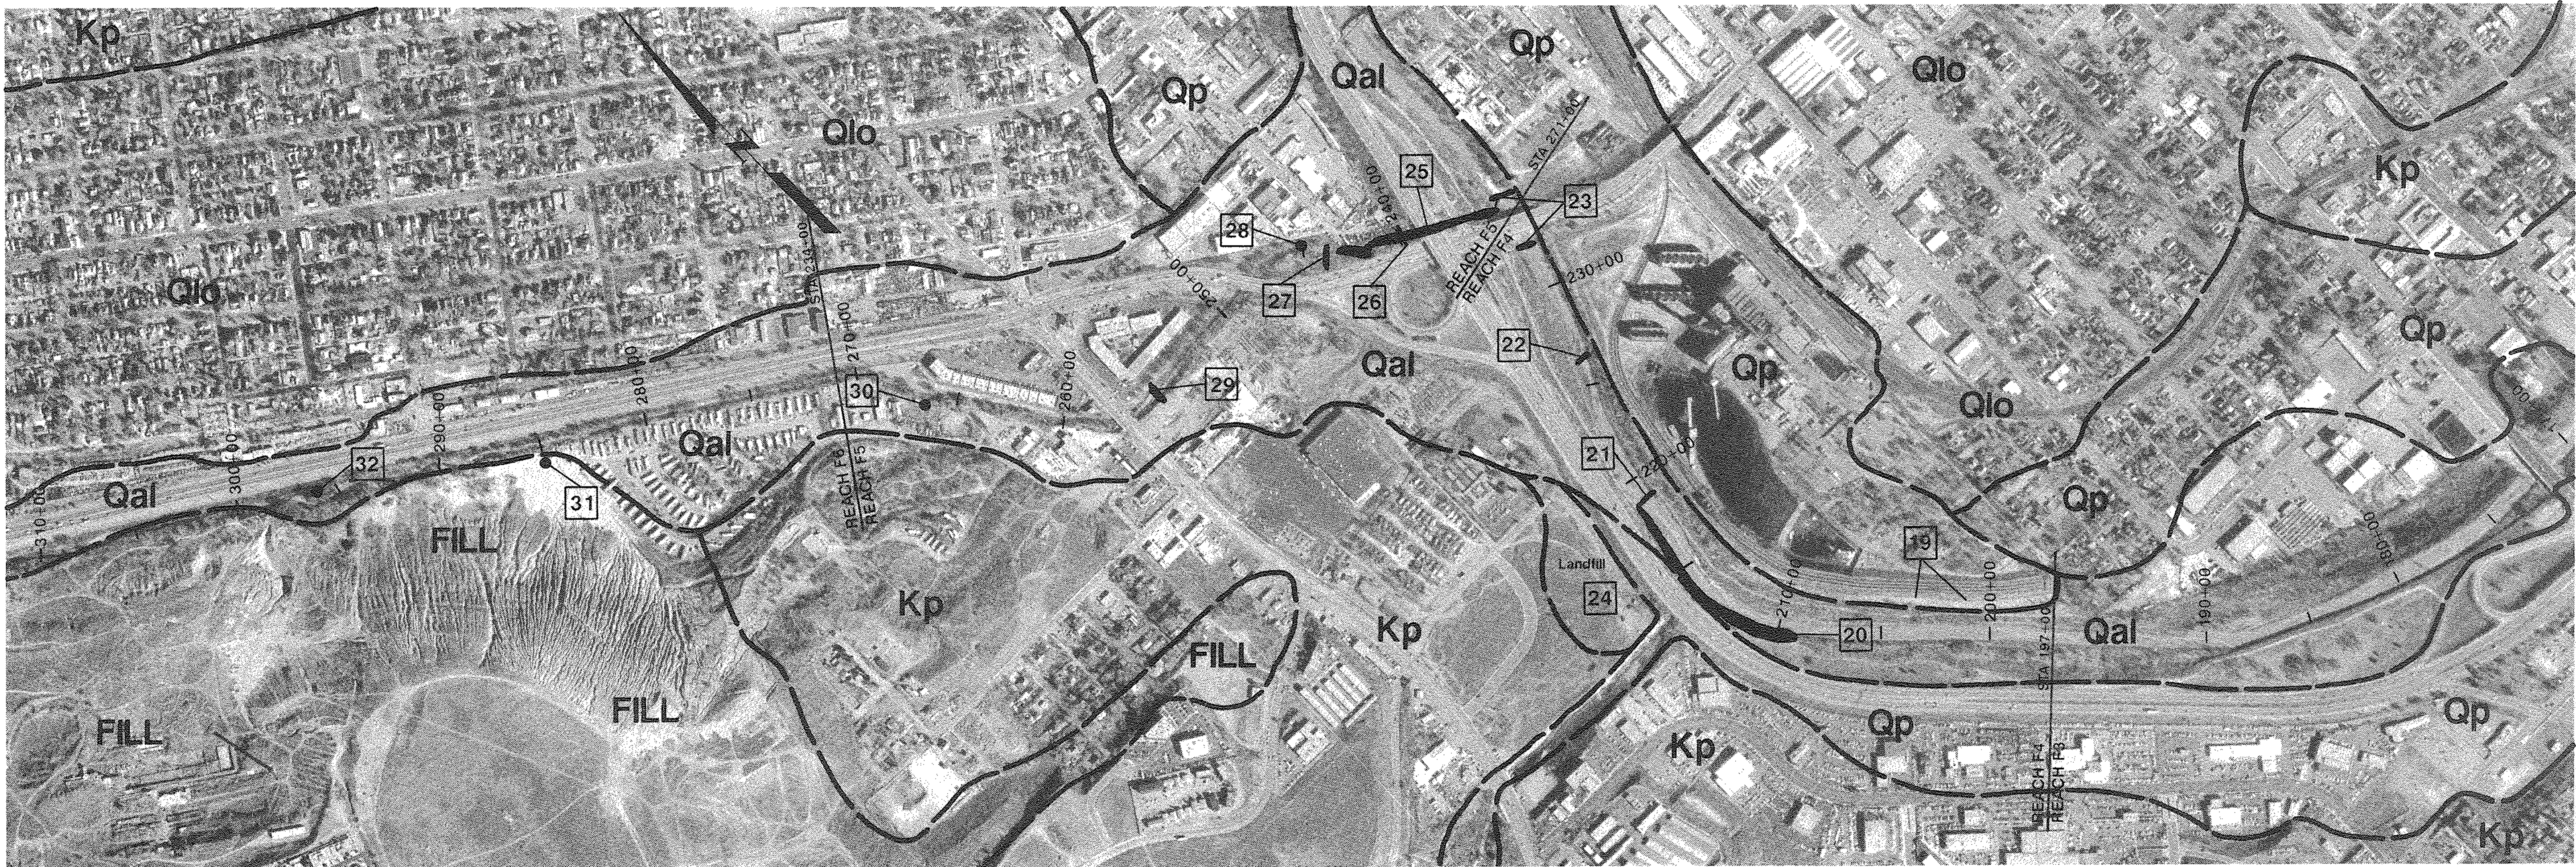
NOTES		NOTES		GENERAL NOTES	
19	FILL SLOPE WITH RIP-RAP AT BASE IN POWER PLANT AREA. RELATIVELY STABLE LOW BANKS BELOW ABOUT 20 TO TEJON STREET AREA.	26	UNDERCUT STEEL PIPE.	BOTTOM OF CHANNEL UPSTREAM OF CONFLUENCE WITH MONUMENT CREEK IS FINE TO COARSE SAND AND GRAVEL. BETWEEN CONFLUENCE AND ABOUT 30, LOWER BANKS CONSIST OF FINE GRAINED SILTY CLAY. UP STREAM OF 30 BANKS CONSIST OF FINE TO COARSE SAND AND GRAVEL (WHERE EXPOSED), AND RUBBLE/DEBRIS FILL.	
20	OLD STREAM PROTECTION BEING UNDERCUT AND NEWER GABION PROTECTION PARTIALLY FAILED. EROSION BOTH SIDES BETWEEN 20 AND 21.	27	CONCRETE ENCASED UTILITY CROSSING.		
21	DROP STRUCTURE; STEEPER, ERODING SECTION AND NARROW DOWNSTREAM. UPSTREAM, WIDE SANDY BOTTOM.	28	90° BEND, ERODING, PIERRE SHALE AT BASE 2- FEET OF BANK.	ENTIRE REACH UPSTREAM OF MONUMENT CREEK HAS BEEN CHANNELIZED, FILLED AND ALTERED. NO NATURAL STRETCH EXISTS. EROSION ALONG BOTH BANKS IS COMMON DUE TO NARROW NATURE OF CHANNEL.

22	CONCRETE ENCASED UTILITY CROSSING.	29	IRRIGATION DIVERSION STRUCTURE.		
23	FAILED DROP STRUCTURE AND CONCRETE CASED UTILITY CROSSING EXPOSED UPSTREAM STEEP AND ERODING ABOVE DROP, CONCRETE RUBBLE IN FILL SLOPES.	30	SOUTH SIDE FENCE UNDERMINED, SEVERE EROSION.		
24	FILLED-IN MEANDER OF FOUNTAIN CREEK. PROBABLE LIQUID OR SOLID WASTE. SEVERAL MONITORING WELLS ON SITE.	31	MONITORING WELL. UPSTREAM TO 21ST STREET, FILL CONSISTS LARGELY OF GOLD MILL TAILINGS.		
25	SEVERE EROSION, BOTH SIDES FROM 5-15' DEEP.	32	SEVERE EROSION AT 90° BEND, NORTH SIDE.
