FIGURE 3.5-1

FOUNTAIN CREEK DRAINAGE BASIN PLANNING STUDY

GEOMORPHOLOGY AND GEOLOGIC RESOURCES

SHEET 4 OF 4

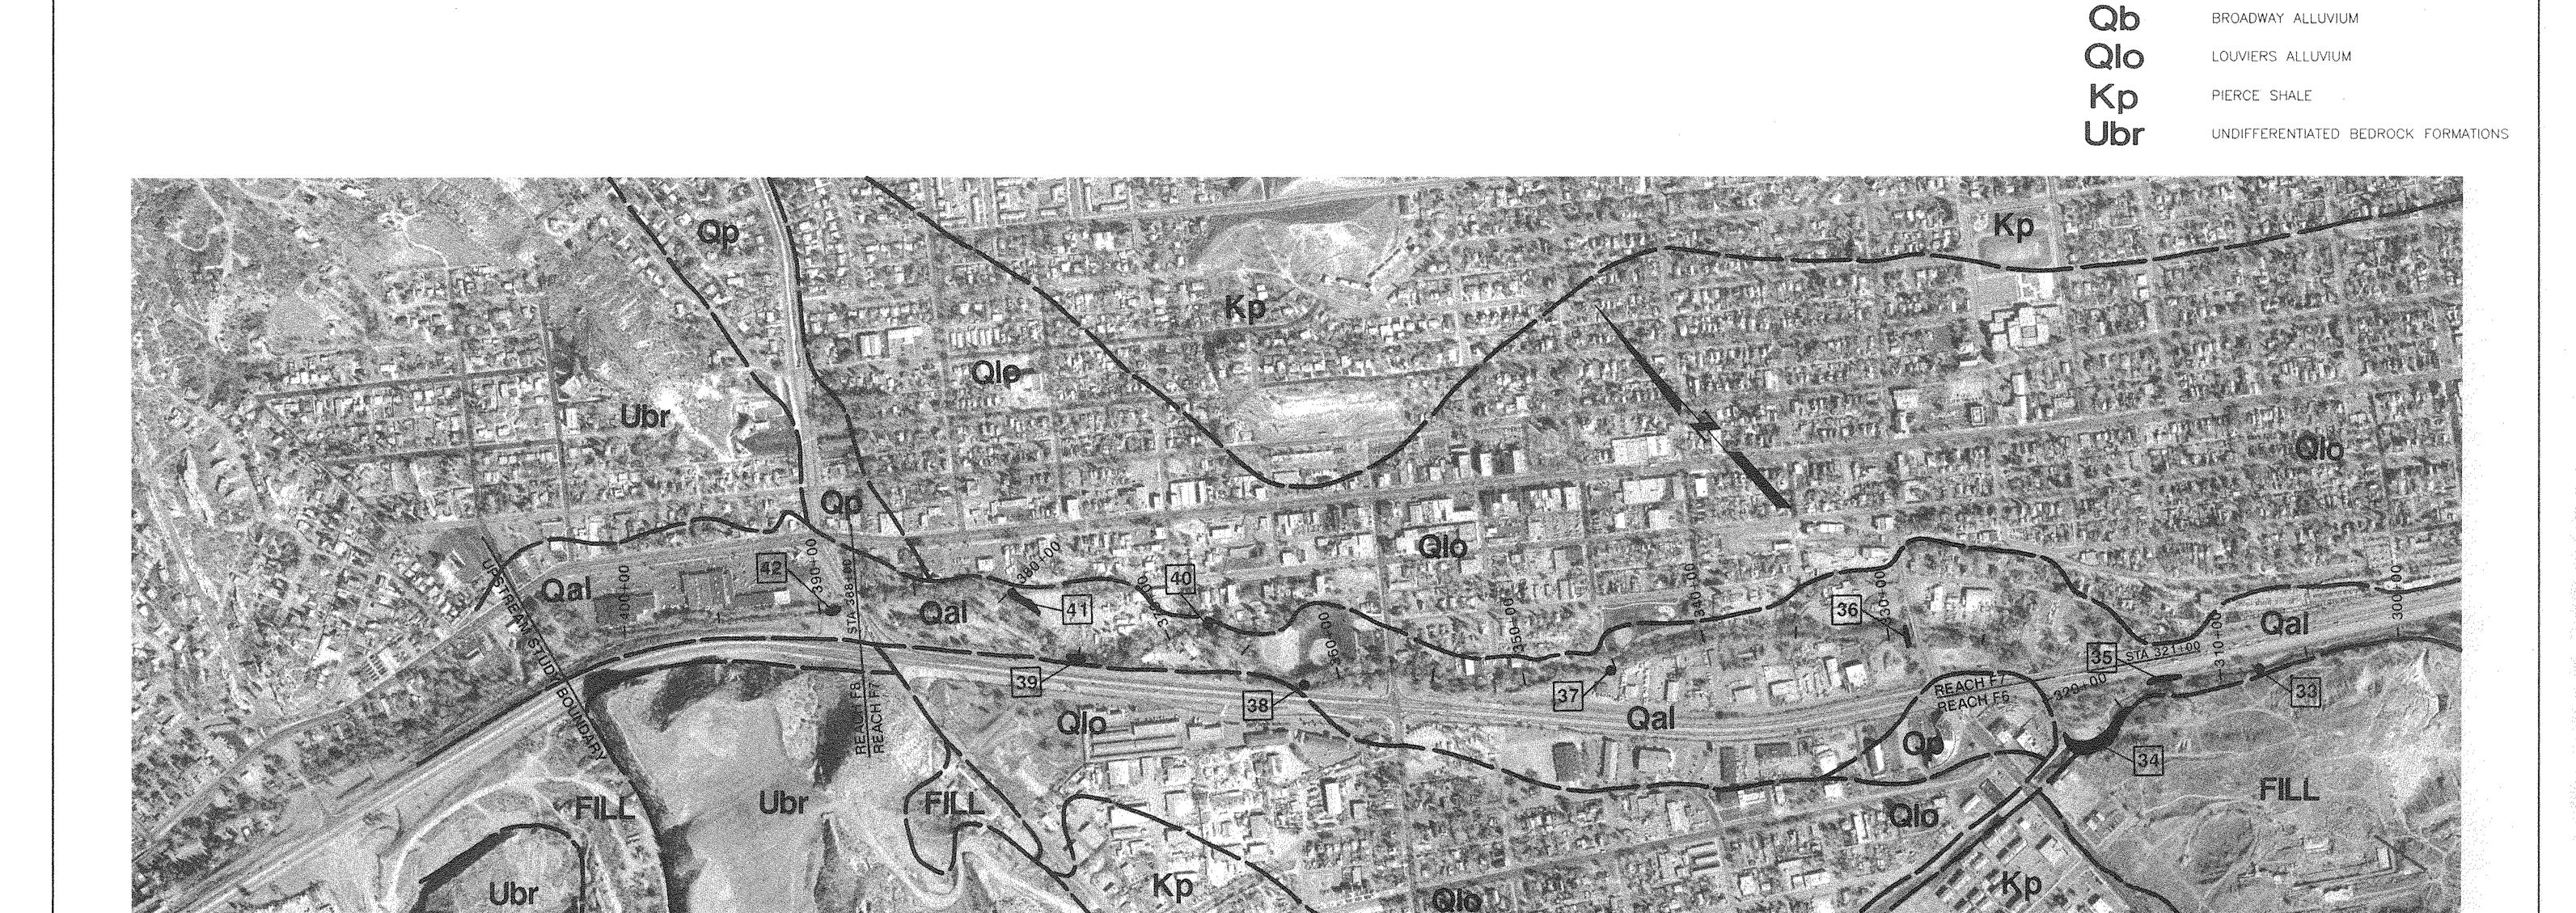
- EROSION 6-8 FEET HIGH.
- SEVERE EROSION UP TO 30-FEET HIGH AT BEND AND OUTFALL UNDERCUT.
- EROSION UP TO 12-FEET HIGH. WEATHERED SHALE AT BASE, NORTH SIDE.
- CONCRETE ENCASED UTILITY CROSSING.
- EROSION OF BOULDER FILL AT BEND.
- PAST EROSION PROBLEMS, SOME CURRENT SOIL SLUMPING.
- ERODING BANK, FENCE UNDERMINED ON SOUTH SIDE.

- SIDE BANK SEEPAGE, NORTH SIDE.
- SHORT WALL BEING UNDERMINED AT CURVE, NORTH SIDE.
- SMALL OUT CROP OF WEATHERED SHALE, SOUTH SIDE.

ENTIRE REACH HAS BEEN CHANNELIZED, FILLED AND ALTERED. NO NATURAL STRETCH EXISTS. EROSION ALONG BOTH BANKS IS COMMON. CHANNEL BOTTOM IS MAINLY FINE TO COARSE SAND WITH SCATTERED GRAVEL AND COBBLES. SOME DEBRIS ALSO PRESENT.

SIDE BANKS ARE VARIABLE AND CONSIST OF DEBRIS/FILL; GRAVELLY CLAY; AND SAND AND GRAVEL.
