**APPENDIX D**  
**EXISTING FACILITIES**  
**Facility Summary**  
**Photographs**

Table 1 Existing Major Drainageway Structure Inventory

JIMMY CAMP CREEK DBPS  
OLD PUEBLO ROAD BRIDGE  
JIMMY CAMP CREEK  
EL PASO COUNTY, COLORADO  
BRIDGE PROFILE

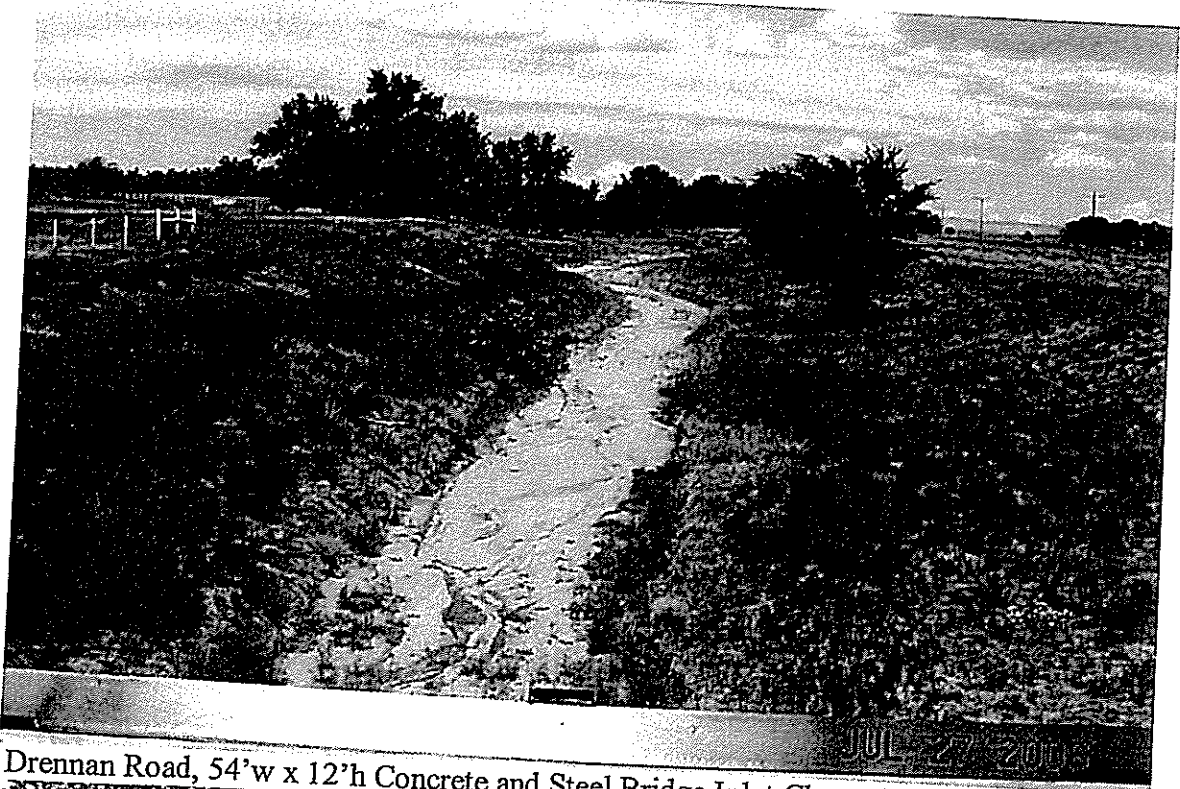
DRG

Drennan Road, 54'w x 12'h Concrete and Steel Bridge Inlet Channel in Good Condition.

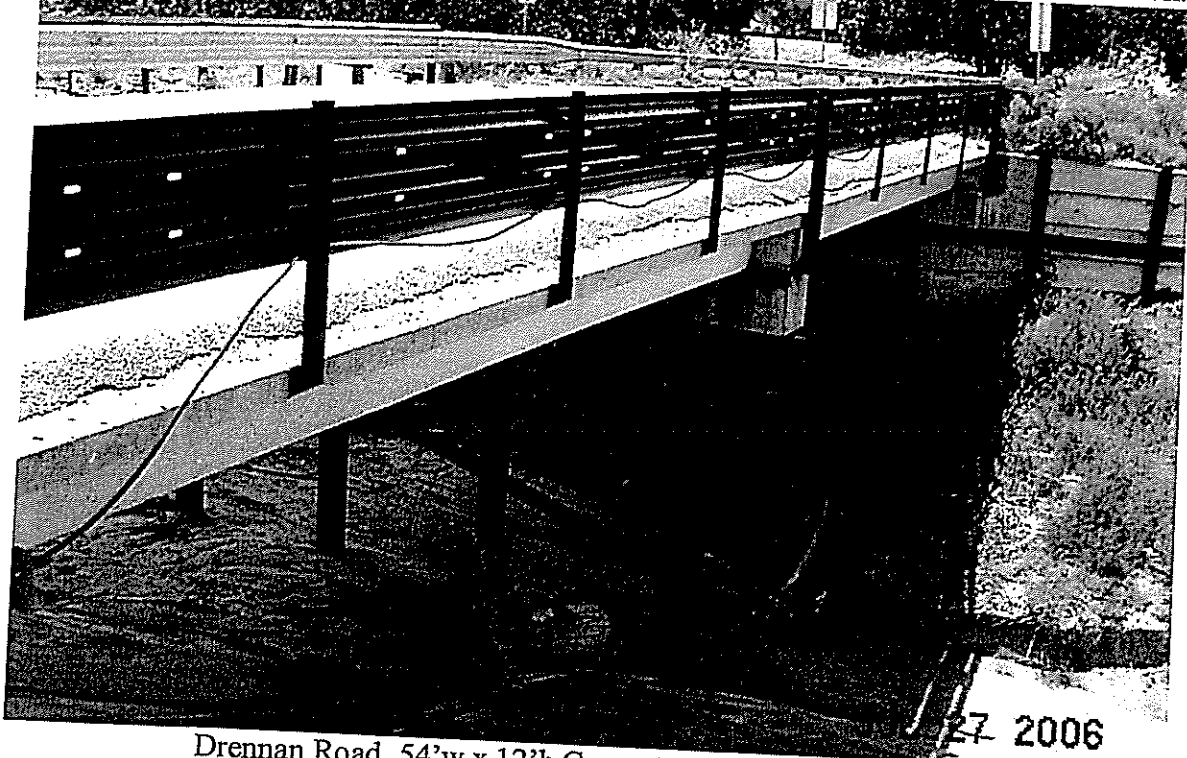
DRG

Drennan Road, 54'w x 12'h Concrete and Steel Bridge Inlet.

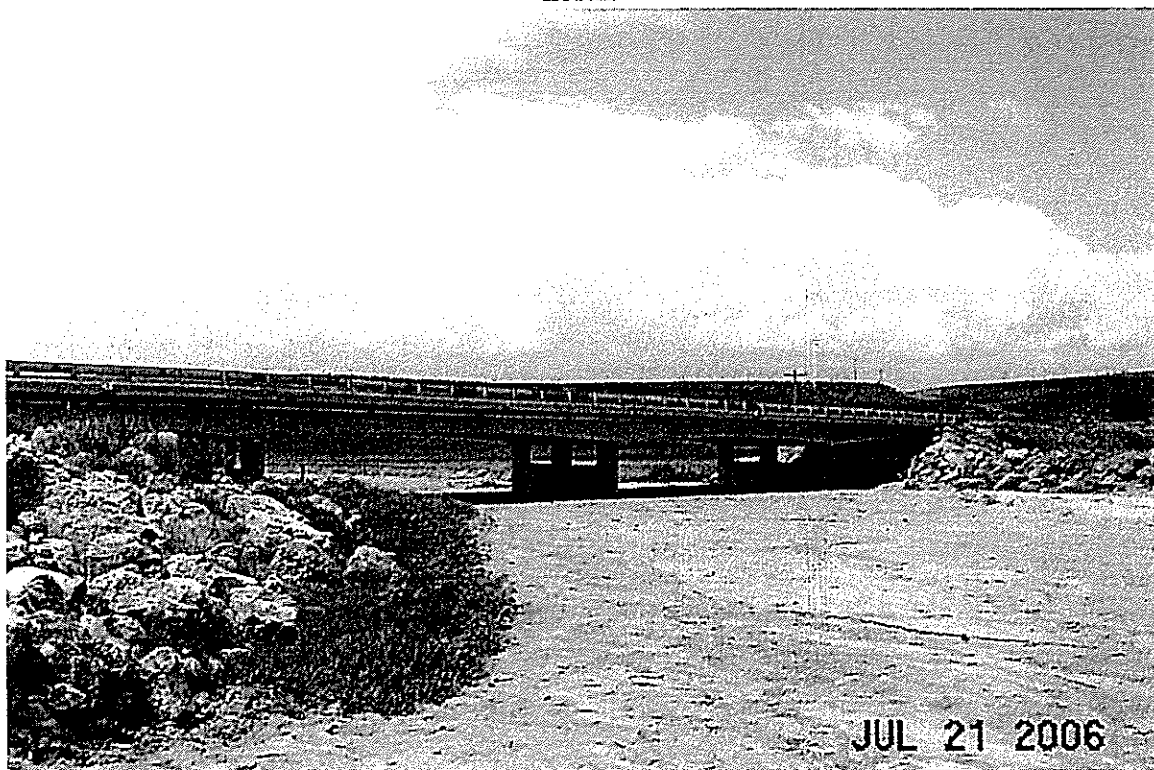
NF2

State Hwy 94, Concrete Bridge looking towards the south.

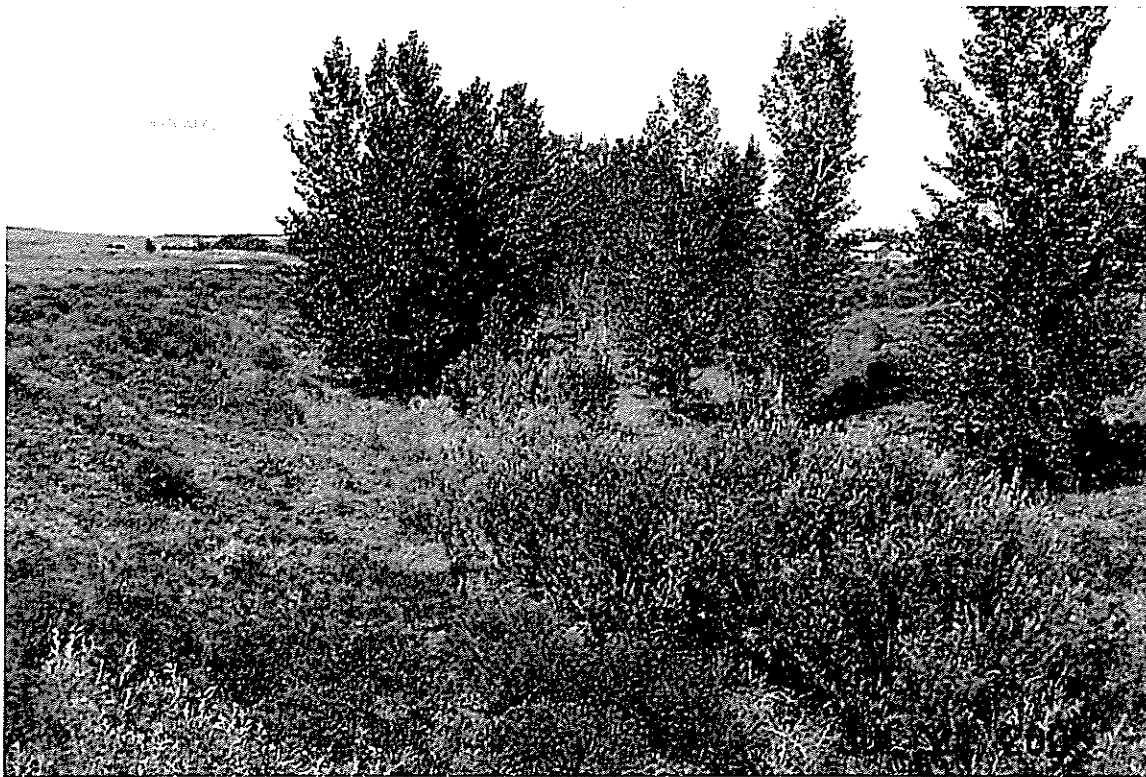
B3

Bradley Road, 40'w x 7' h Concrete Bridge Inlet Channel in Good Condition.

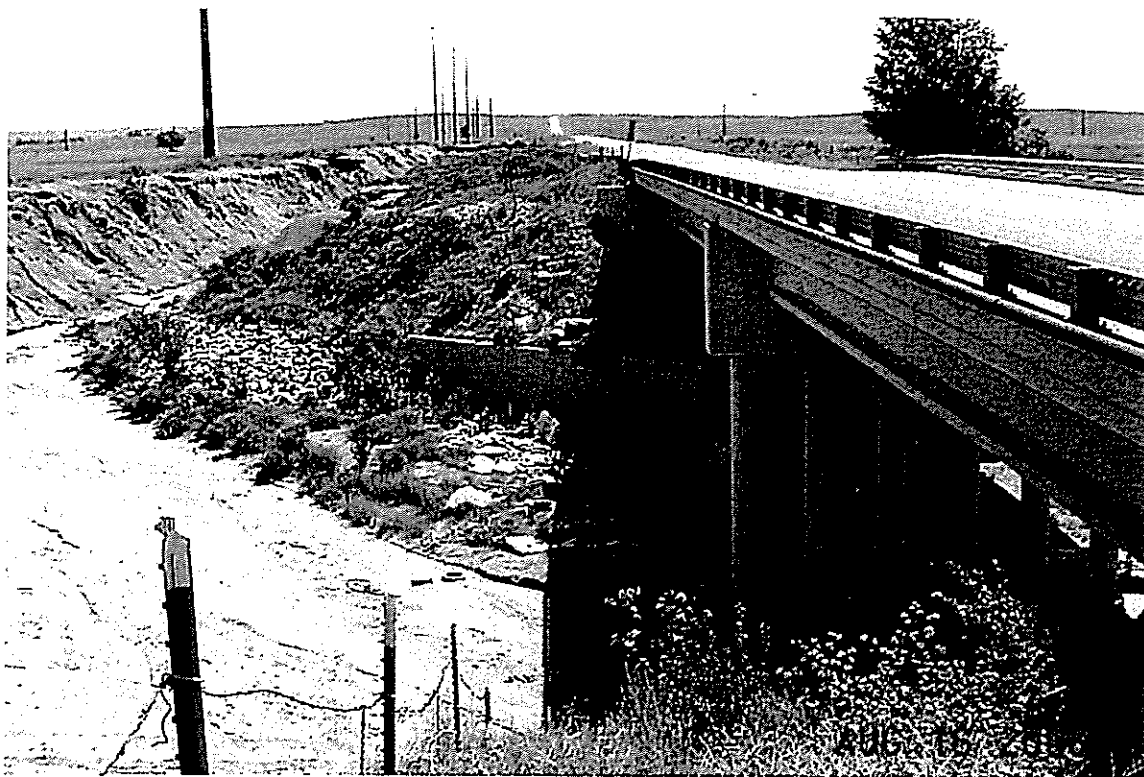
PR4

Coral Basin Jimmy Camp Creek Drennan Road Bridge

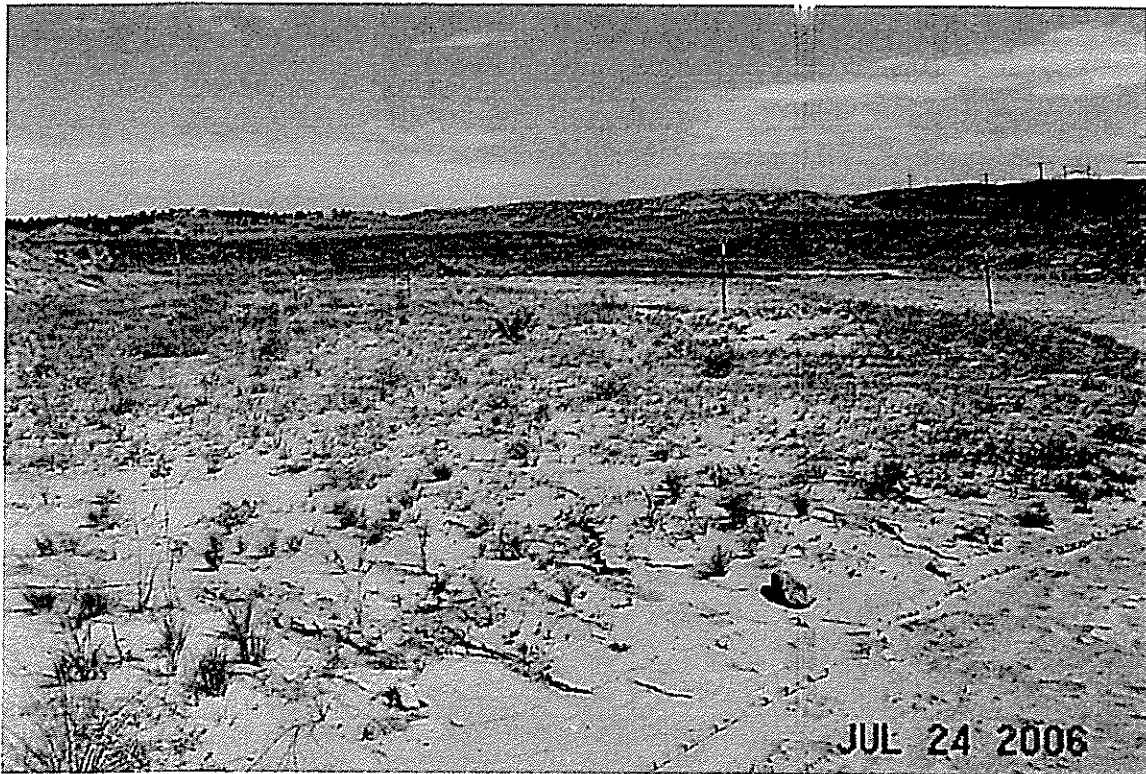
NF-12

State Hwy 94, 37'3"w x 10'h Concrete Bridge Inlet Channel in Fair Condition.

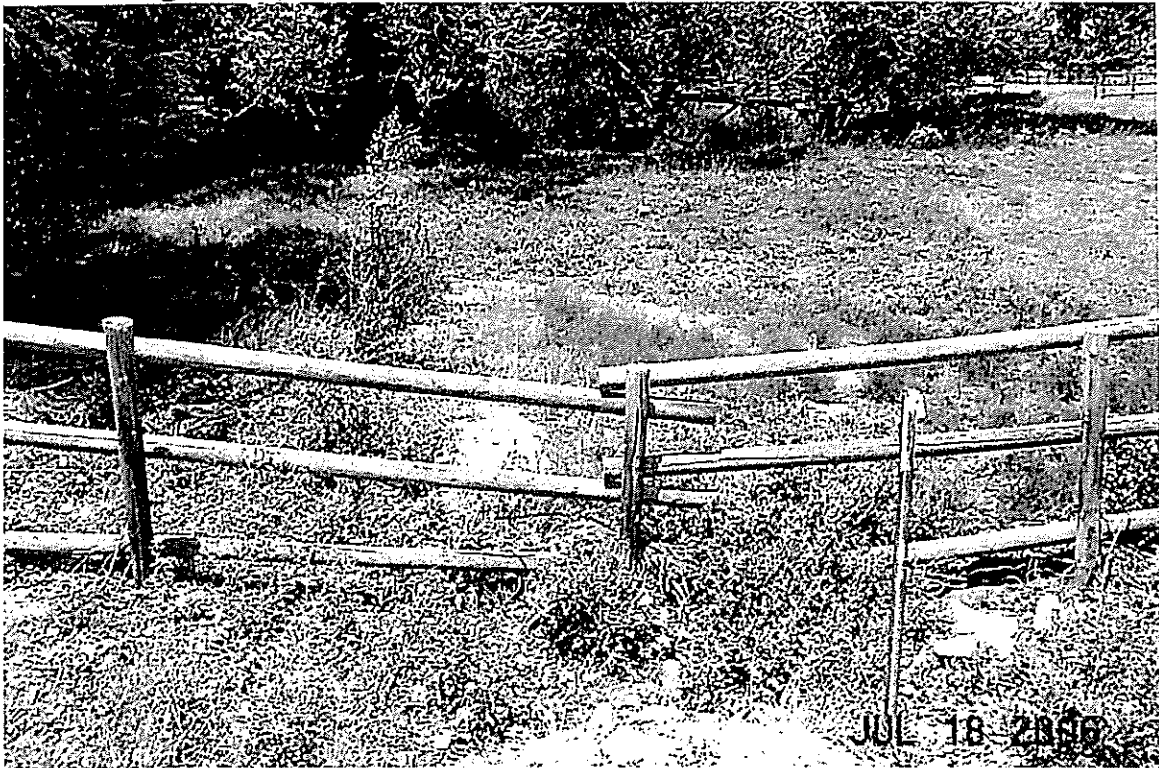
02

Dodge Circle, 62" w x 33" h CMP Inlet Channel in Fair Condition.

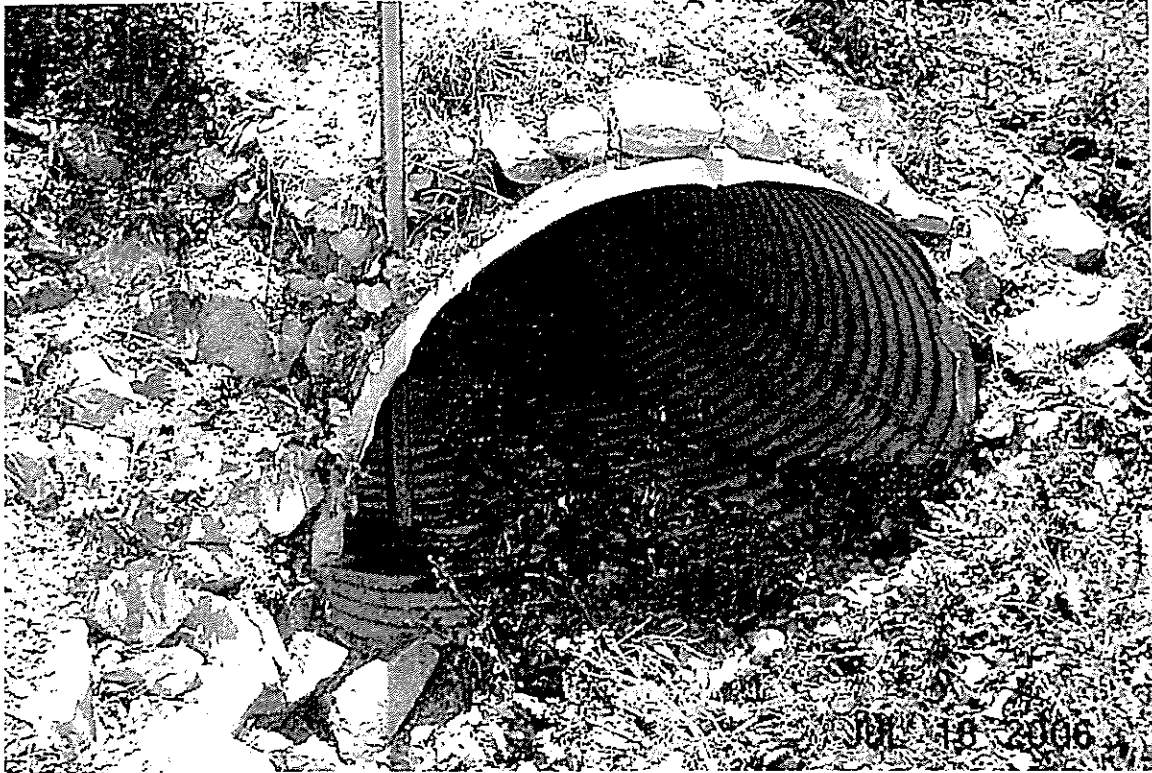
D2

Dodge Circle, 62" w x 33" h CMP Inlet, bent.

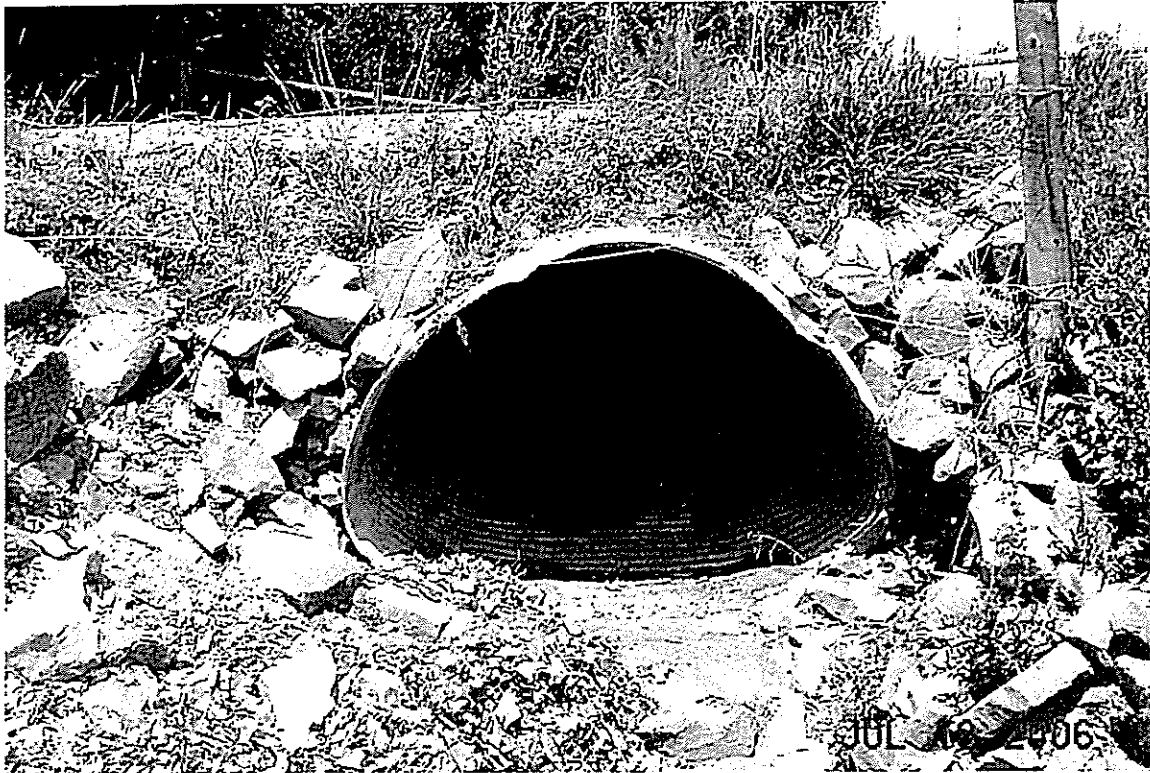
D2

Dodge Circle, 62" w x 33" h CMP Outlet, bent.

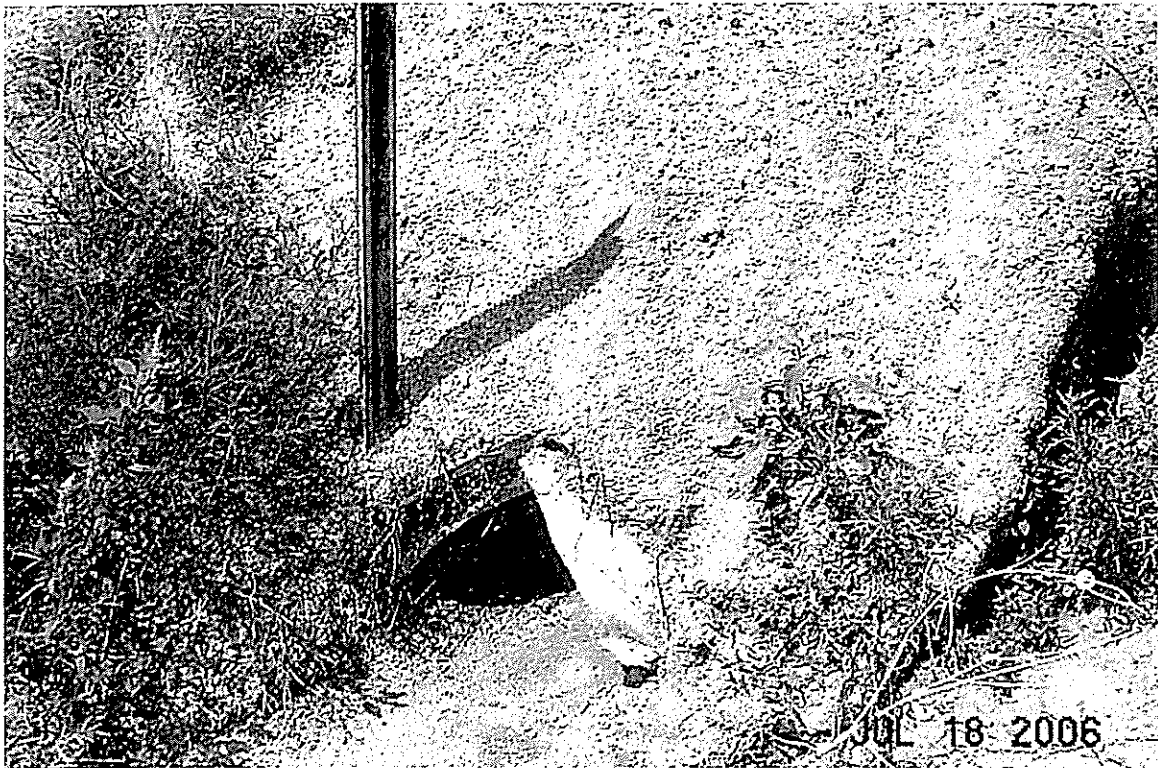
D3

Dodge Circle, 21" CMP Outlet, bent.

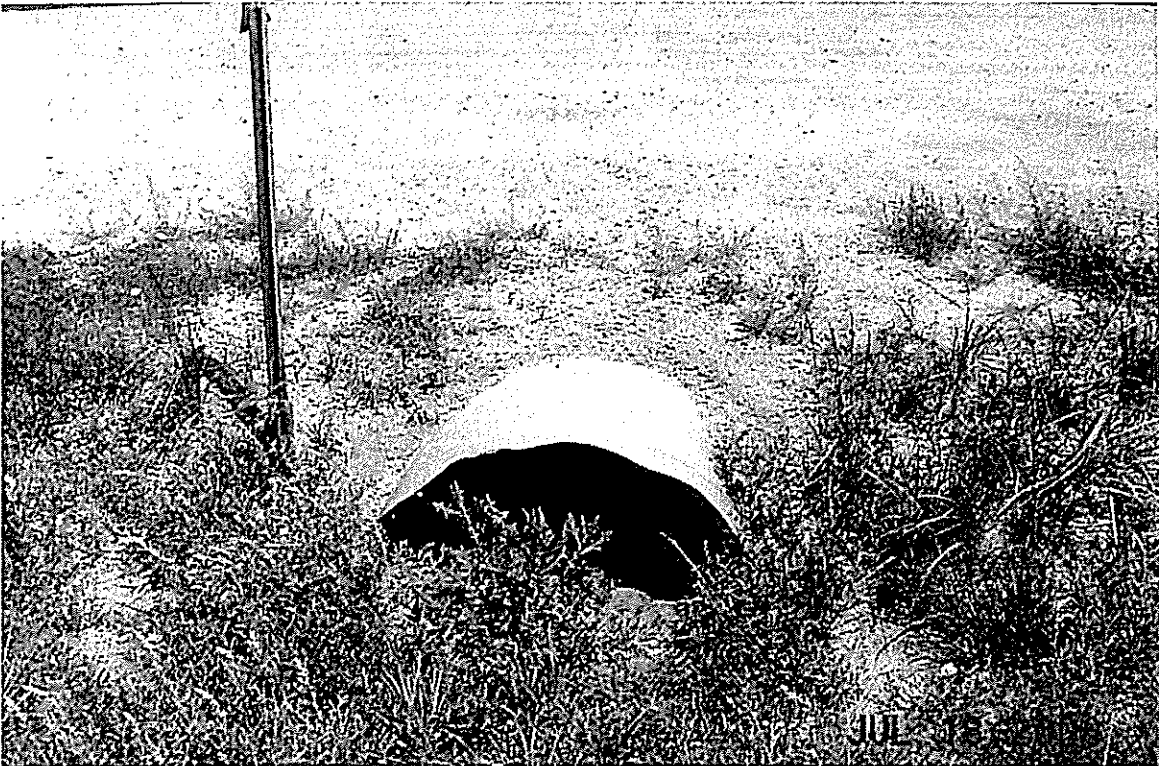
D4

Dodge Circle, 36" CMP Inlet, bent.

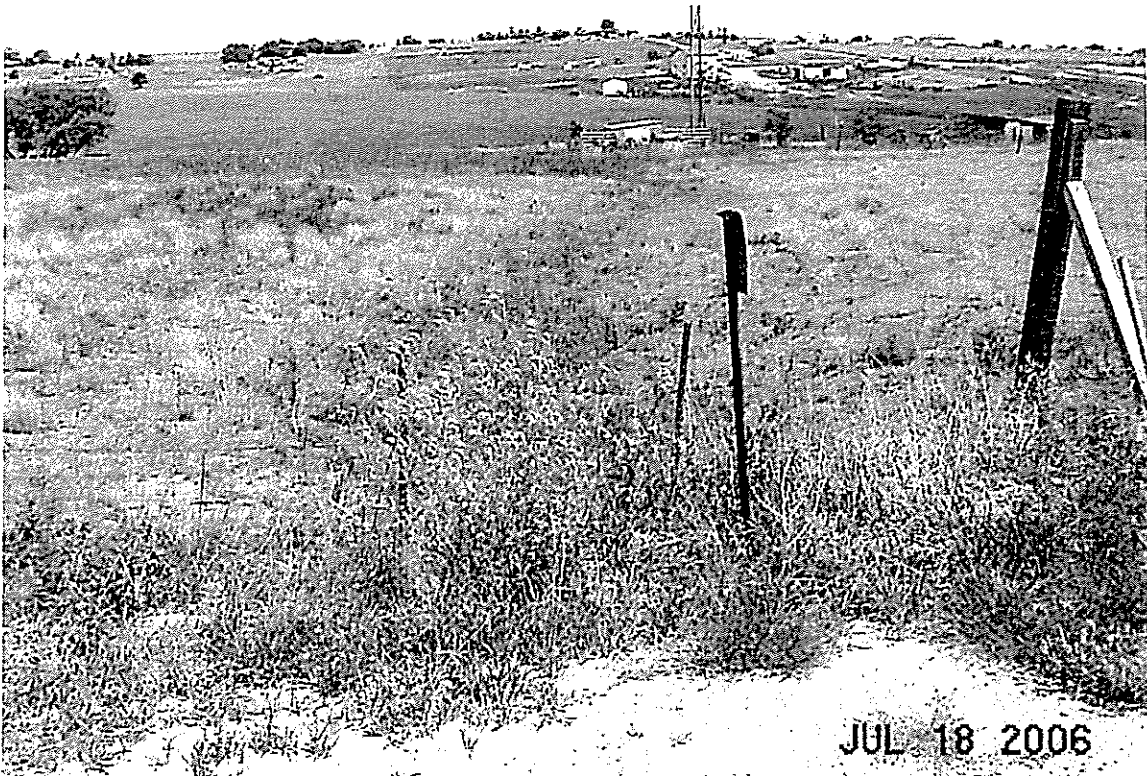
D4

Dodge Circle, 36" CMP Outlet Channel in Good Condition. Appears to be a drainage channel.

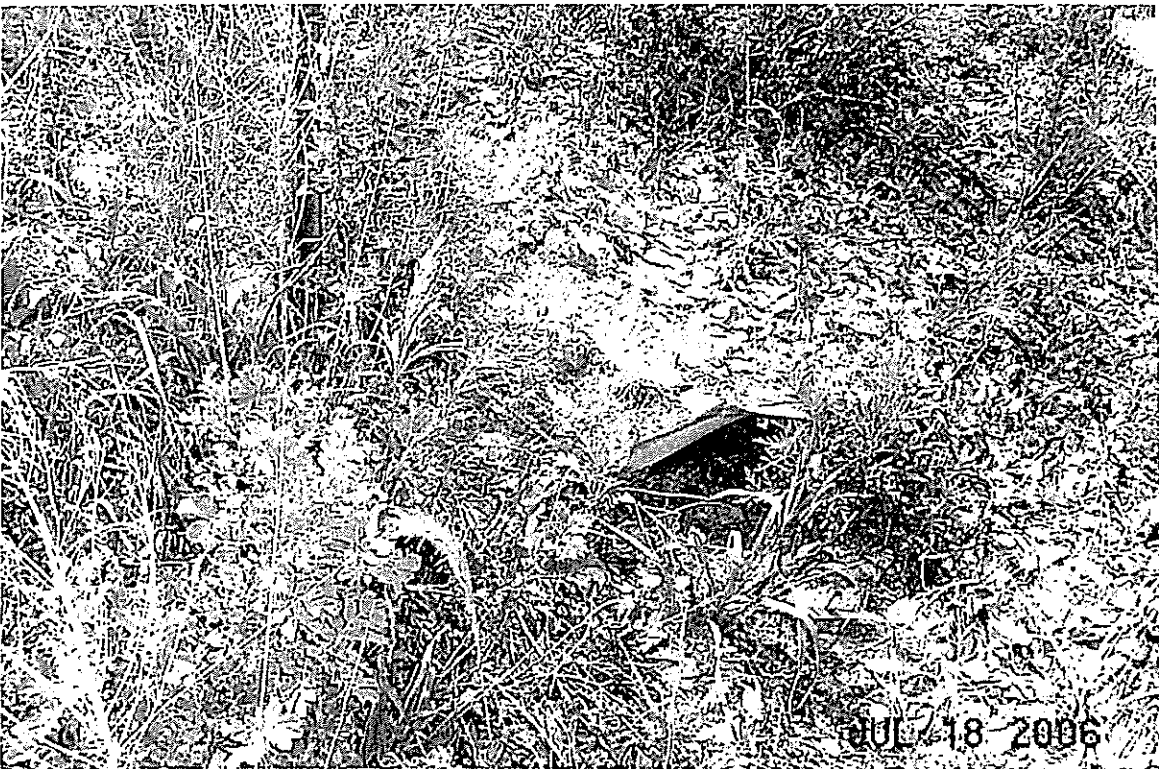
D5  
D4

Dodge Circle, 36" CMP Outlet, bent.

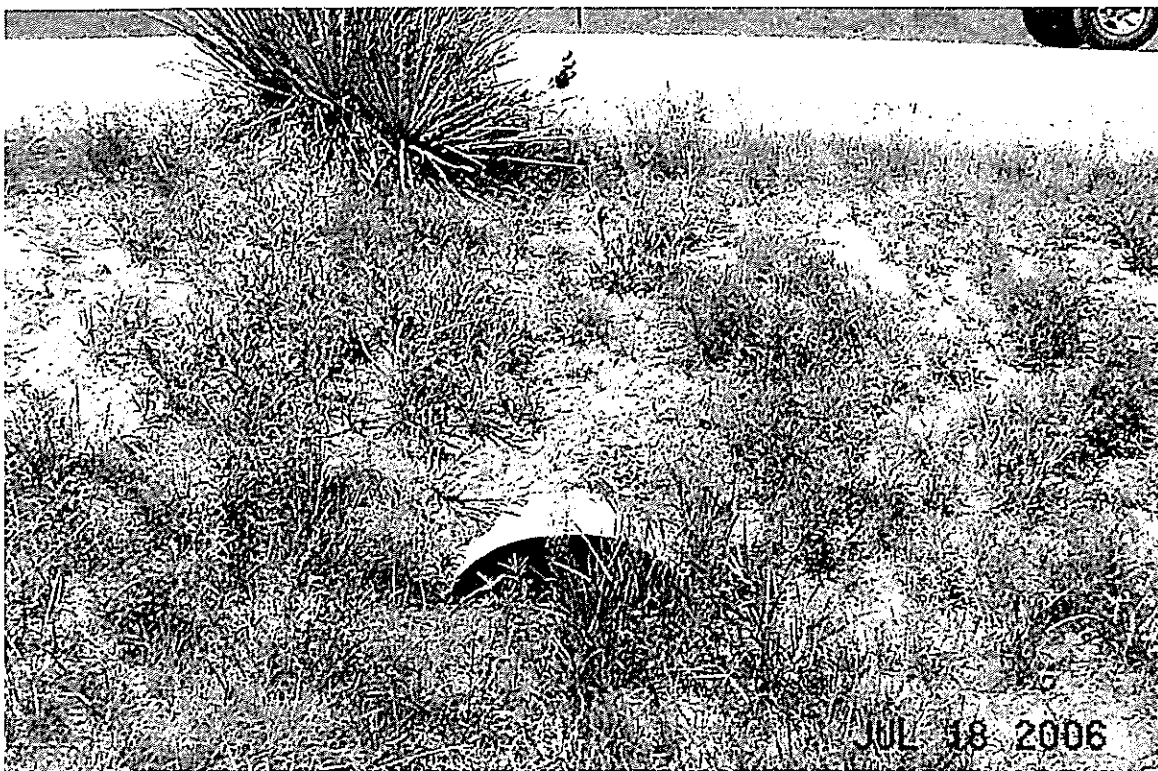
D5

Dodge Circle, 36" CMP Outlet, OK.  
24"

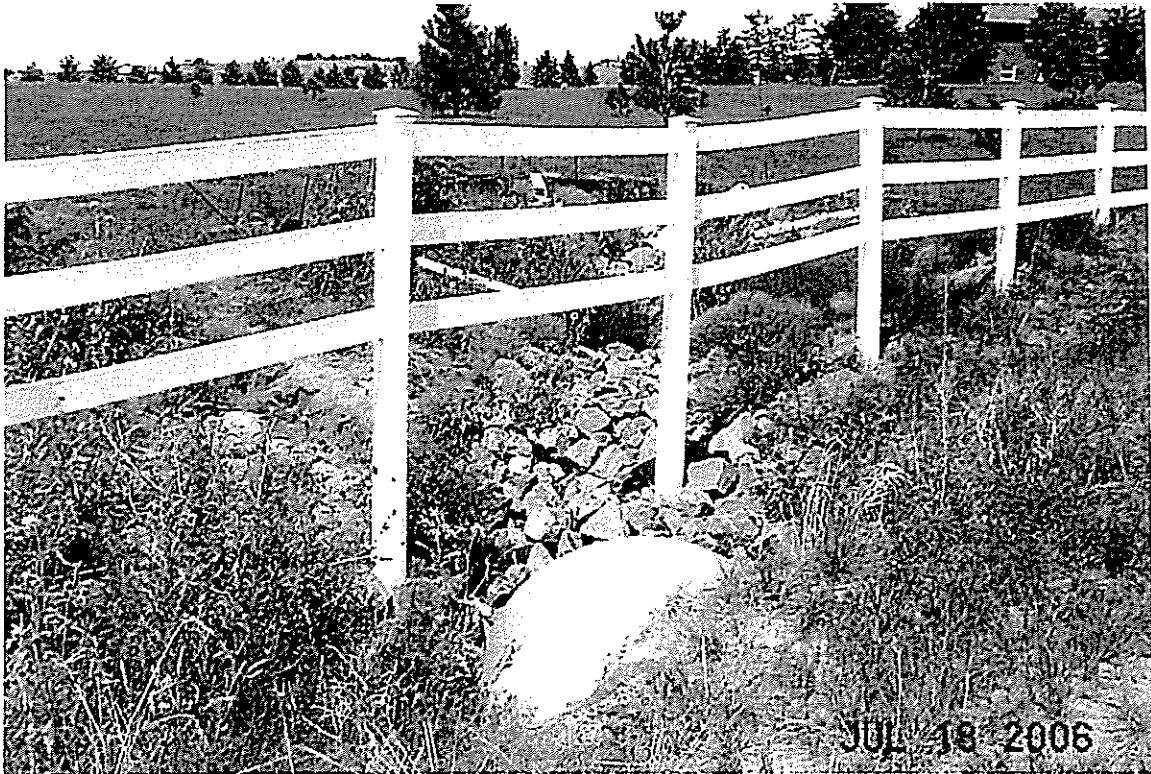
D6

Dodge Circle, 54" w x 38" h CMP Inlet Channel in Good Condition.

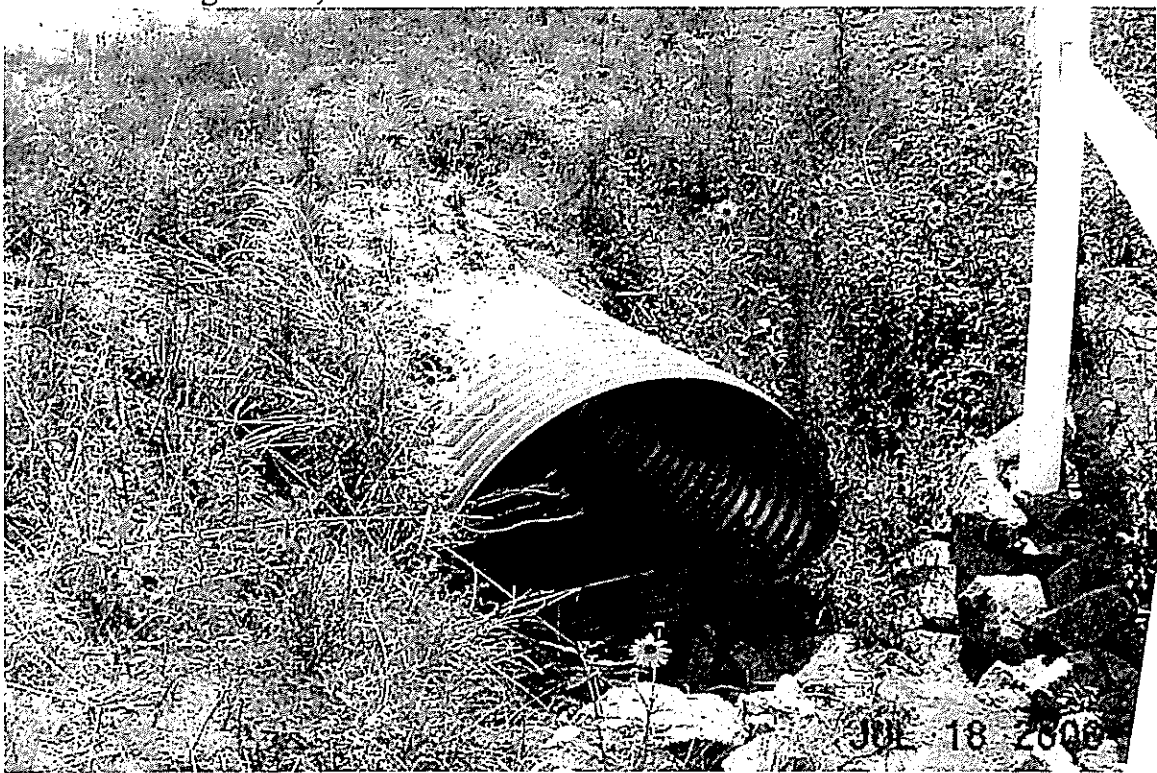
D6

Dodge Circle, 54" w x 38" h CMP Inlet, bent.

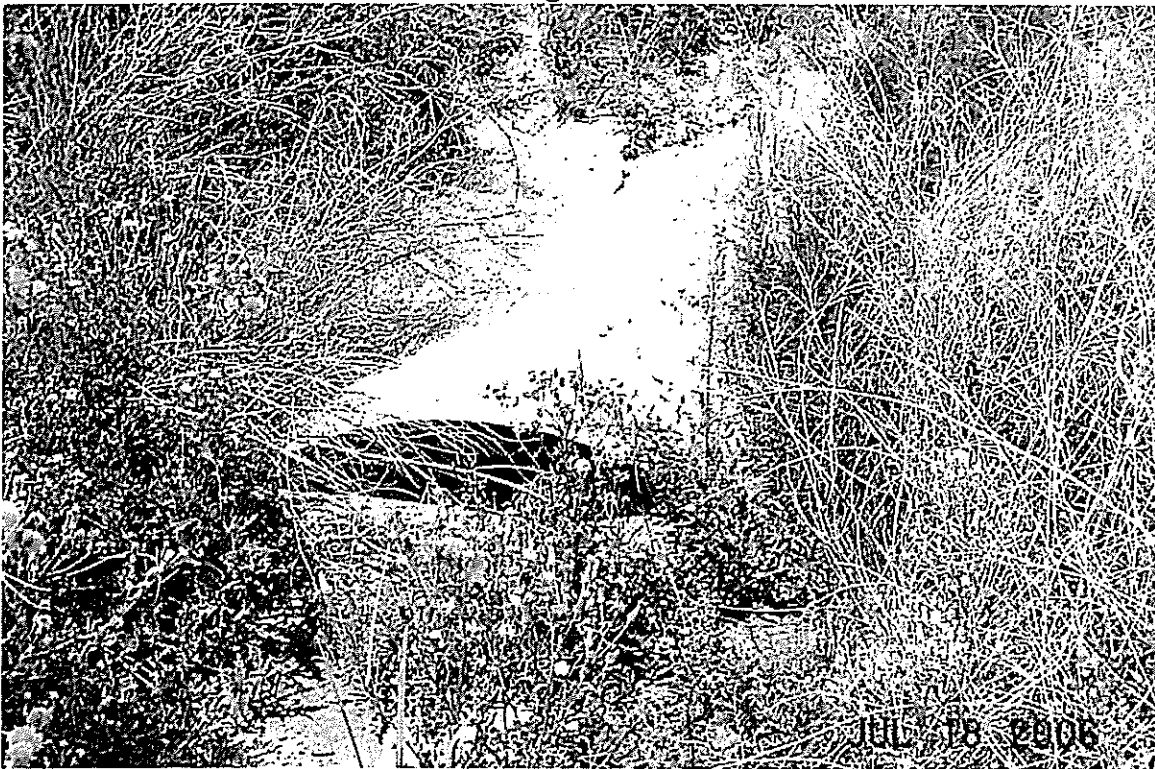
D6

Dodge Circle, 54" w x 38" h CMP Outlet.

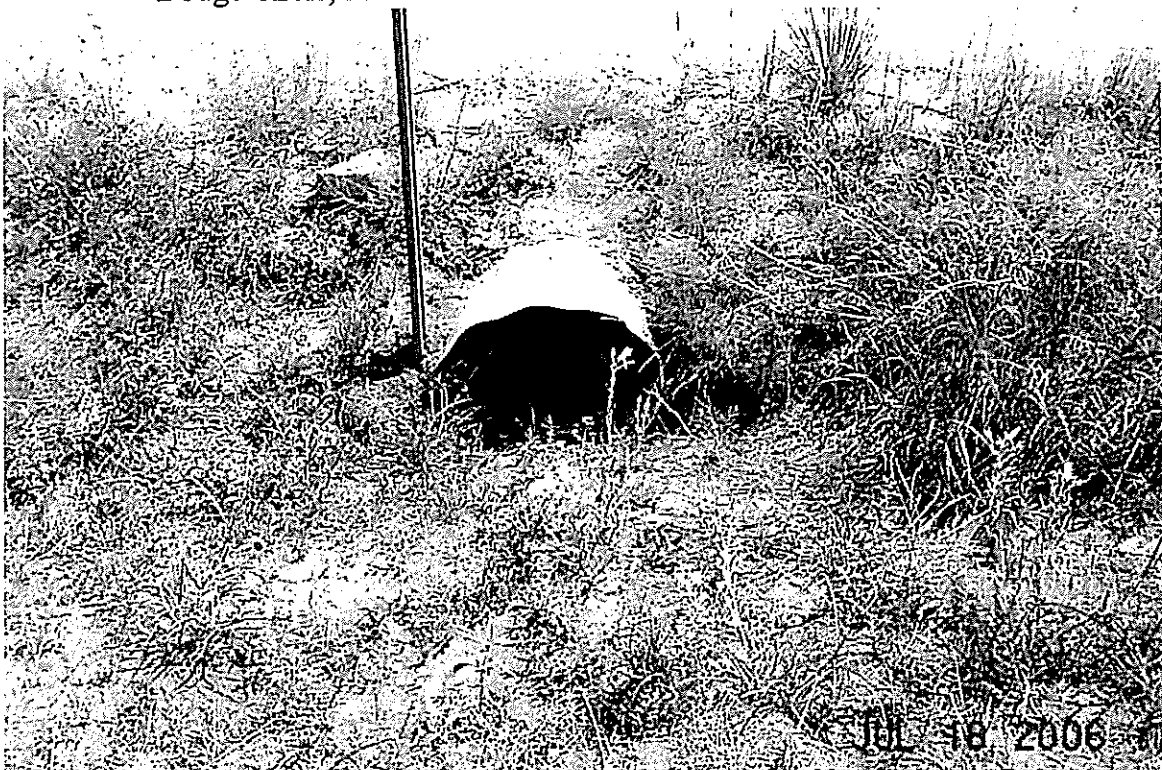
07

Dodge Circle, 30"w x 18" h CMP Inlet, bent.

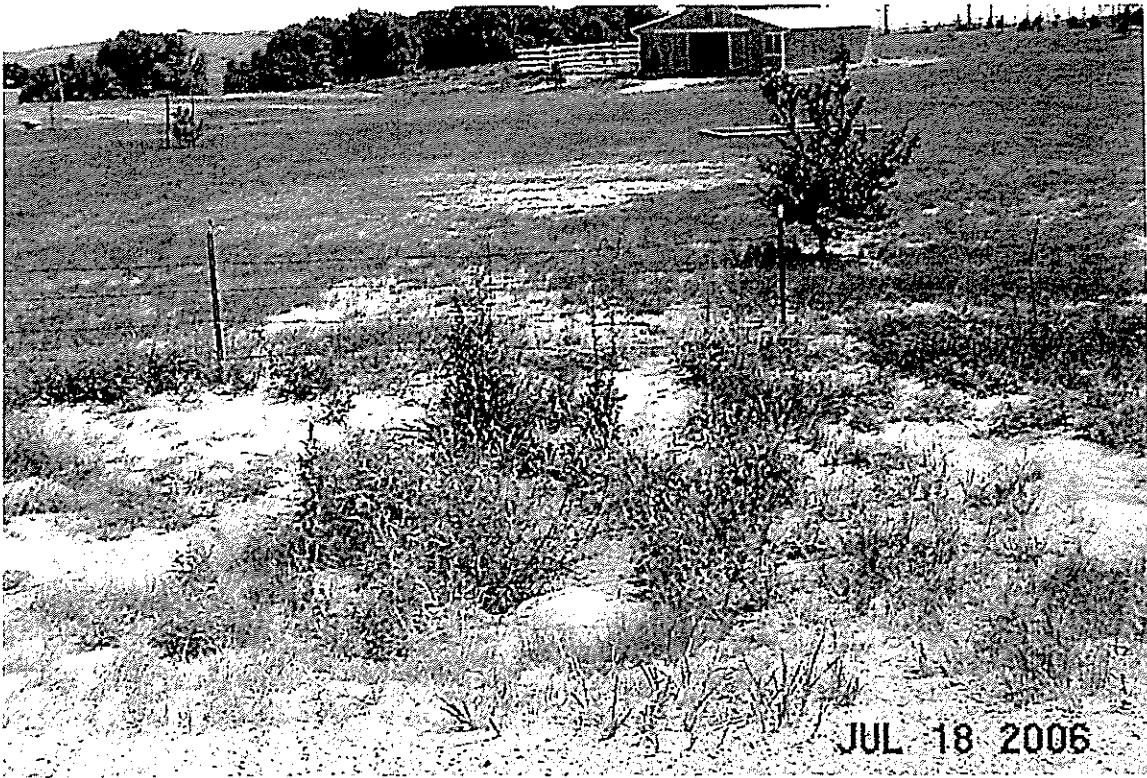
D7

Dodge Circle, 30" w x 18" h CMP Outlet Channel in Fair Condition.

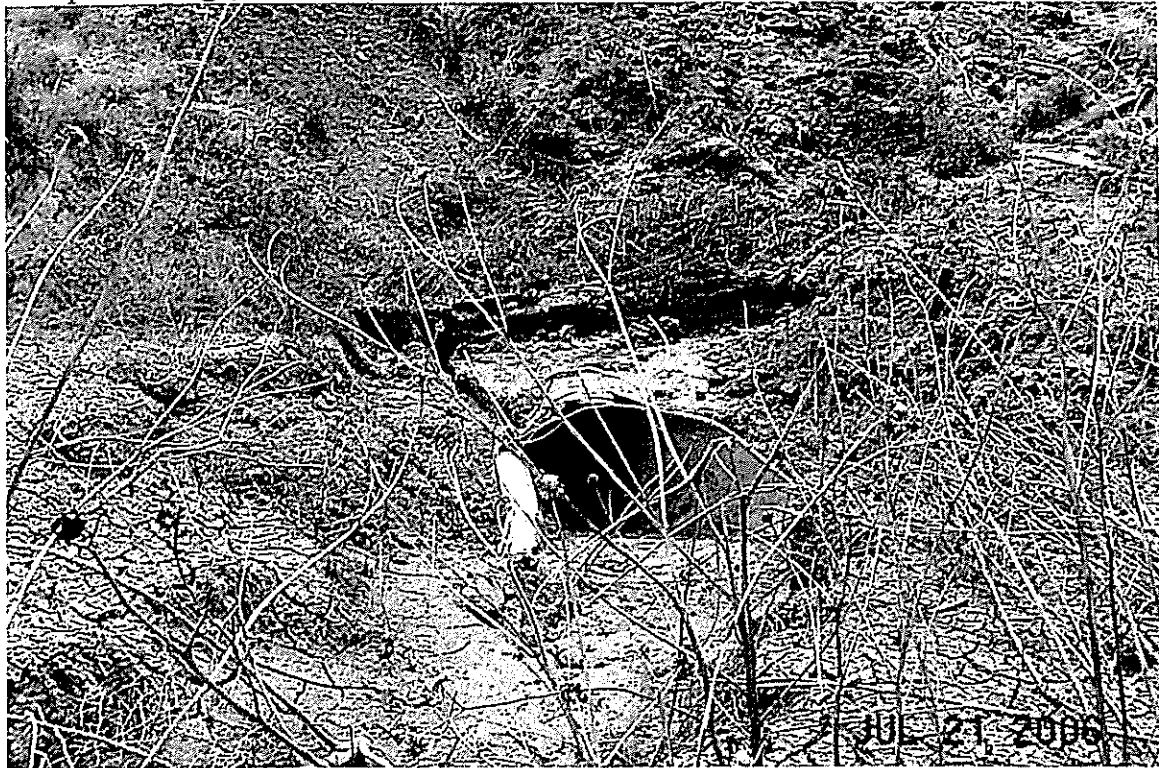
SI

Space Village, 28" CMP Inlet, bent.

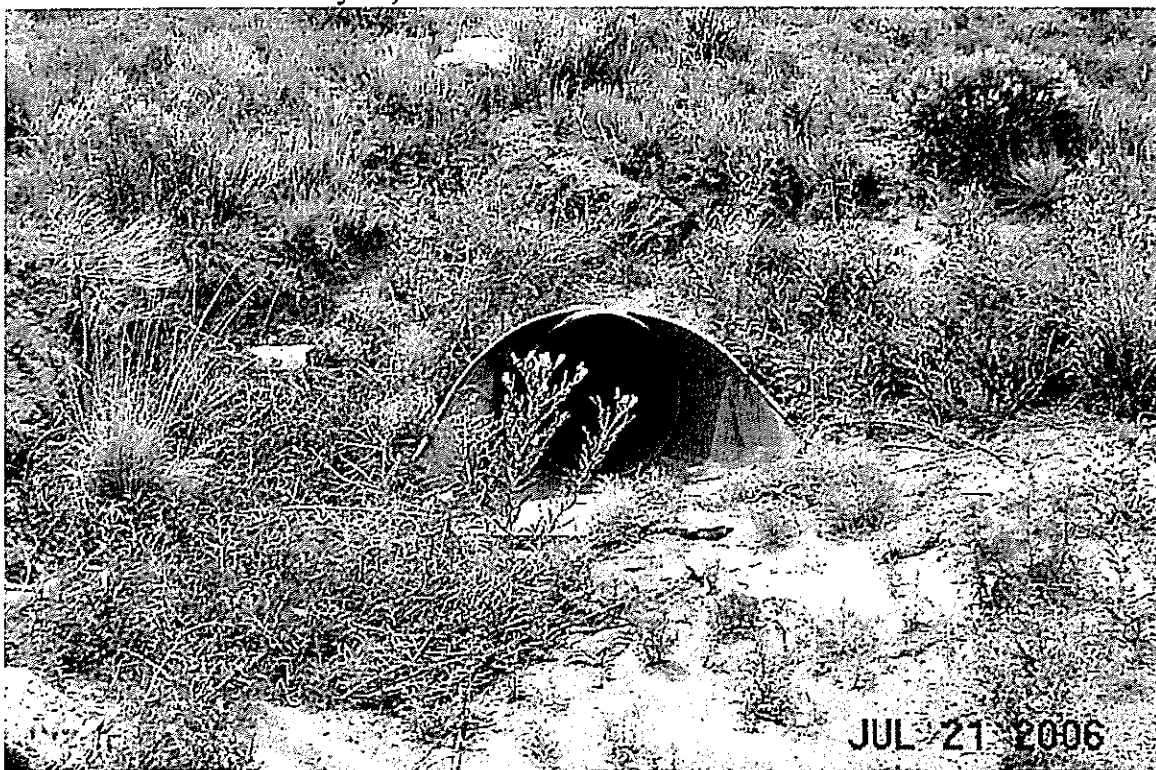
NFI

State Hwy 94, 36" CMP Inlet, bent.

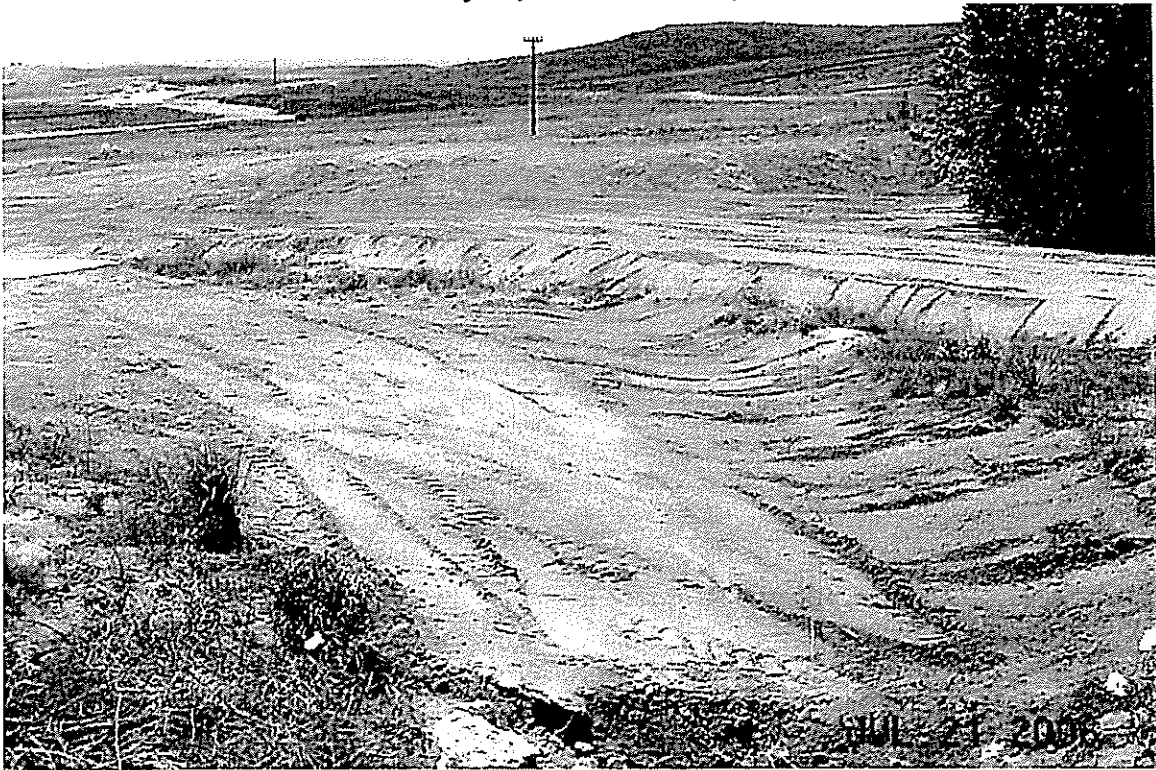
NFI

State Hwy 94, 36" CMP, Outlet Channel in Fair Condition. Appears to be drainage.

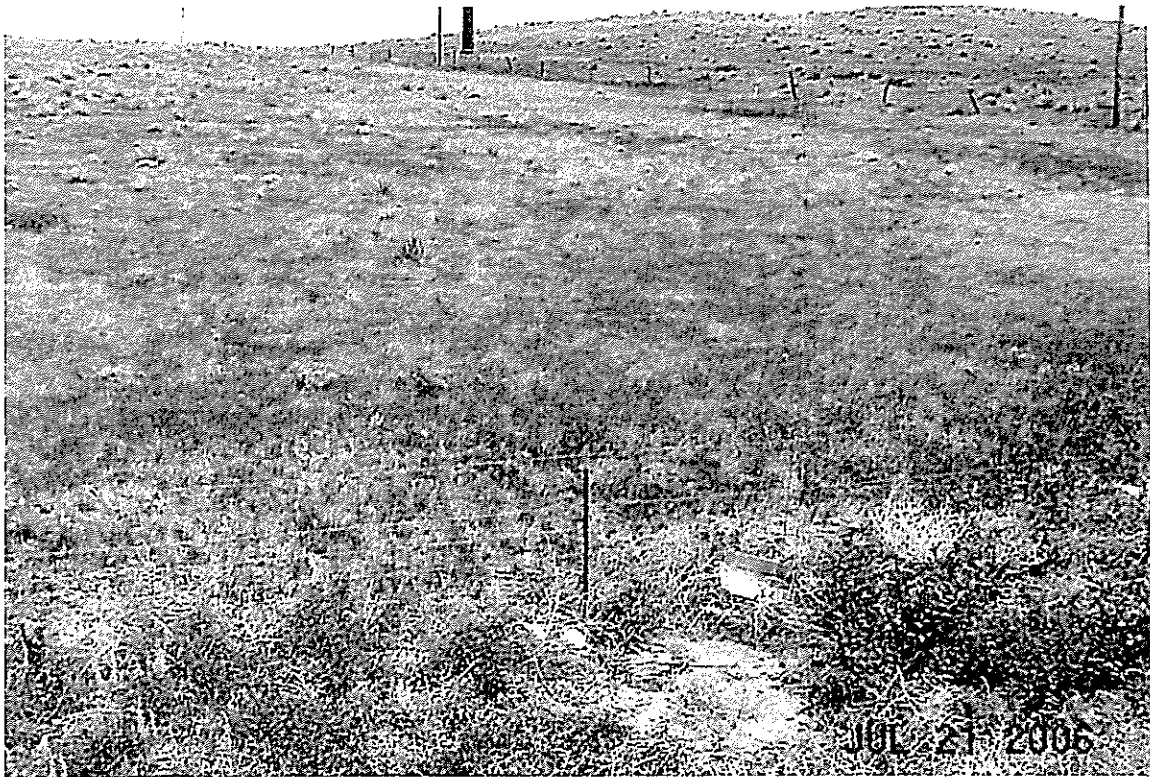
NF3

State Hwy 94, 24" CMP Inlet Channel in Good Condition.

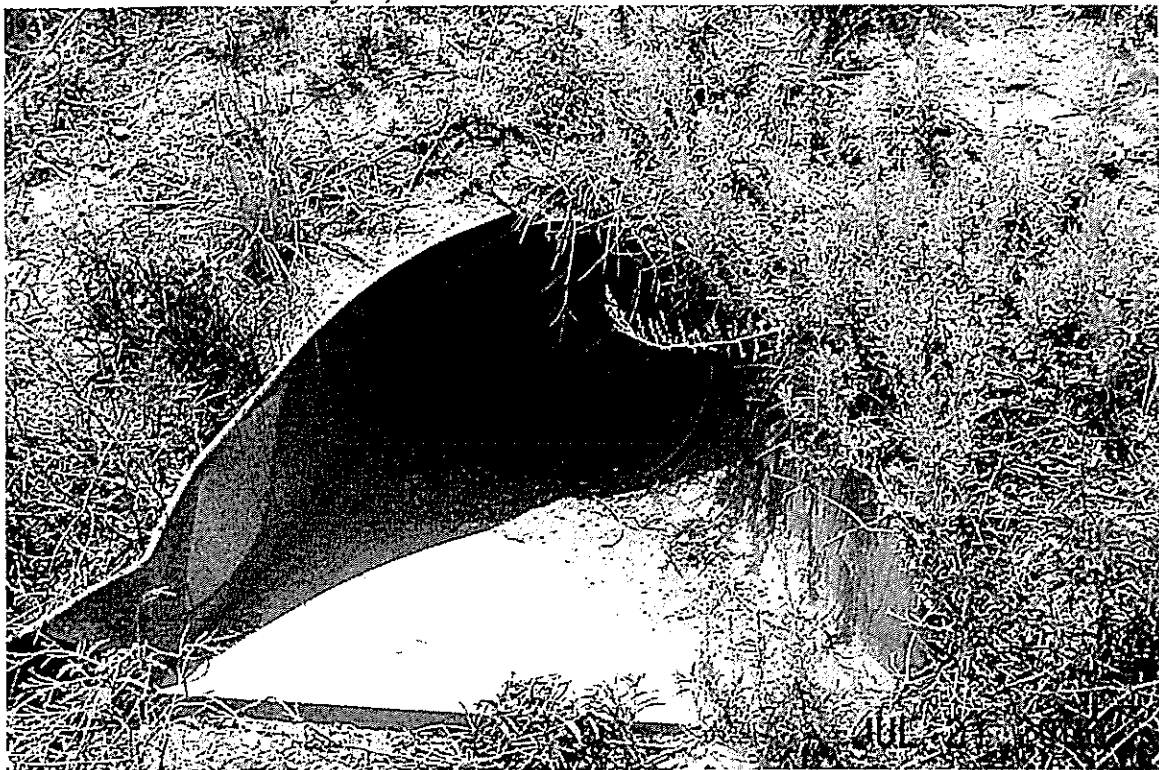
NF3

State Hwy 94, 24" CMP Inlet, CMP OK, Inlet bent.

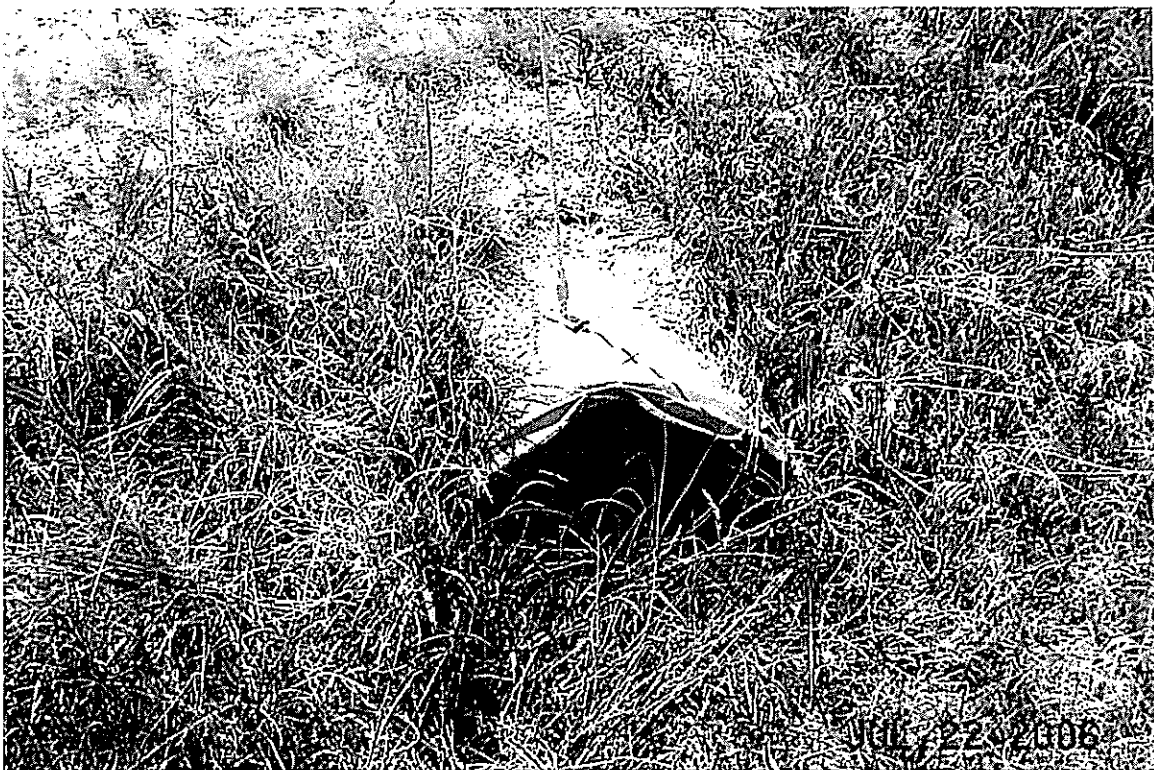
M1

Meridian Road, 21" CMP Inlet, bent.
