**APPENDIX D**  
**EXISTING FACILITIES**  
**Facility Summary**  
**Photographs**

Table 1 Existing Major Drainageway Structure Inventory

JIMMY CAMP CREEK DBPS  
OLD PUEBLO ROAD BRIDGE  
JIMMY CAMP CREEK  
EL PASO COUNTY, COLORADO  
BRIDGE PROFILE

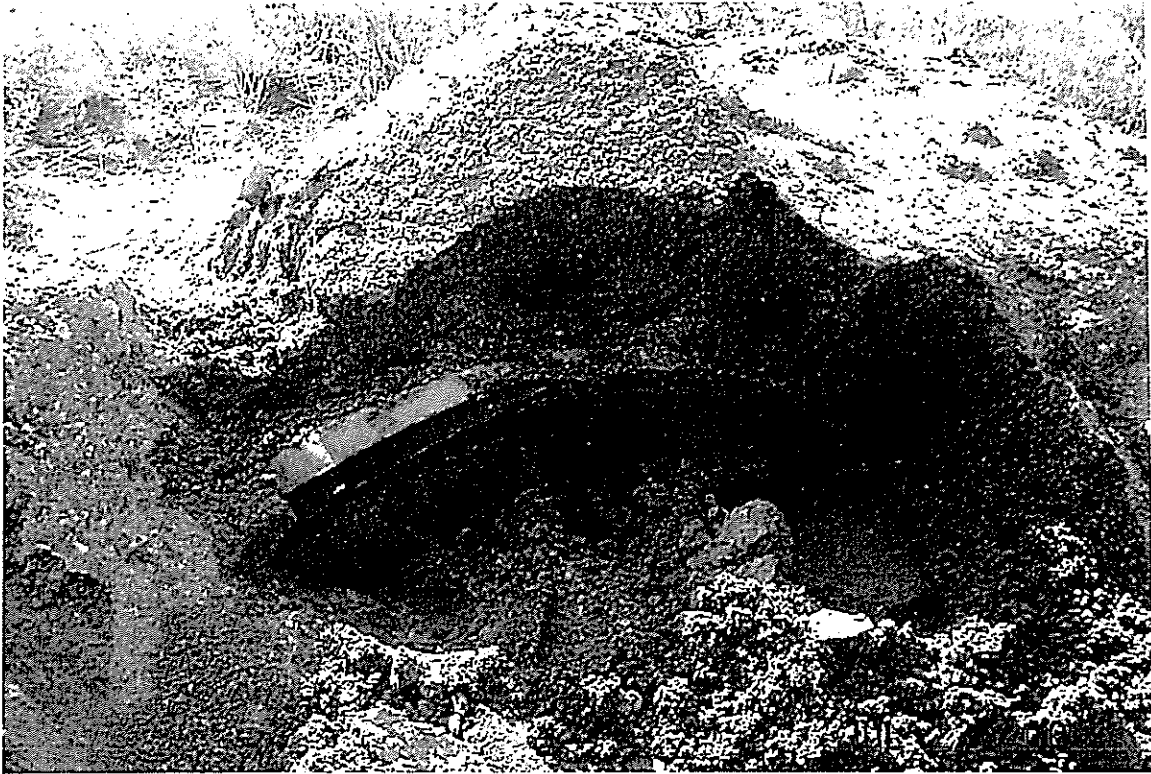
M3

Meridian Road, Two 48" w x 34" h CMPs Inlets. South Inlet is damaged.

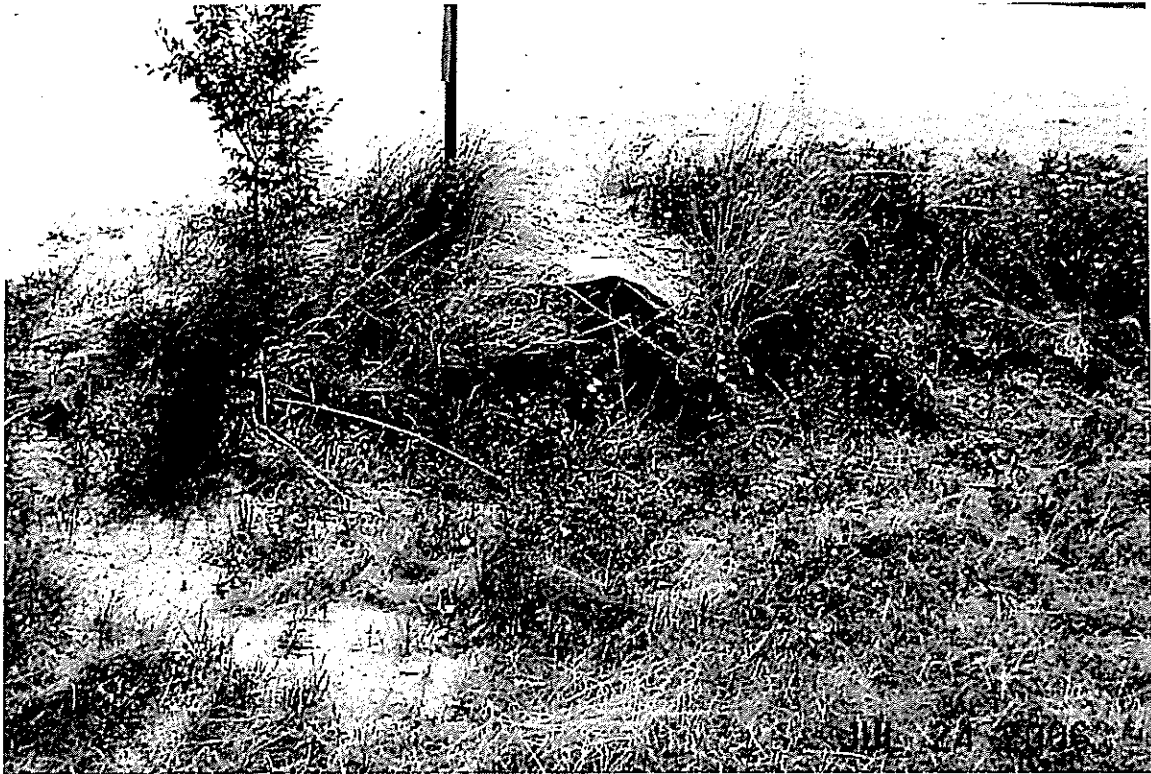
C3

Corral Valley Road, 24" CMP Outlet, bent.

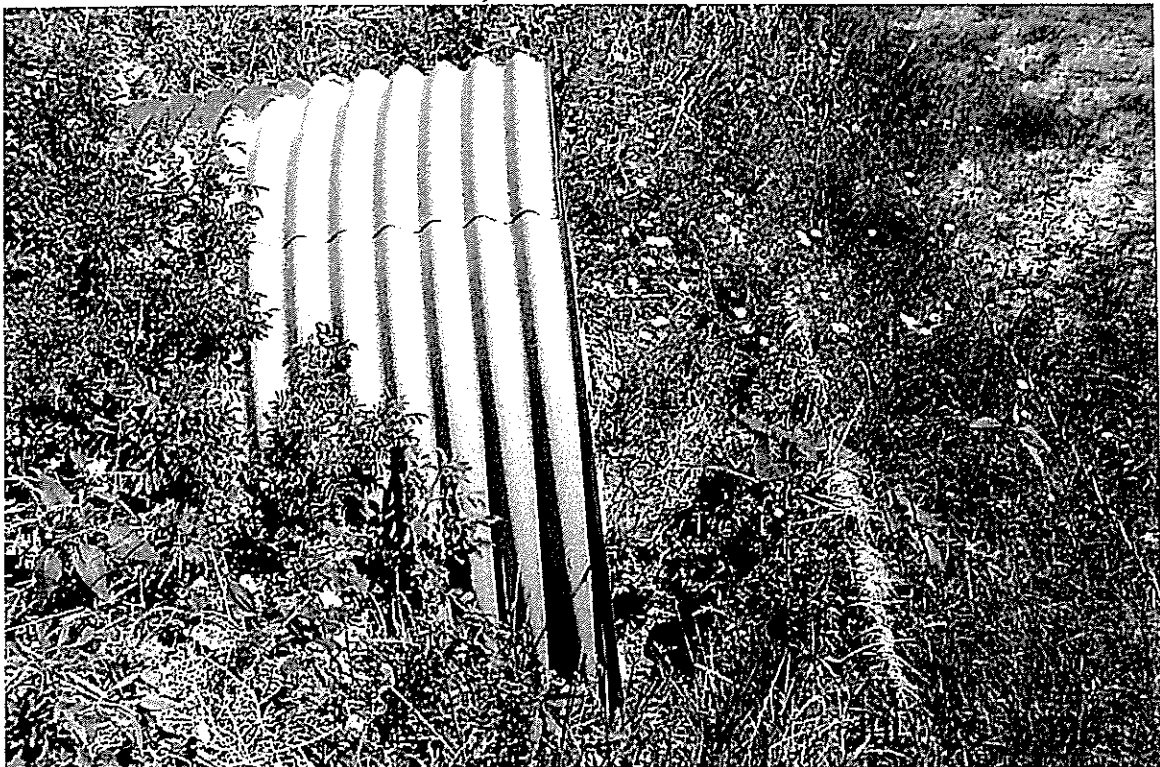
F1

Franceville Coal Mine Road, 54" CMP Inlet.

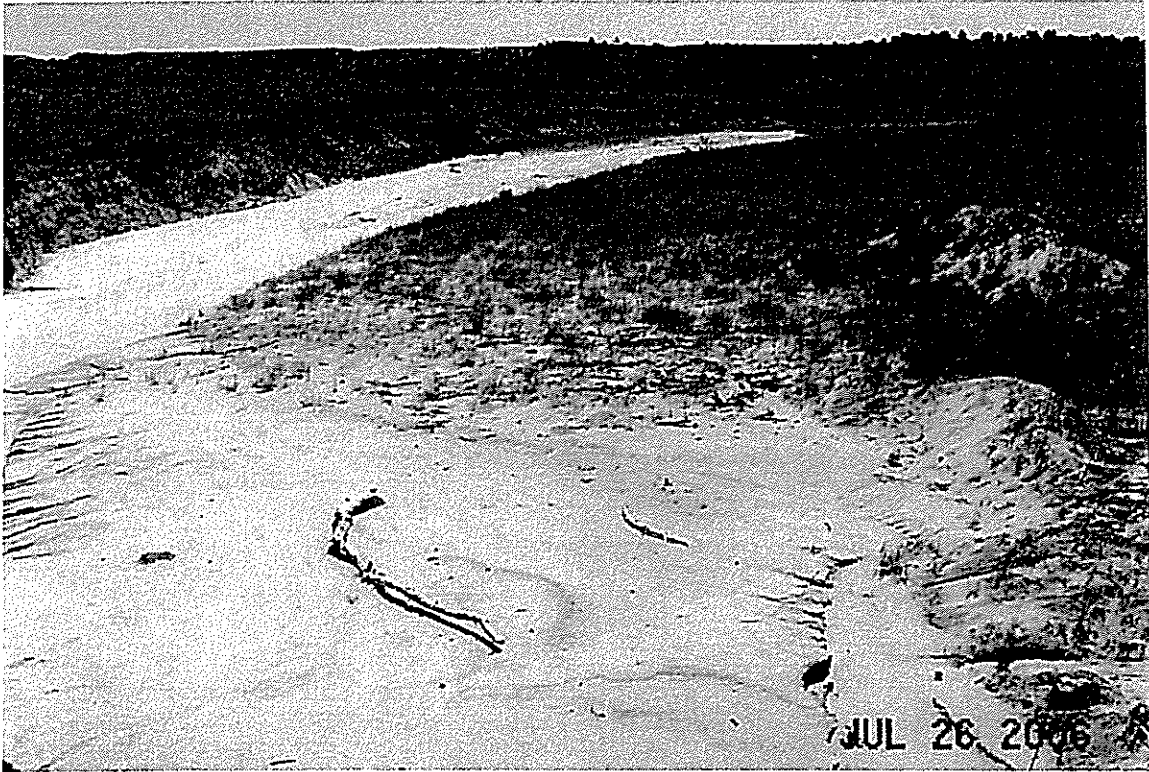
F2

Franceville Coal Mine Road, Three 60" RCPs Inlet Channel in Fair Condition.
