**APPENDIX A**  
**HYDROLOGY**

MESA DRAINAGE BASIN  
STRUCTURE INVENTORY

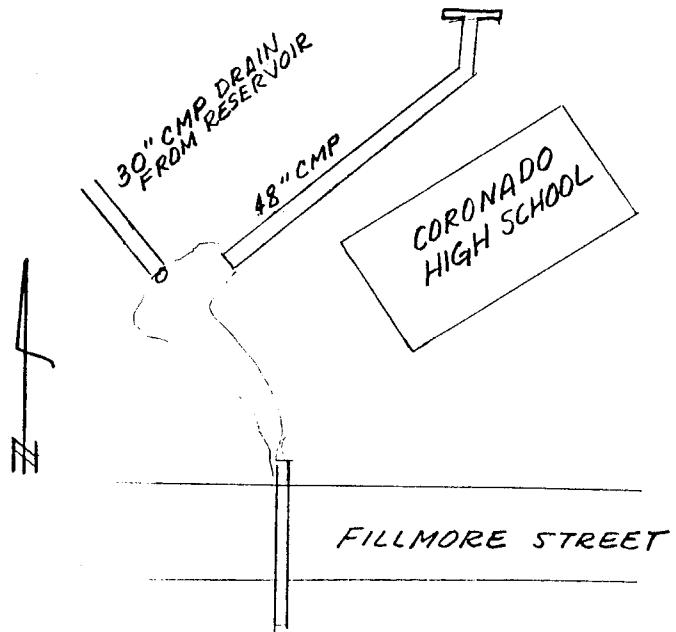
Condition: GOOD CONDITION. OUTLET HAS REBAR WELDED ACROSS AND PROBABLY NEEDS  
REGULAR MAINTENANCE

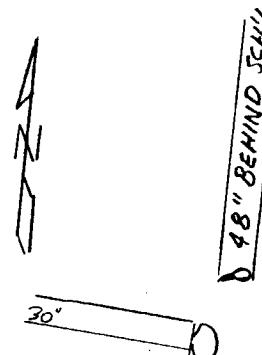
STRUCTURE NO. 7

Condition: GOOD : FLAPPER GATE ON DISCHARGE - THIS IS APPARENTLY A DRAIN  
FROM THE RESERVOIR

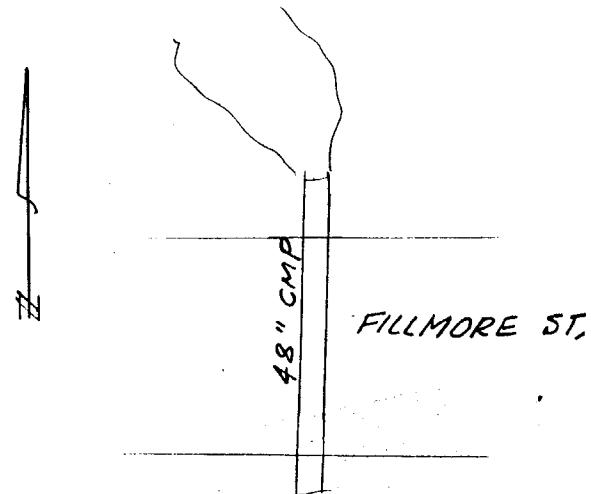
Condition: BOTTOM OF PIPE IS STARTING TO SHOW SOME HOLES

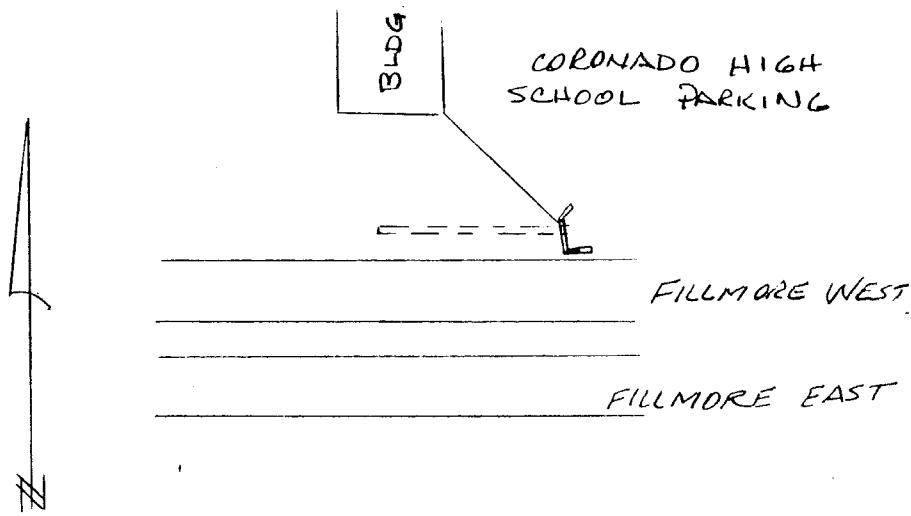
Condition: GOOD, EACH END HAS BARS WELDED ACROSS AND REQUIRES MAINTENANCE

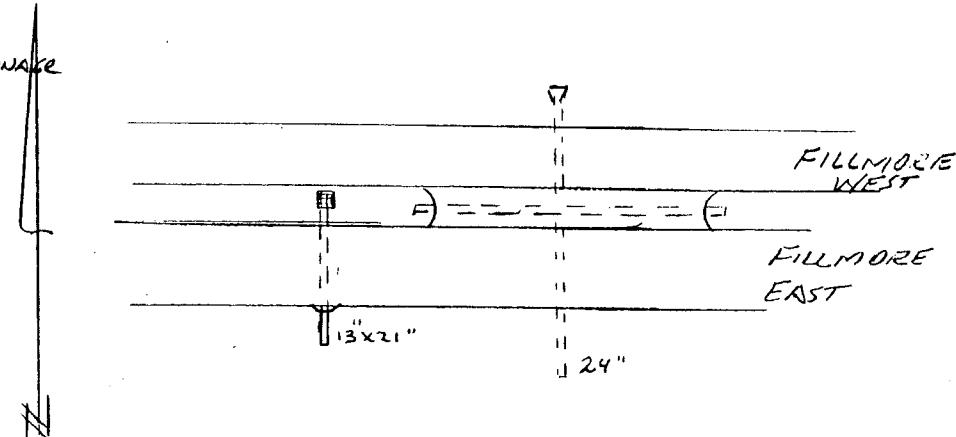
Condition: DISCHARGE PIPE IS ERODED BADLY UNDERNEATH FILLMORE, NEEDS IMMEDIATE ATTENTION

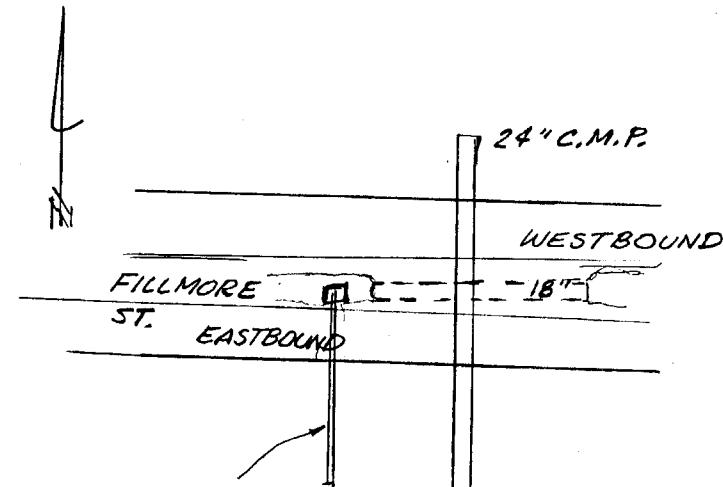
Condition: DOWNSTREAM END MOSTLY PLUGGED

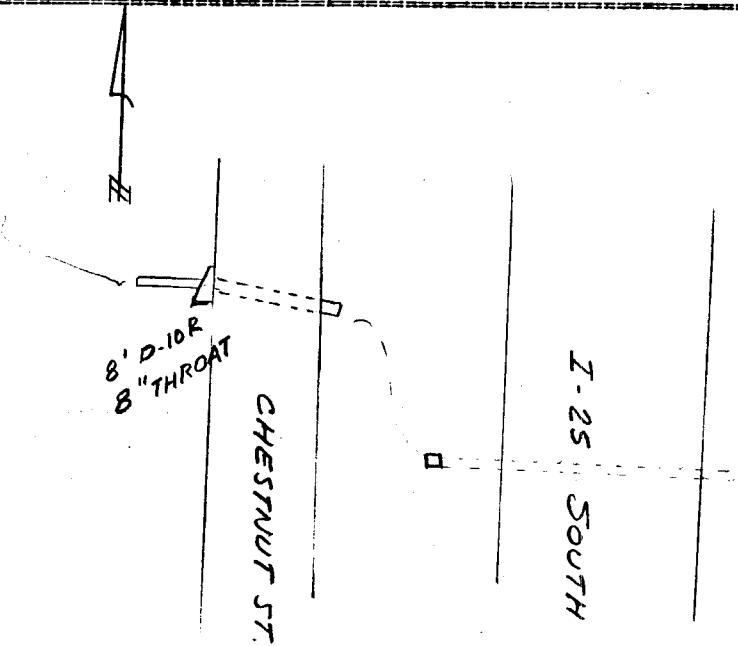
Condition: D-10-R IN VERY BAD CONDITION, SHOULD BE REPLACED IMMEDIATELY

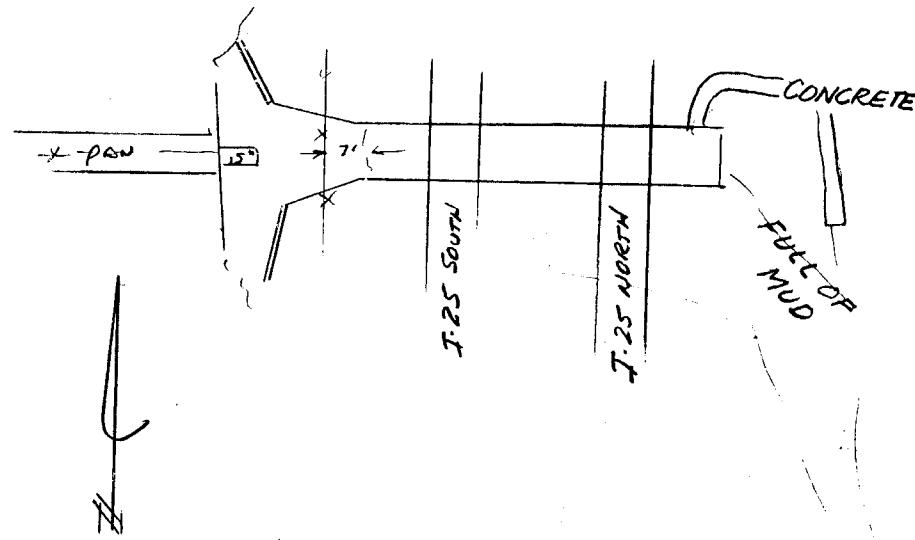
Condition: FAIR CONDITION-SOME IRREGULARITY IN FLOW, DOWNSTREAM &amp; PARTIALLY PLUGGED
