Monument Creek Study

THE CITY OF COLORADO SPRINGS, COLORADO

G. J. WEISS AND ASSOCIATES

MARCH 1974

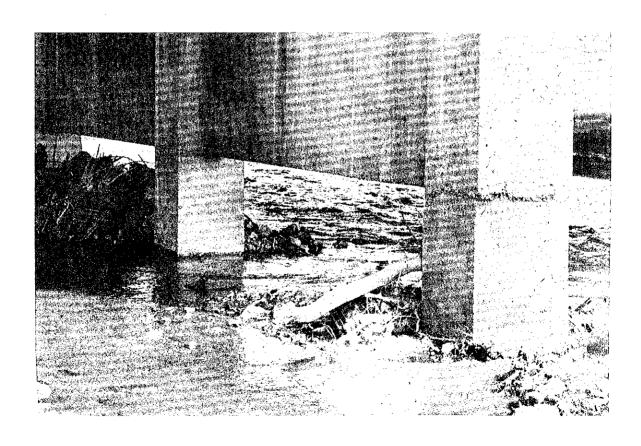
The structure appears to be in good condition, but channel erosion has lowered the stream bed below the solid piers, exposing about 4' of the caissons. The 100 year flood plain level is 2.0' below the low steel of the bridge, as shown in the Corps of Engineers Study, dated March 1973.

STATION 67 + 00 EXPOSED CAISSONS AT CIMARRON

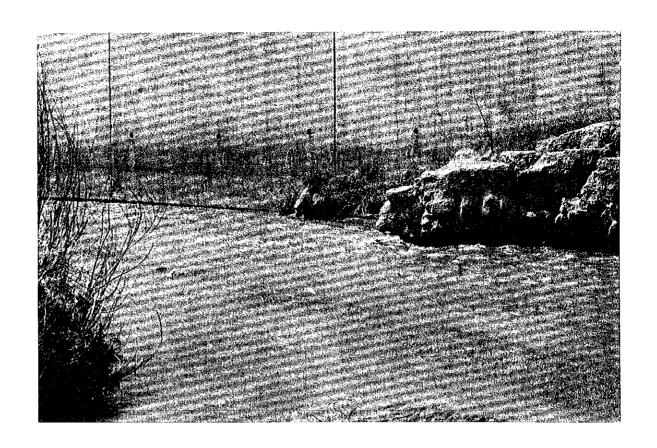
The channel has an 80° change of direction flowing between these two points. A vertical concrete wall exists on the west (outside) bank of the curve with erosion evident along the bottom of the wall. The east bank (inside of curve) has not been lined and is stabilized only by a few sections of broken concrete in the fill. A large section of the washed out bridge abutment lies in the channel, in this area and causes an obstruction to flow during large runoff.

STATION 109 + OO EROSION ALONG WALL AT BIJOU

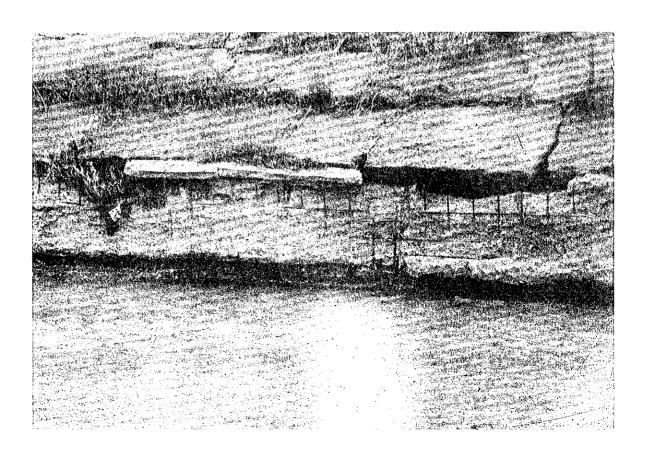
The vertical retaining wall is being undercut by the stream flow and portions of the concrete wall are spalling with the rebar being visible.

STATION 183 + OO DETERIORATION OF EAST WALL

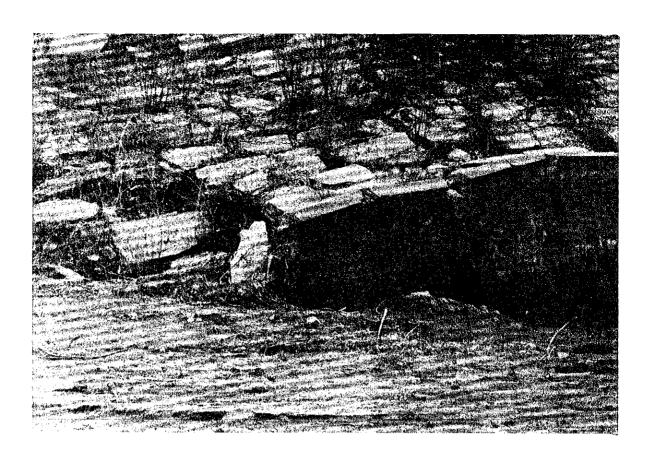
The vertical wall along the east bank has been undercut during some previous storms and about 100' of wall has completely collapsed and washed downstream, leaving an earth dike. Another 500' of vertical wall is leaning and the rock slope lining behind it has sunken adjacent to the vertical wall. This section of lining is on the outside curve of the channel and is very susceptible to further serious damage until such time as it is repaired.

STATION 202 + 50 FAILURE OF EAST BANK

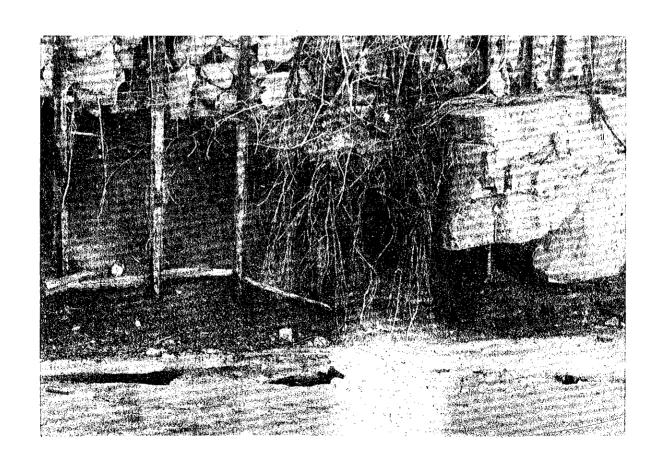
STATION 224 + 10 UNDERCUT APPROACH TO R.R. BRIDGE
