DOUGLAS CREEK DRAINAGE STUDY

JUNE 1974

THE LINCOLN DEVORE TESTING LABORATORY
COLORADO SPRINGS, COLORADO

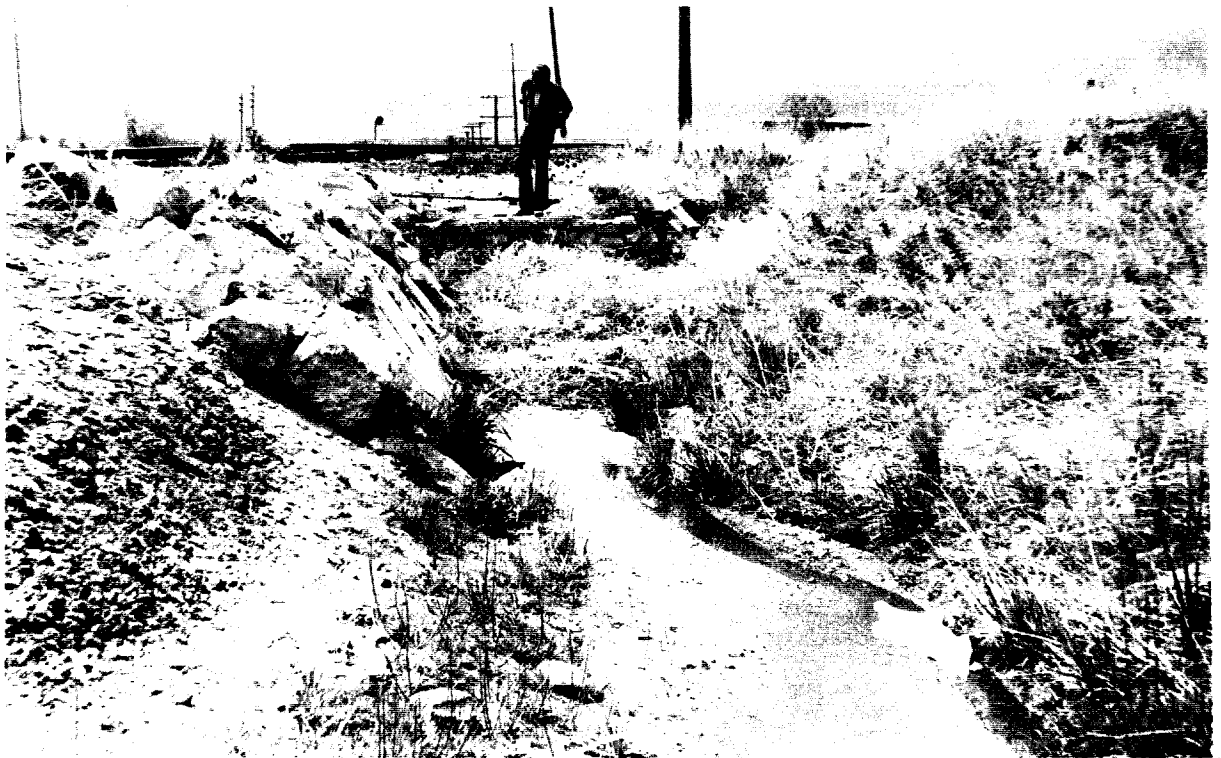
18. View of culvert containing the trackside drainage ditch under the Rusina Valley Railway spur immediately north of North Douglas Creek and west of the junction with the railroad mainline. This culvert is blocked by weeds and debris, and is typical of many structures needing maintenance.
