ROCKRIMMON DBPS  
ALTERNATIVE ANALYSIS

October 18, 1990

KLH Engineering, Inc.  
206-208 Sutton Lane  
Colorado Springs, CO 80907

ROCKRIMMON DBPS  
KLH NO. 88 548 00  
Summary of Alternatives

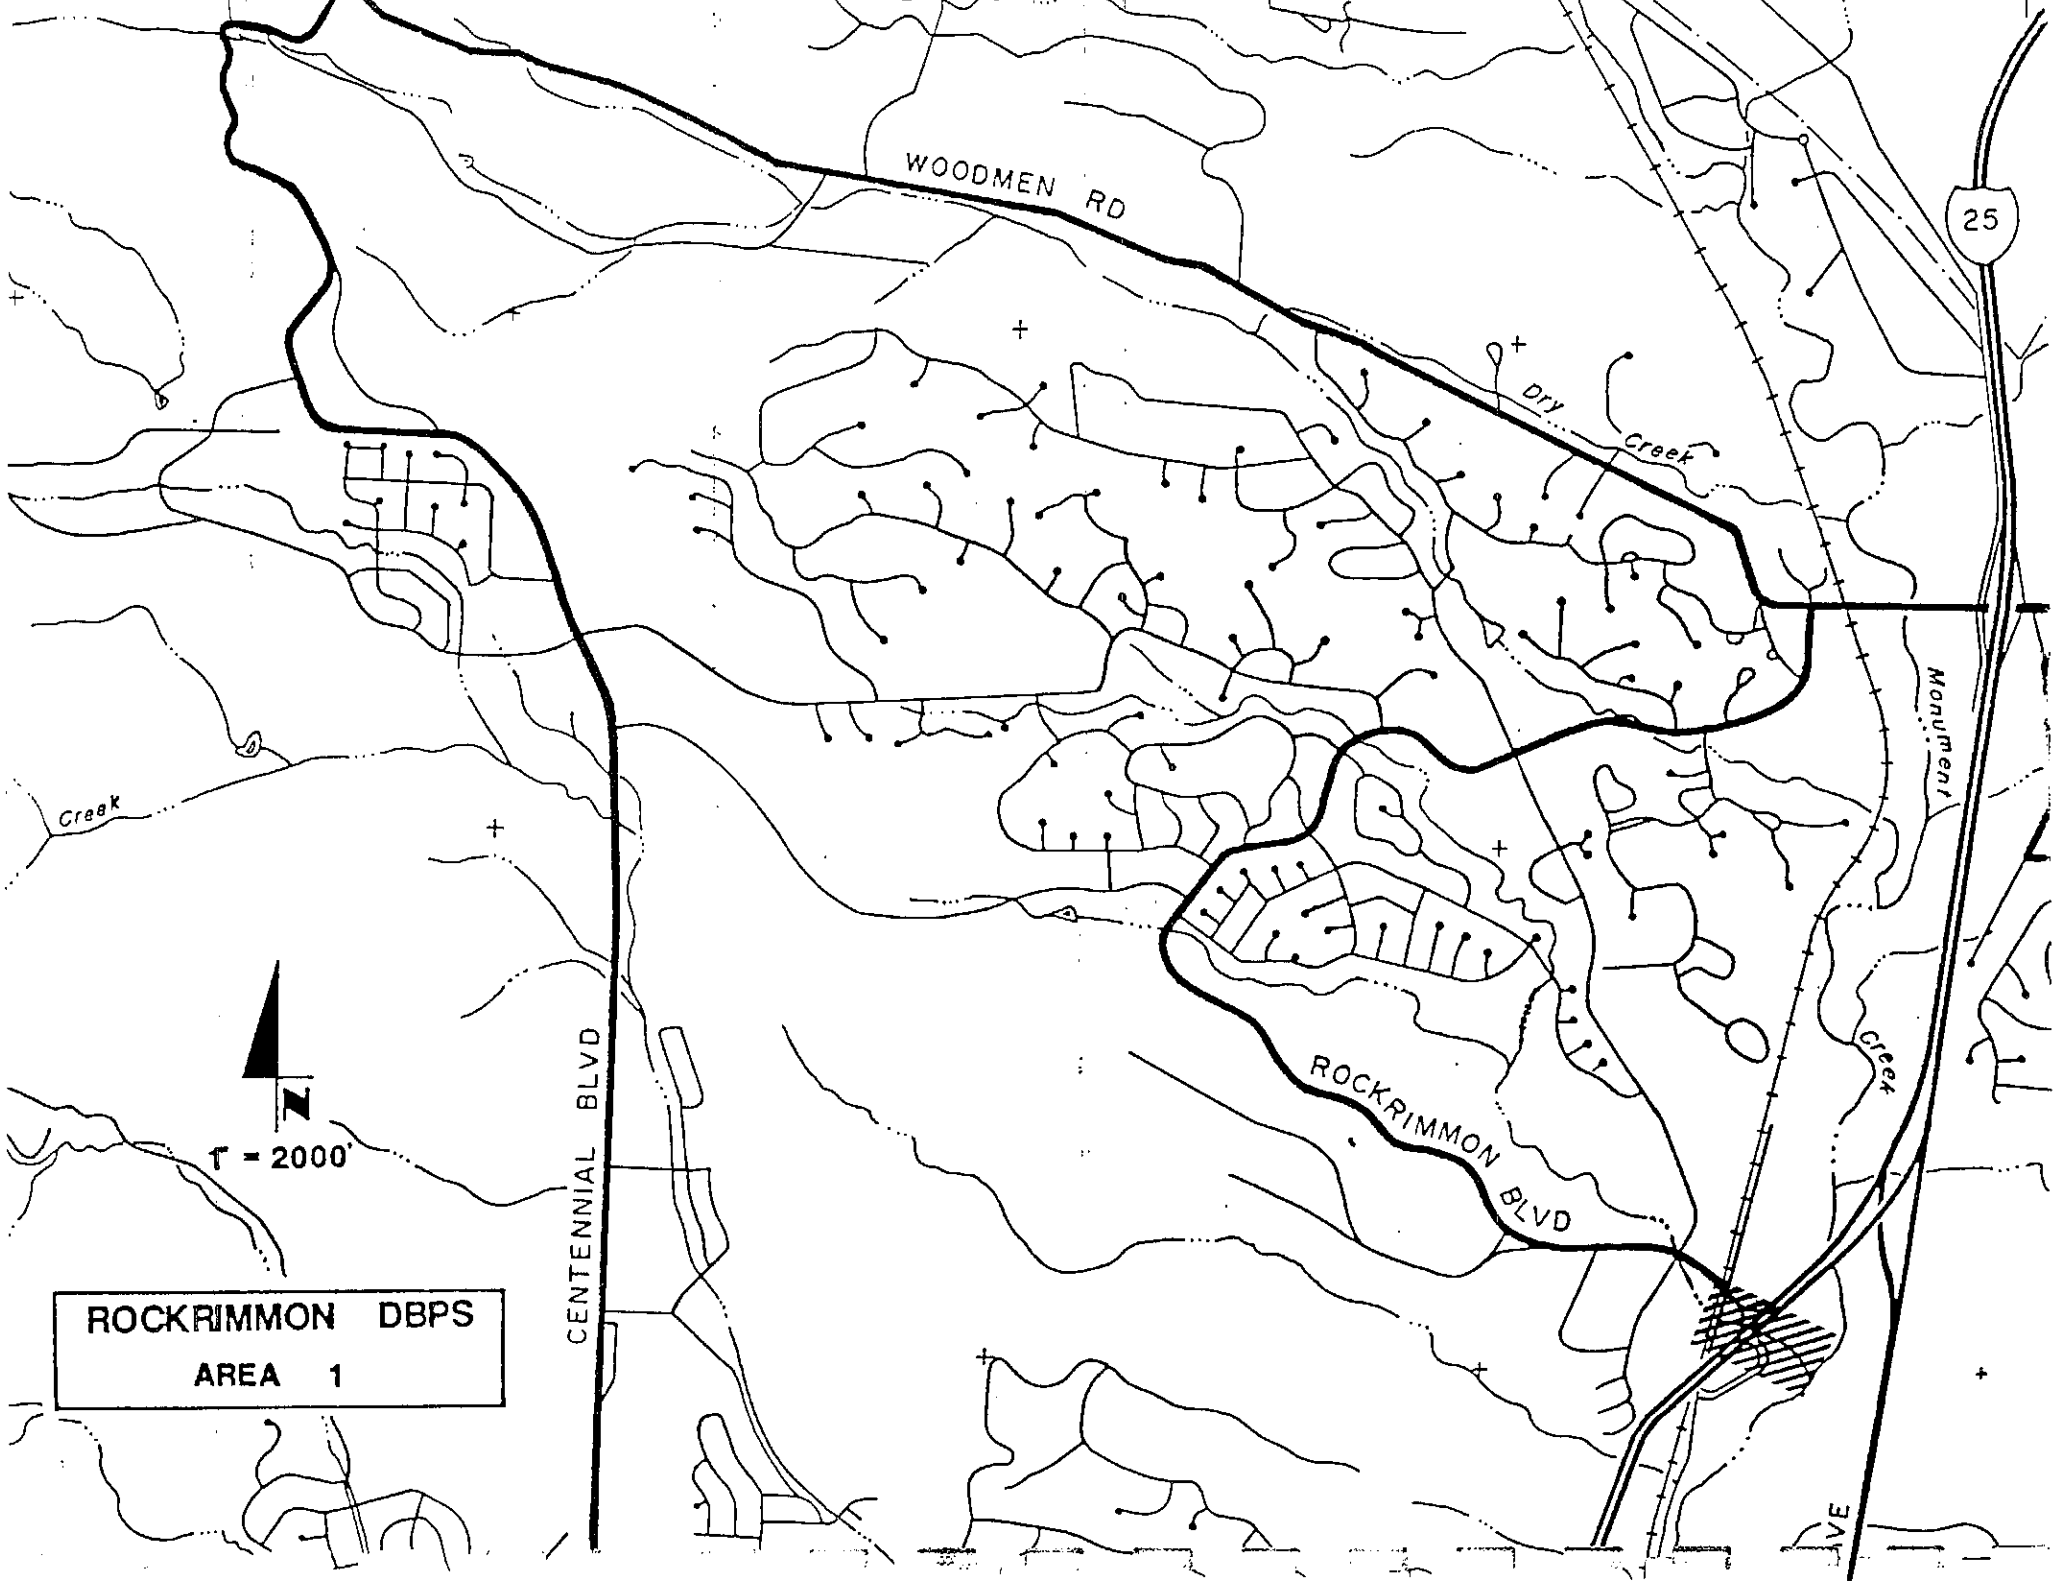
ROCKRIMMON DBPS  
AREA 1

The majority of this reach consists of existing concrete box culverts under an office complex parking area, Mark Dabling Blvd., I-25 and the D & RGW Railroad. The remainder of the channel consists of a 160 L.F. section of concrete channel with vertical side walls and a 50 L.F. section of open ditch at a change in box culvert direction. All of this reach is stable under the present conditions, but it is all inadequate for the 100-yr. storm runoff. Proposed measures for increasing the capacity of this reach are included in the report being prepared. If these improvements are implemented, the 50 L.F. section of open ditch will have to be protected to avoid erosion. Land uses for this reach are already completely in place and include mostly transportation corridors with one office complex.

If future improvements are made to expand the capacity of the existing channel, short term impacts such as erosion and increased sedimentation should be handled in an acceptable manner. If flows or velocities are increased along this reach, the potential for increased erosion will exist at the outfall point to Monument Creek. Acceptable methods of mitigating this impact should be considered before any improvements occur upstream.

It is recommended that an attempt be made to reduce the flow with detention facilities to the capacity of this reach. If this proves to be impossible or unfeasible, additional culverts will be required. Recommend Alternative B for open channel area.

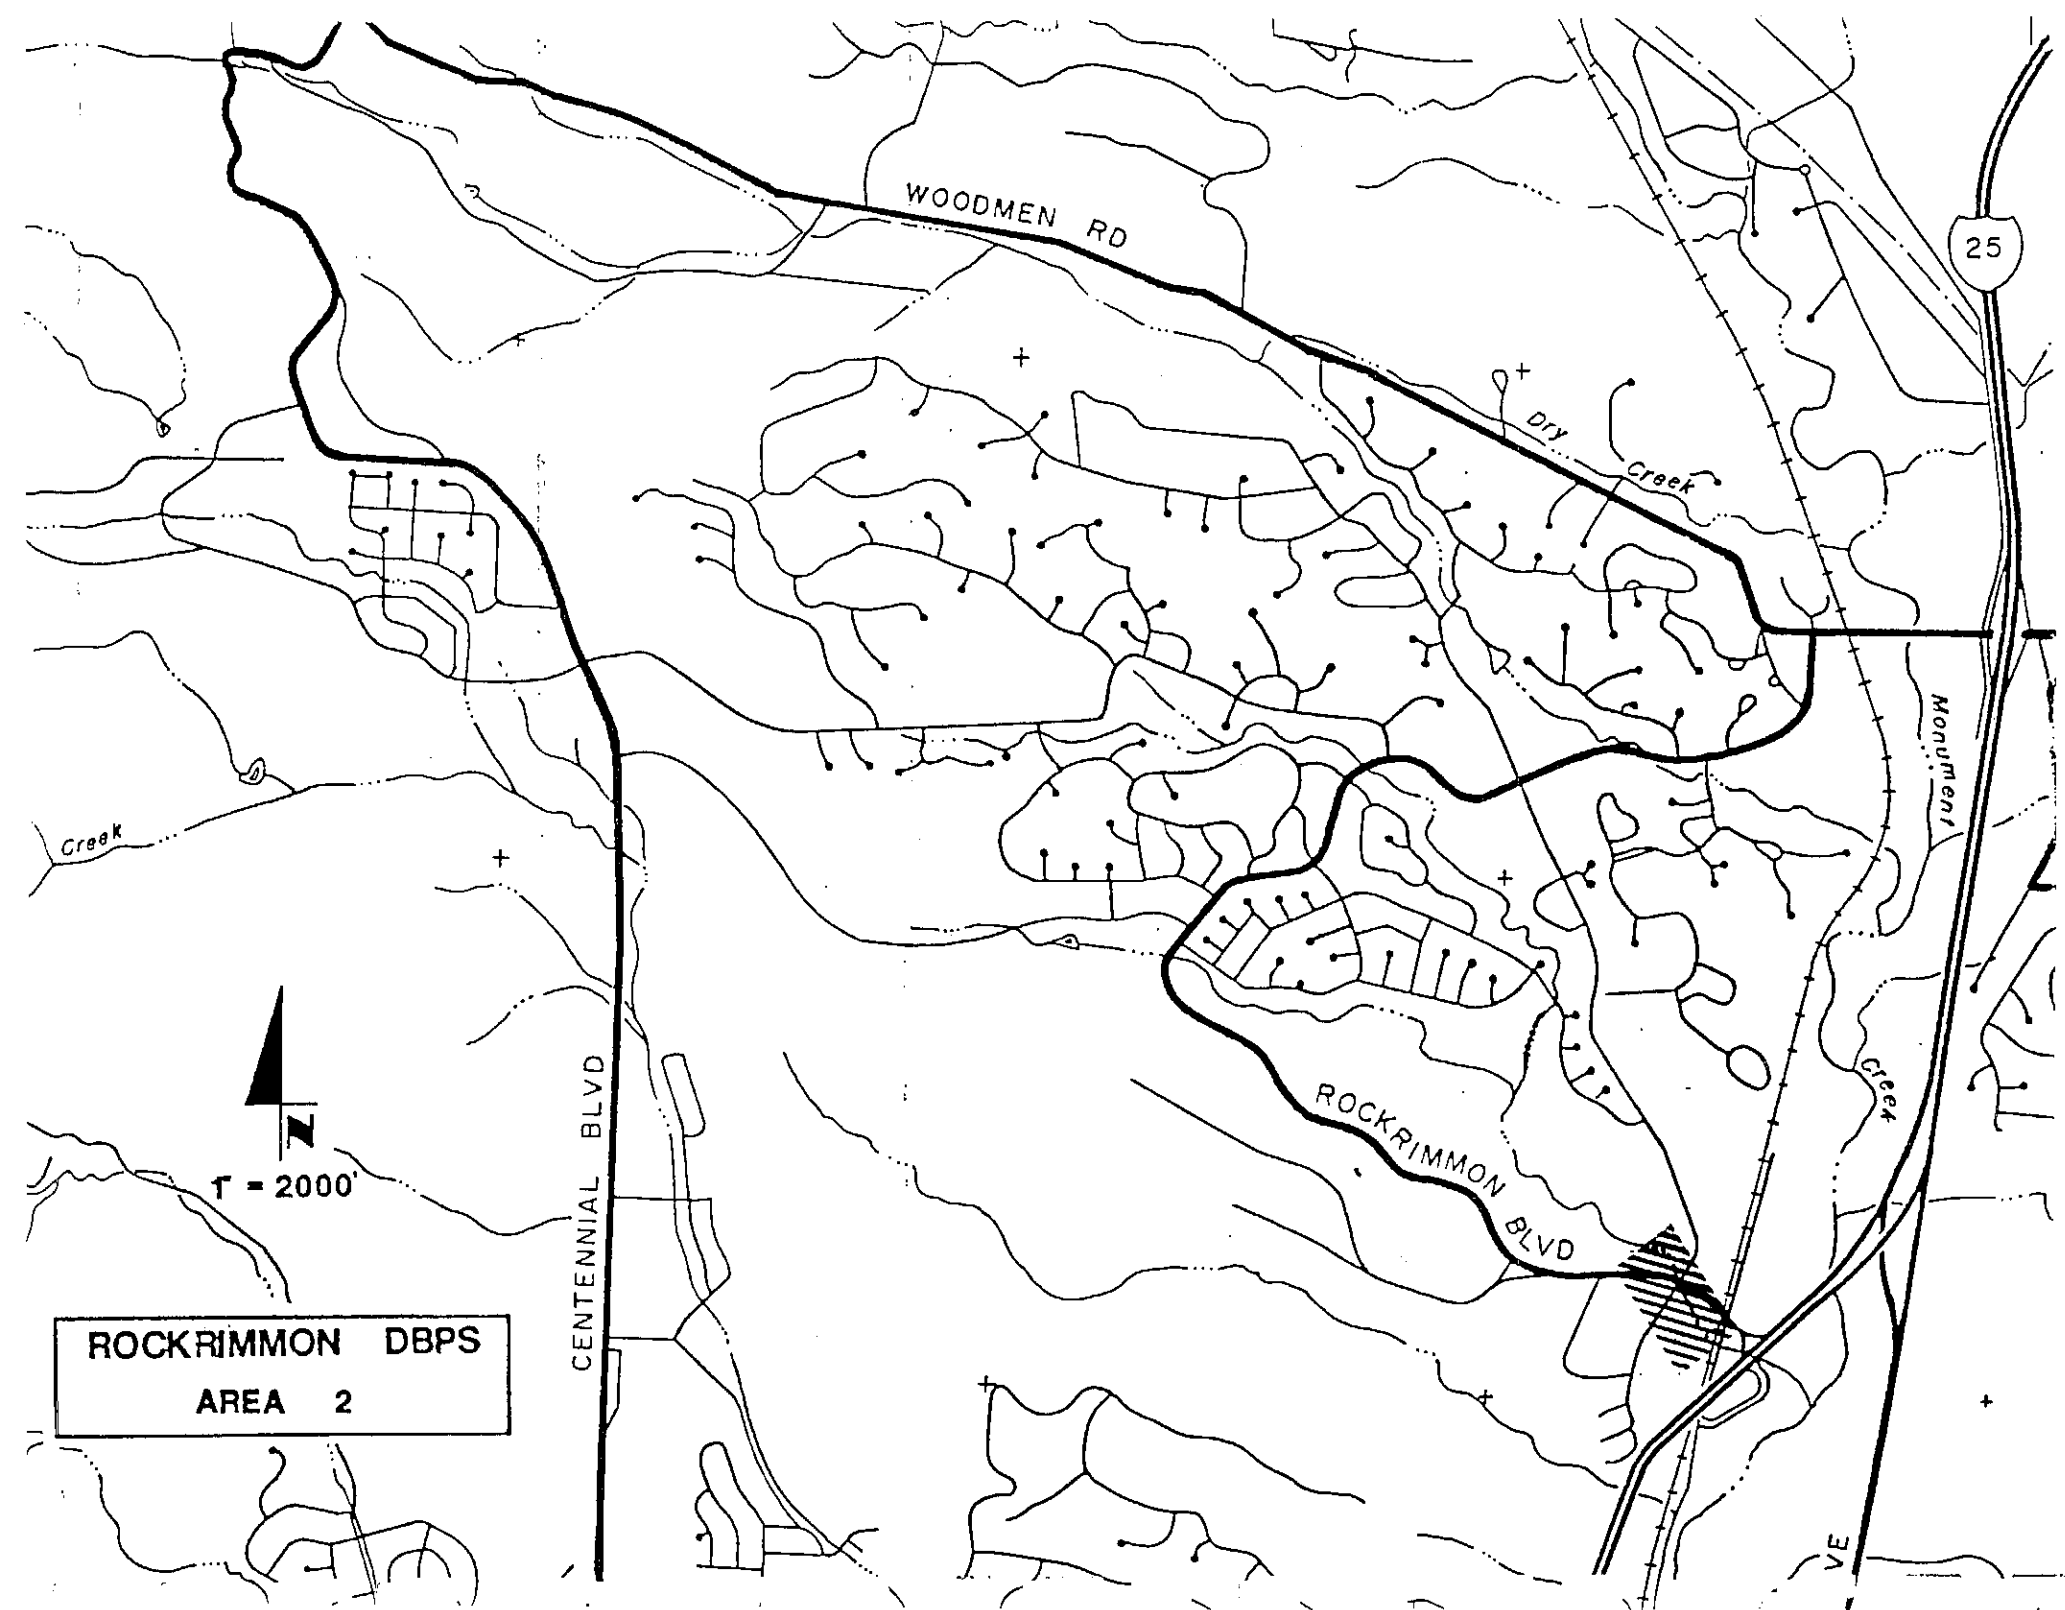
ROCKRIMMON DBPS  
AREA 2

Half of this reach consists of concrete lined channel and a concrete box culvert. Neither is adequate for the 100-year flow, though neither shows any signs of erosion, except at the discharge point of the culvert. The remainder of this reach consists of an open dirt channel with relatively minor erosion occurring. If the culverts through reach 1 are made adequate for the 100-year flows, the increased velocities in this area will cause significant erosion. There are no wetlands or wildlife habitats in this reach. Land use in the surrounding area is commercial/industrial.

Existing concrete lined channel is adequate for 100-year storm, but does not have required freeboard. Detention upstream will reduce flows and provide required freeboard. Recommend no improvements of this section. Also recommend the construction of a drop structure with associated bed and bank stabilization at the discharge end of the culvert under the intersection of Delmonico and Rockrimmon.

It is recommended that an attempt be made to reduce the flow with detention facilities to the capacity of this reach. If this proves to be impossible or unfeasible, additional culverts will be required. Recommend Alternative A for open channel area.

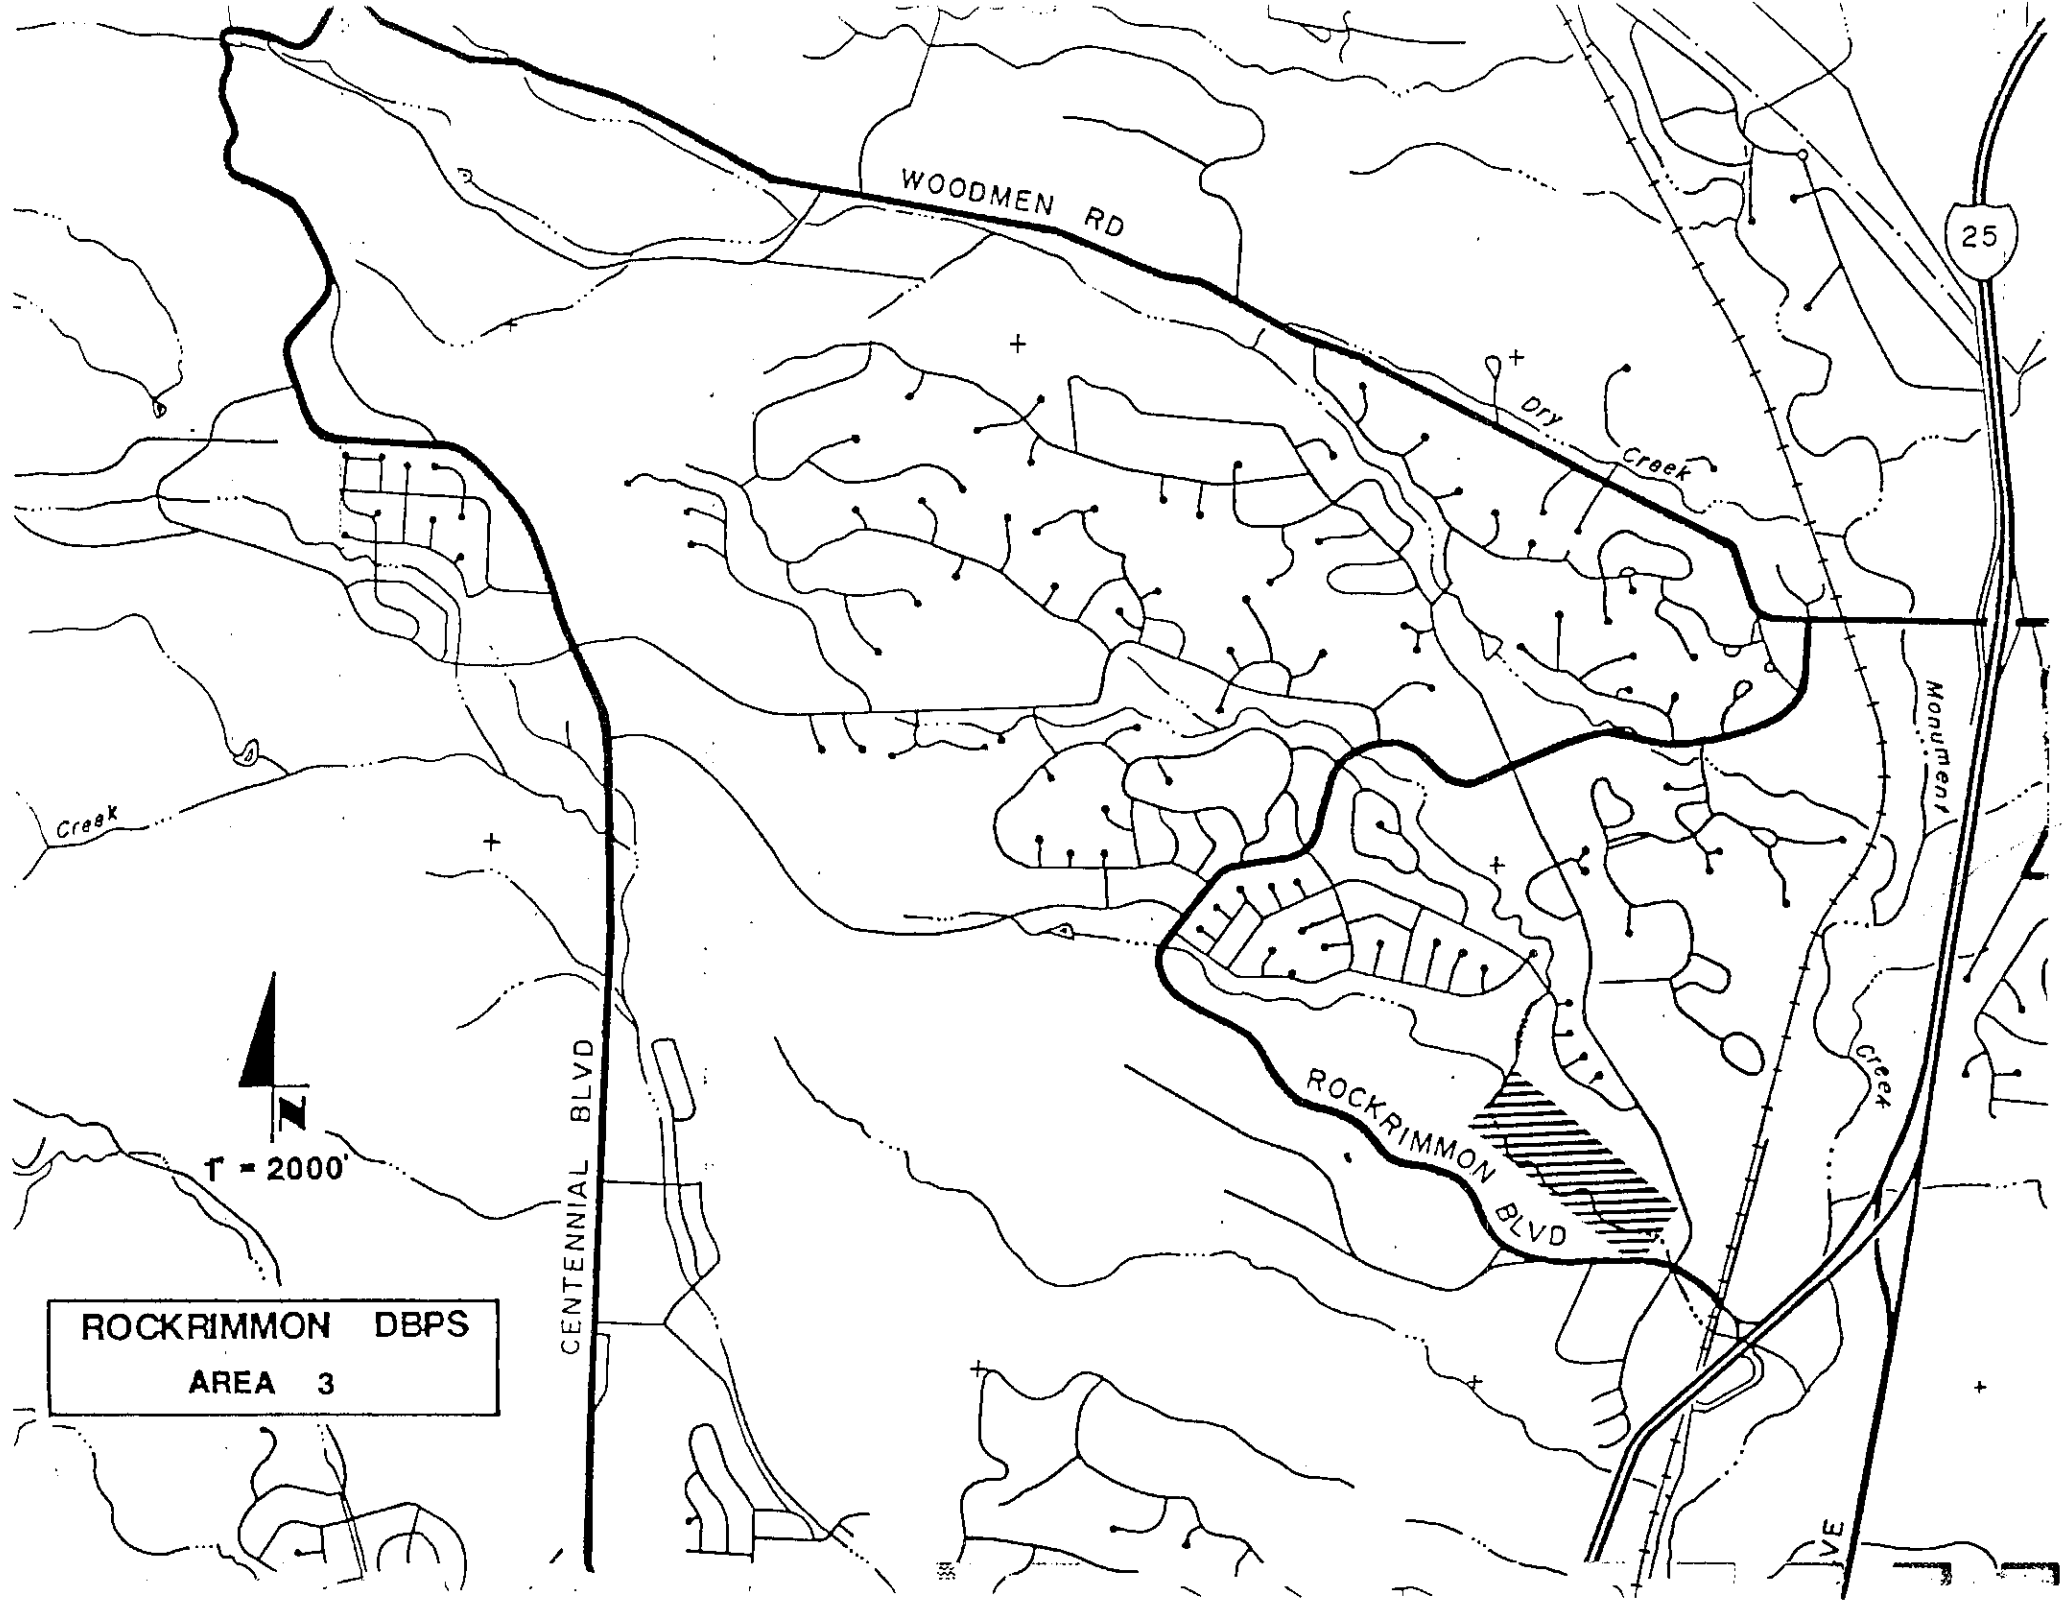
ROCKRIMMON DBPS  
AREA 3

Approximately the lower half of this reach has a relatively mild gradient and scattered sandstone formations which is preventing all but minor erosion in isolated areas. There is an adequately vegetated buffer area in these areas to accommodate minor erosion. The upper half of this reach is slightly steeper with sharper bends in the channel. Some more erosion is occurring here, particularly on the outside of curves. The main channel lies entirely on private property. Therefore, private developer(s) will need to construct selected improvements or R.O.W. acquired by the City of Colorado Springs. Two smaller channels entering the main channel from the west are experiencing major erosion. These areas will probably be improved when this land is developed by the land owner.

It is recommended for this reach that the stream channel and banks be left in a natural state (Alternative A), except that drop structures be installed in such a way and at intervals to limit flow velocities to 3 fps. Also recommend that Alternative B be used on outside of a couple of sharp bends where erosion is currently occurring.

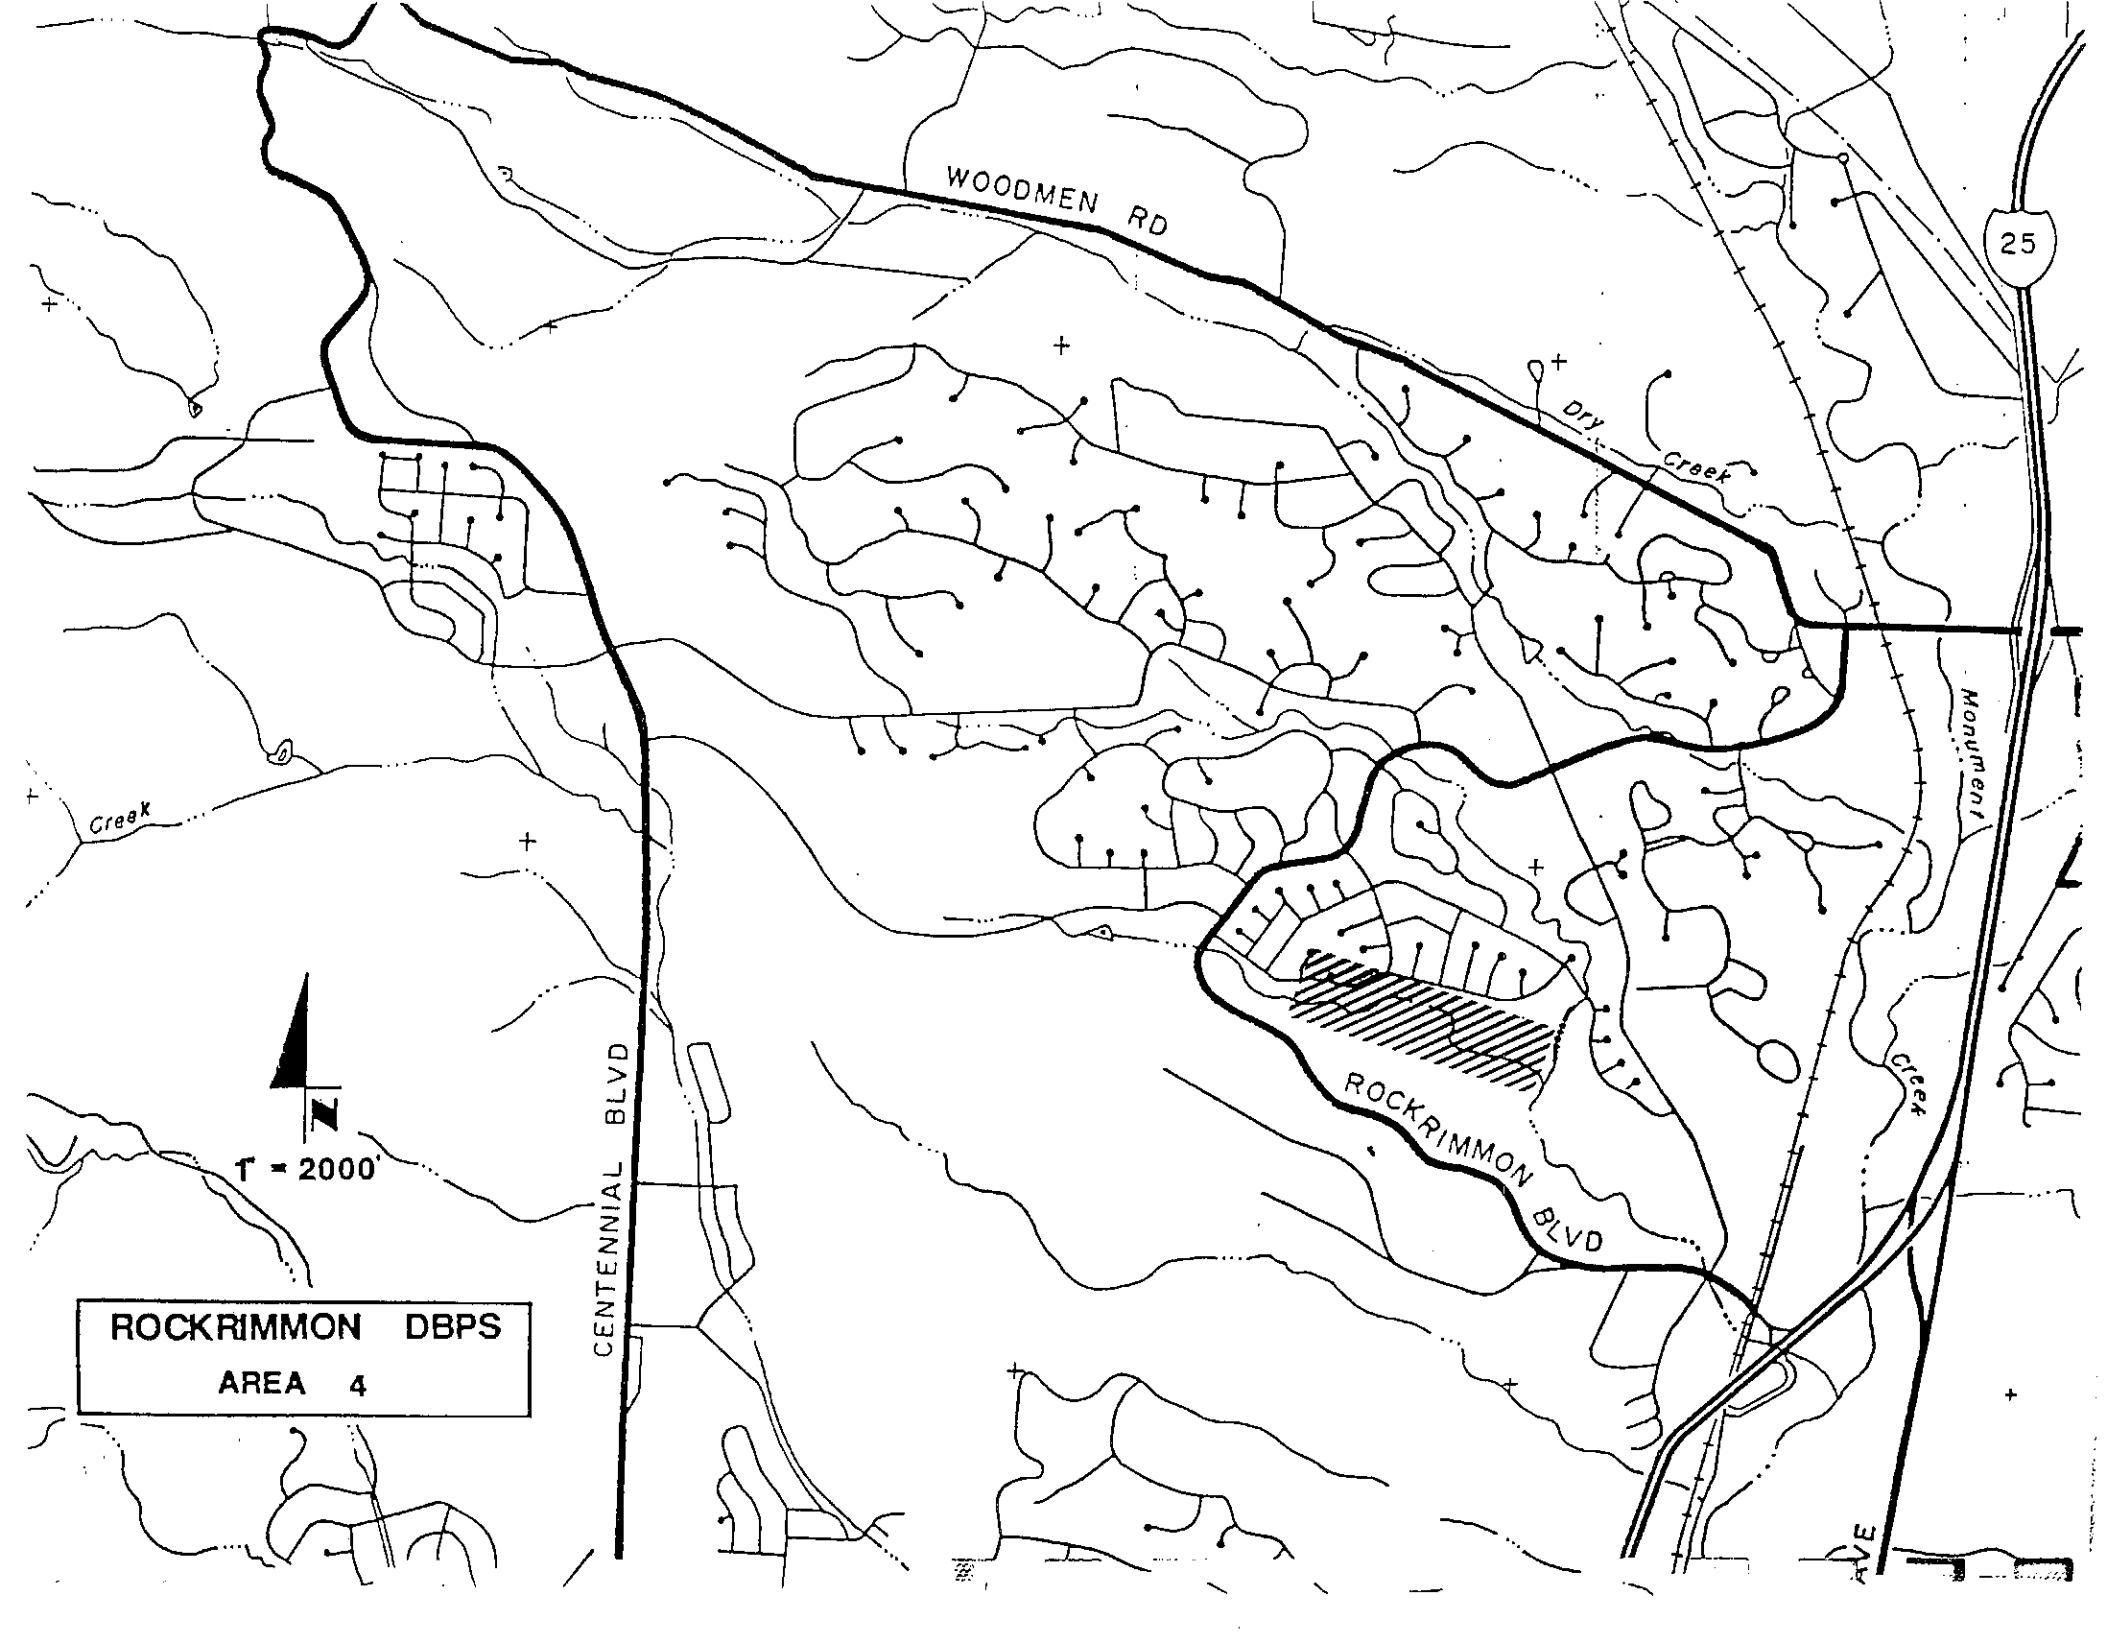
ROCKRIMMON DBPS  
AREA 4

The lower 600'± of this reach is relatively flat with little or no erosion occurring. The remainder of this reach is steeper with high, steep banks which are exhibiting severe erosion. There is a substantial buffer area here, but because of the extreme depth of the channel in this area, continued erosion will encroach further into private property. Several outfall points for local drainage in this reach are seriously eroded and in need of repair/improvement. The channel in this reach lies entirely within private property. Private developer(s) would need to construct these improvements or R.O.W. acquired by the City of Colorado Springs.

For this reach, we recommend the use of Alternative A with drop structures and Alternative B at the outside of curves as required. Velocities should be reduced to a maximum of 3 fps.

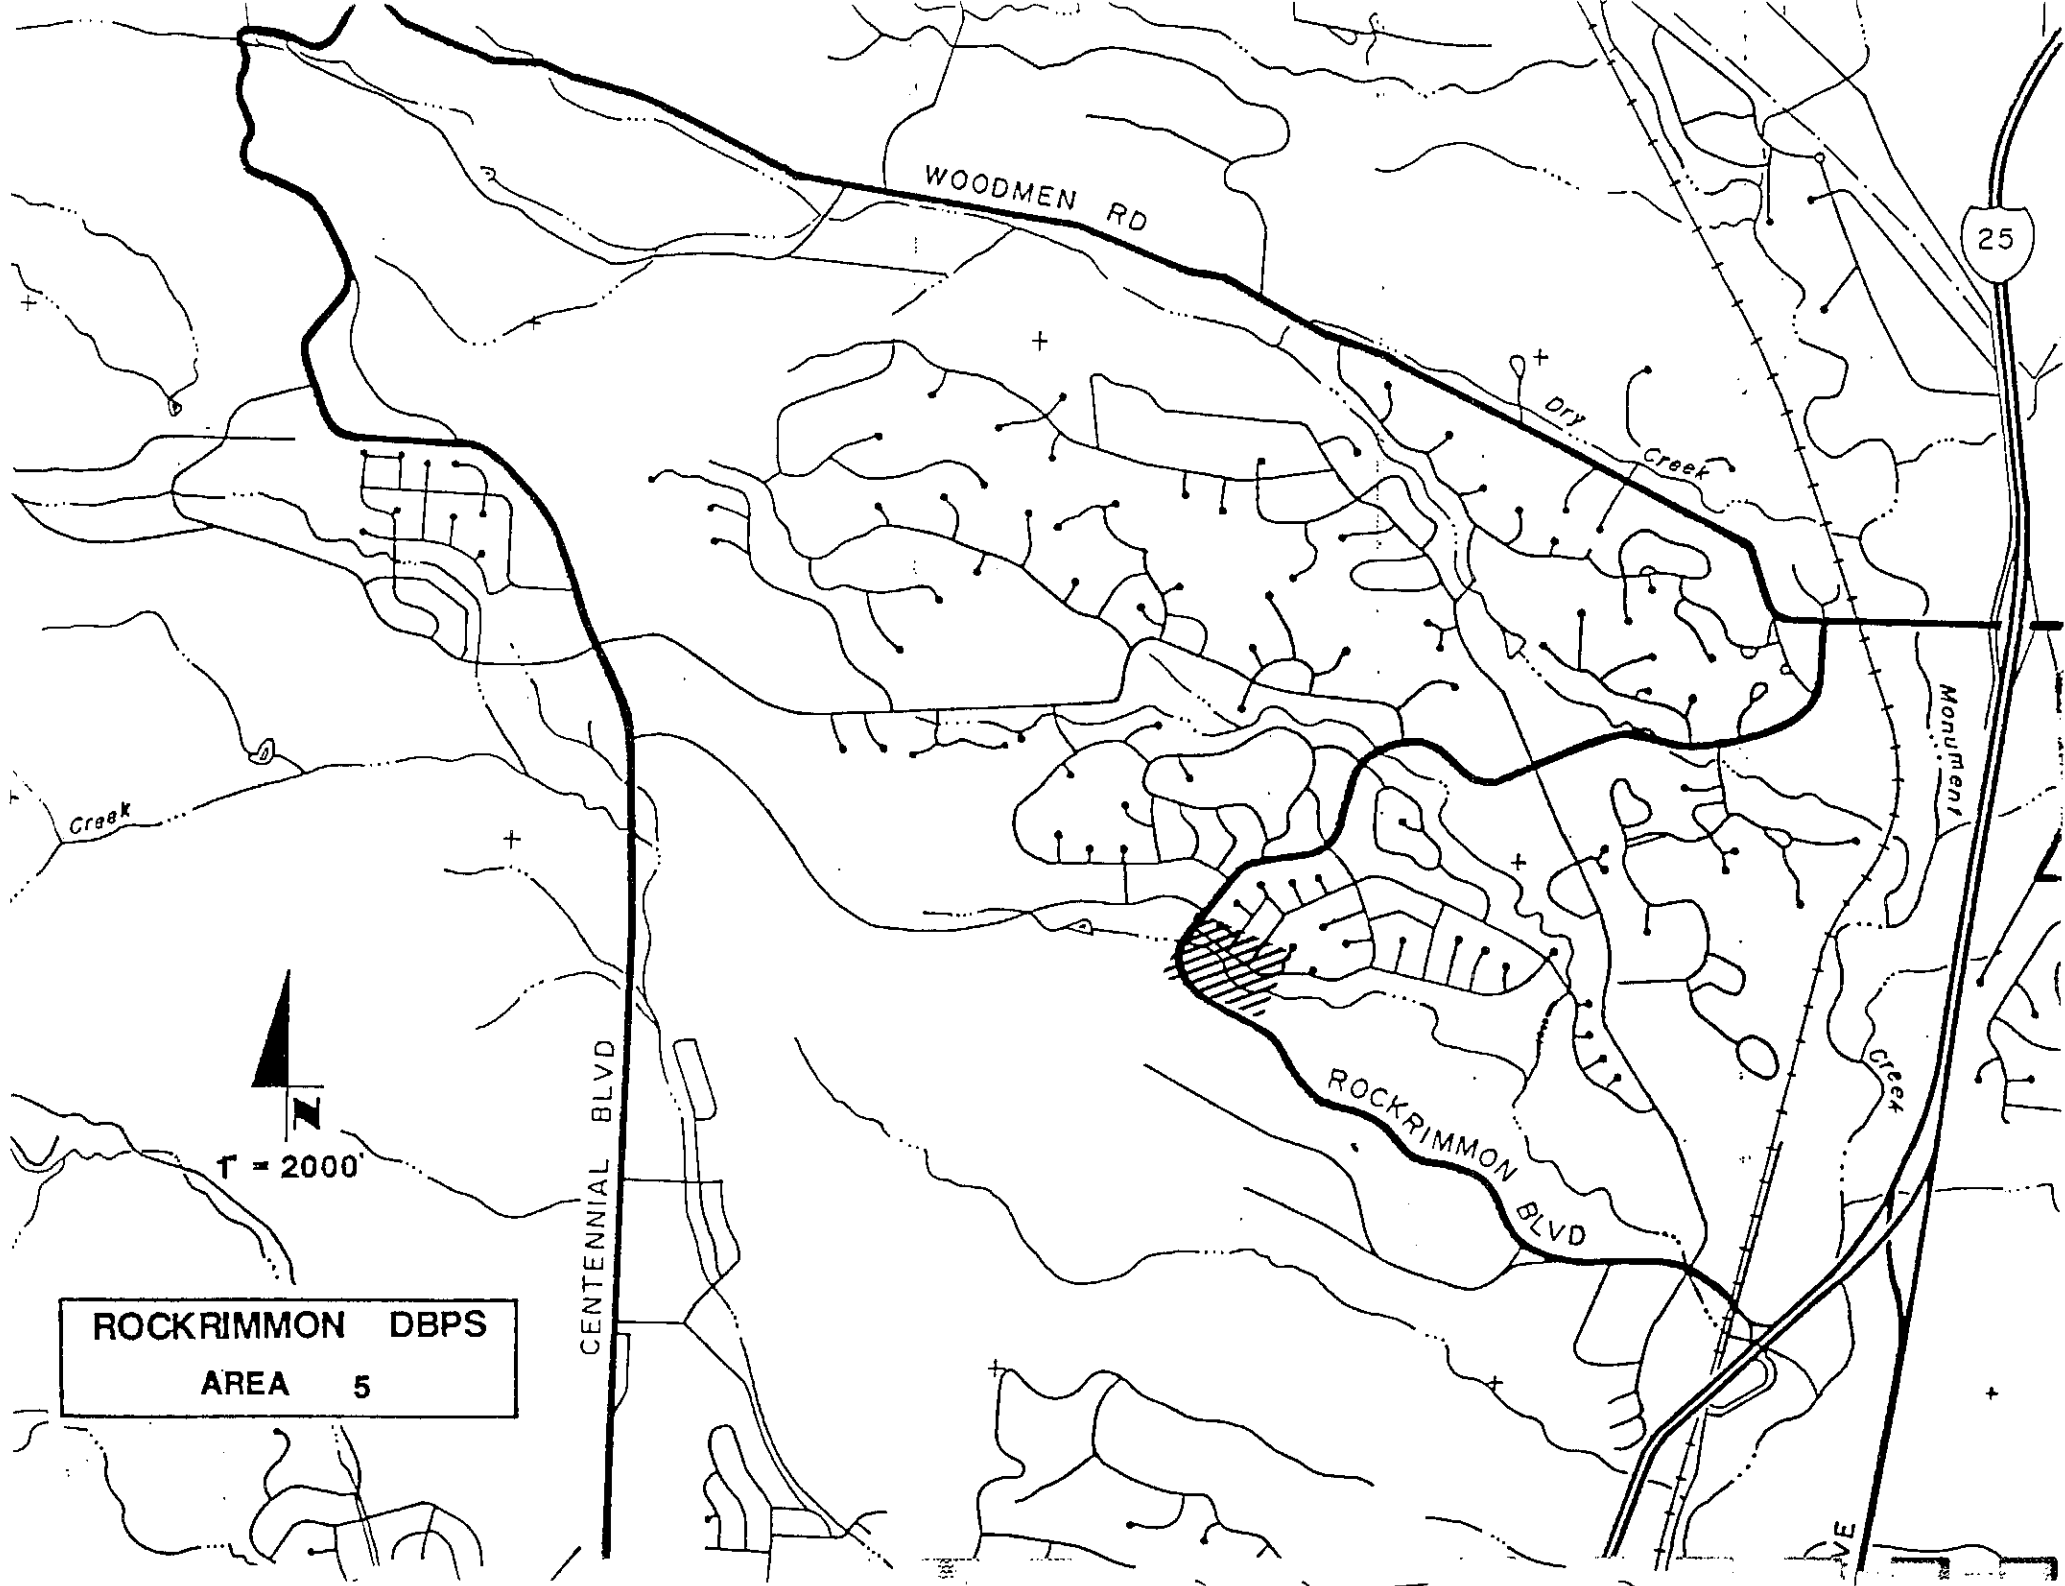
ROCKRIMMON DBPS  
AREA 5

This entire reach is currently concrete lined. The concrete channel is adequate for only part of its length to convey the 100-year flow, but the grassed channel area outside the concrete is more than adequate and is showing no signs of erosion. No alternatives are evaluated for this reach as no remedial work is required.

We recommend no remedial action be taken in this reach.

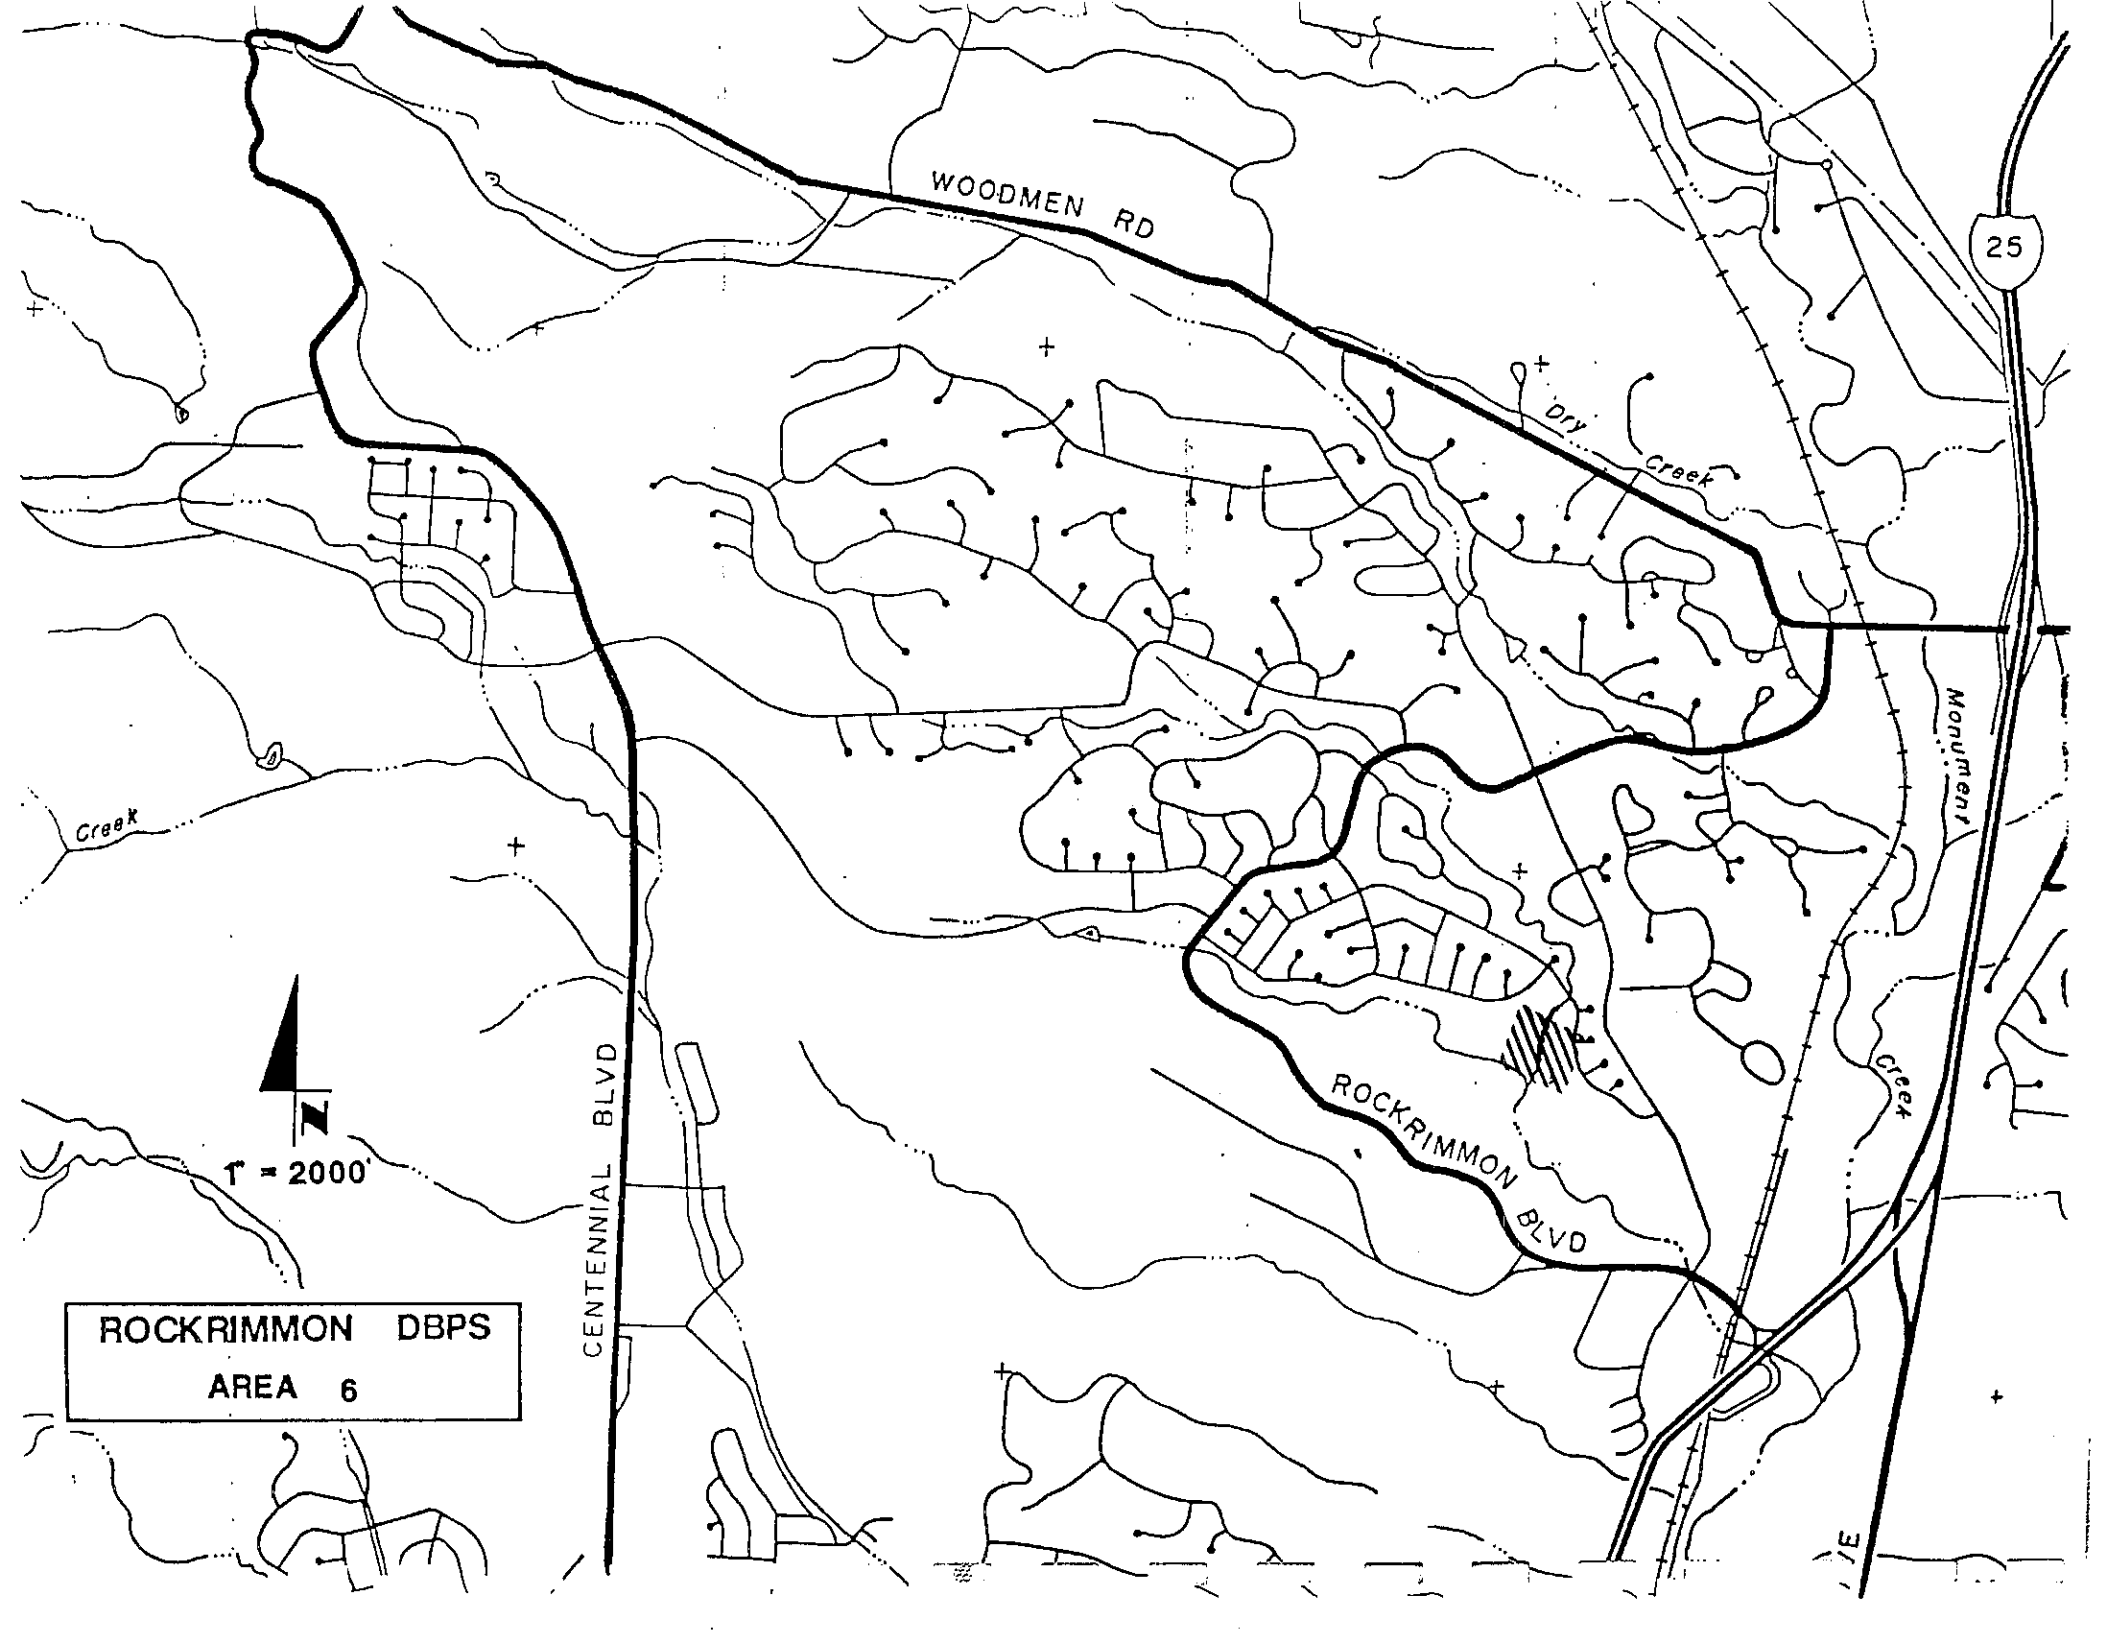
ROCKRIMMON DBPS  
AREA 6

This reach is short but very steep. It is the channel from the old lake bed to the South Rockrimmon main channel. It was originally riprap lined. The west bank is stable, but the bottom and east bank have failed totally. This section of channel lies entirely on private property. The improvements would have to be undertaken by private developer(s) or R.O.W. acquired by the City of Colorado Springs.

For this reach, Alternate B is recommended with drop structures to reduce velocities. An energy dissipator may be required at the point of connection with the South channel.
