ROCKRIMMON DBPS  
ALTERNATIVE ANALYSIS

October 18, 1990

KLH Engineering, Inc.  
206-208 Sutton Lane  
Colorado Springs, CO 80907

ROCKRIMMON DBPS  
KLH NO. 88 548 00  
Summary of Alternatives

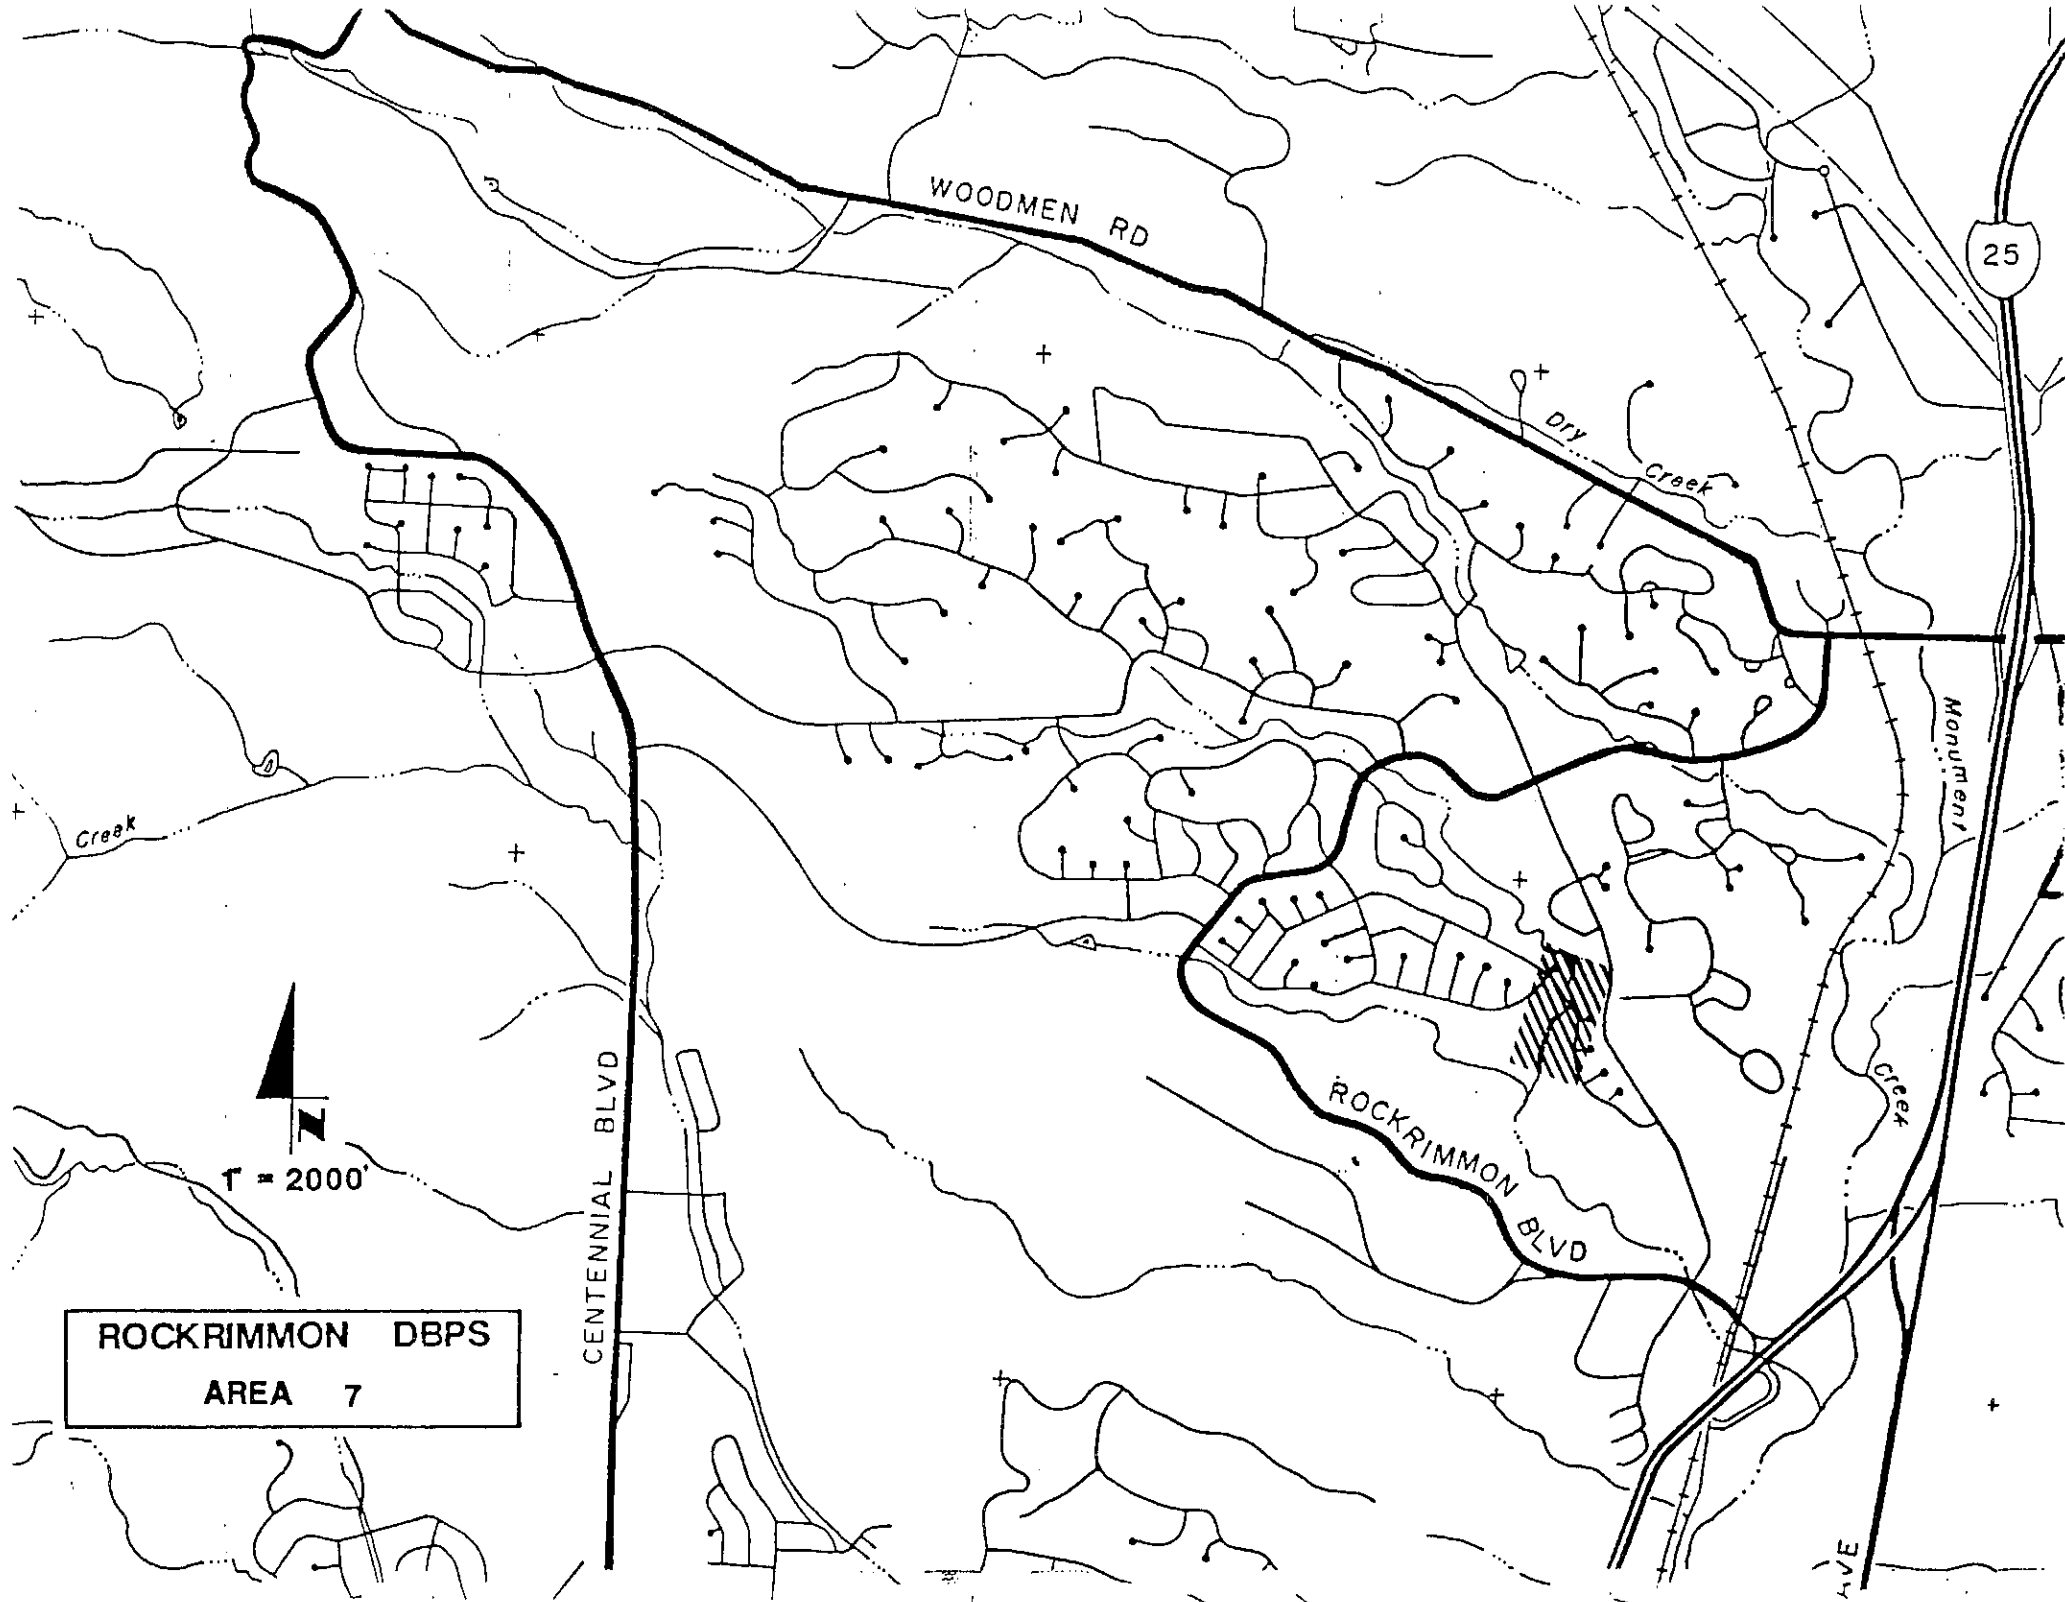
ROCKRIMMON DBPS  
AREA 7

The portion of this reach under Saddle Mountain Road is piped with an energy dissipator at the discharge end. The remainder of this reach is relatively mild and supports wetlands on both sides of Saddle Mountain Road. There is very little erosion except at three specific points toward the north end of this reach.

Recommend Alternative A for this reach with the exception of one bend north of Saddle Mountain Road. There is progressive erosion on the outside of two (2) curves and Alternative B is recommended at these locations. Several judiciously placed drop structures are recommended for the section north of Saddle Mountain Road. An additional pipe arch culvert is recommended above the existing culvert under Saddle Mountain Road to prevent overtopping of the roadway.

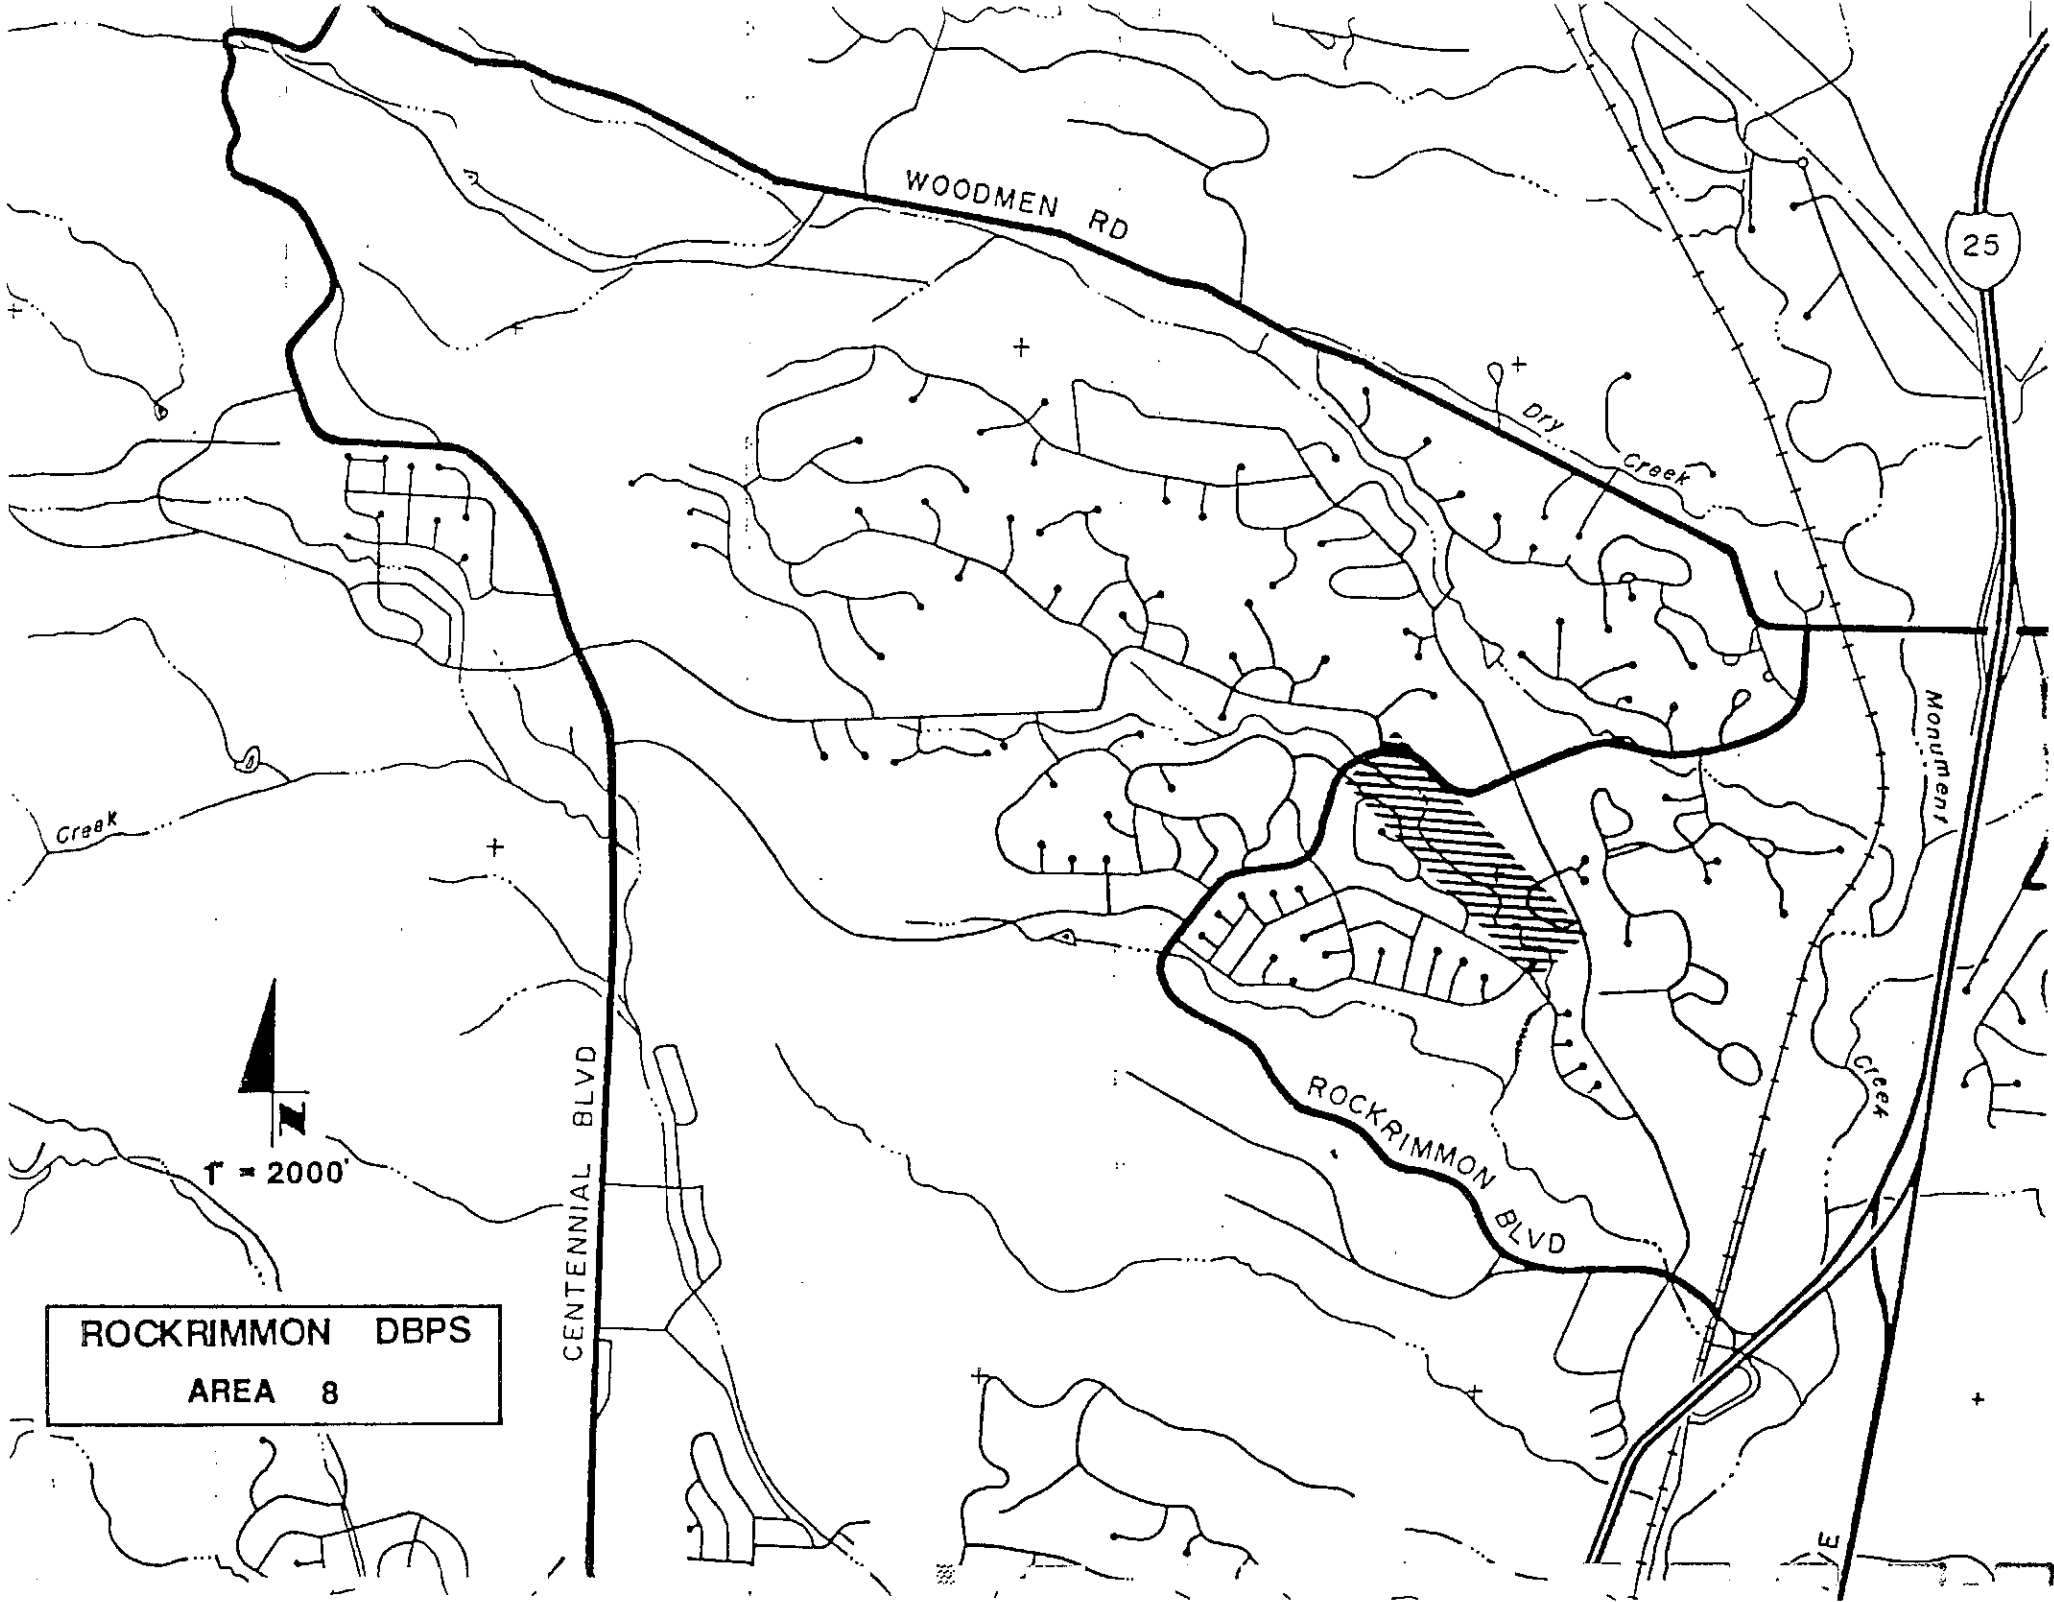
ROCKRIMMON DBPS  
AREA 8

This reach is relatively steep (2-3%) and has active erosion occurring and some downcutting of the bed. There are a number of sharp bends in the channel alignment and the erosion is most evident on the outside of bends. There are a number of locations in this reach where erosion is on, or very near, private property.

A combination of Alternatives A and B is recommended for this reach. Alternative A with drop structures sufficient to reduce velocities to 3 fps or less is recommended for most of this reach with Alternative B protection for the outside of some exceptionally troublesome curves. A drop structure with bed and bank protection should also be installed at the discharge point of the culvert under Rockrimmon Blvd.

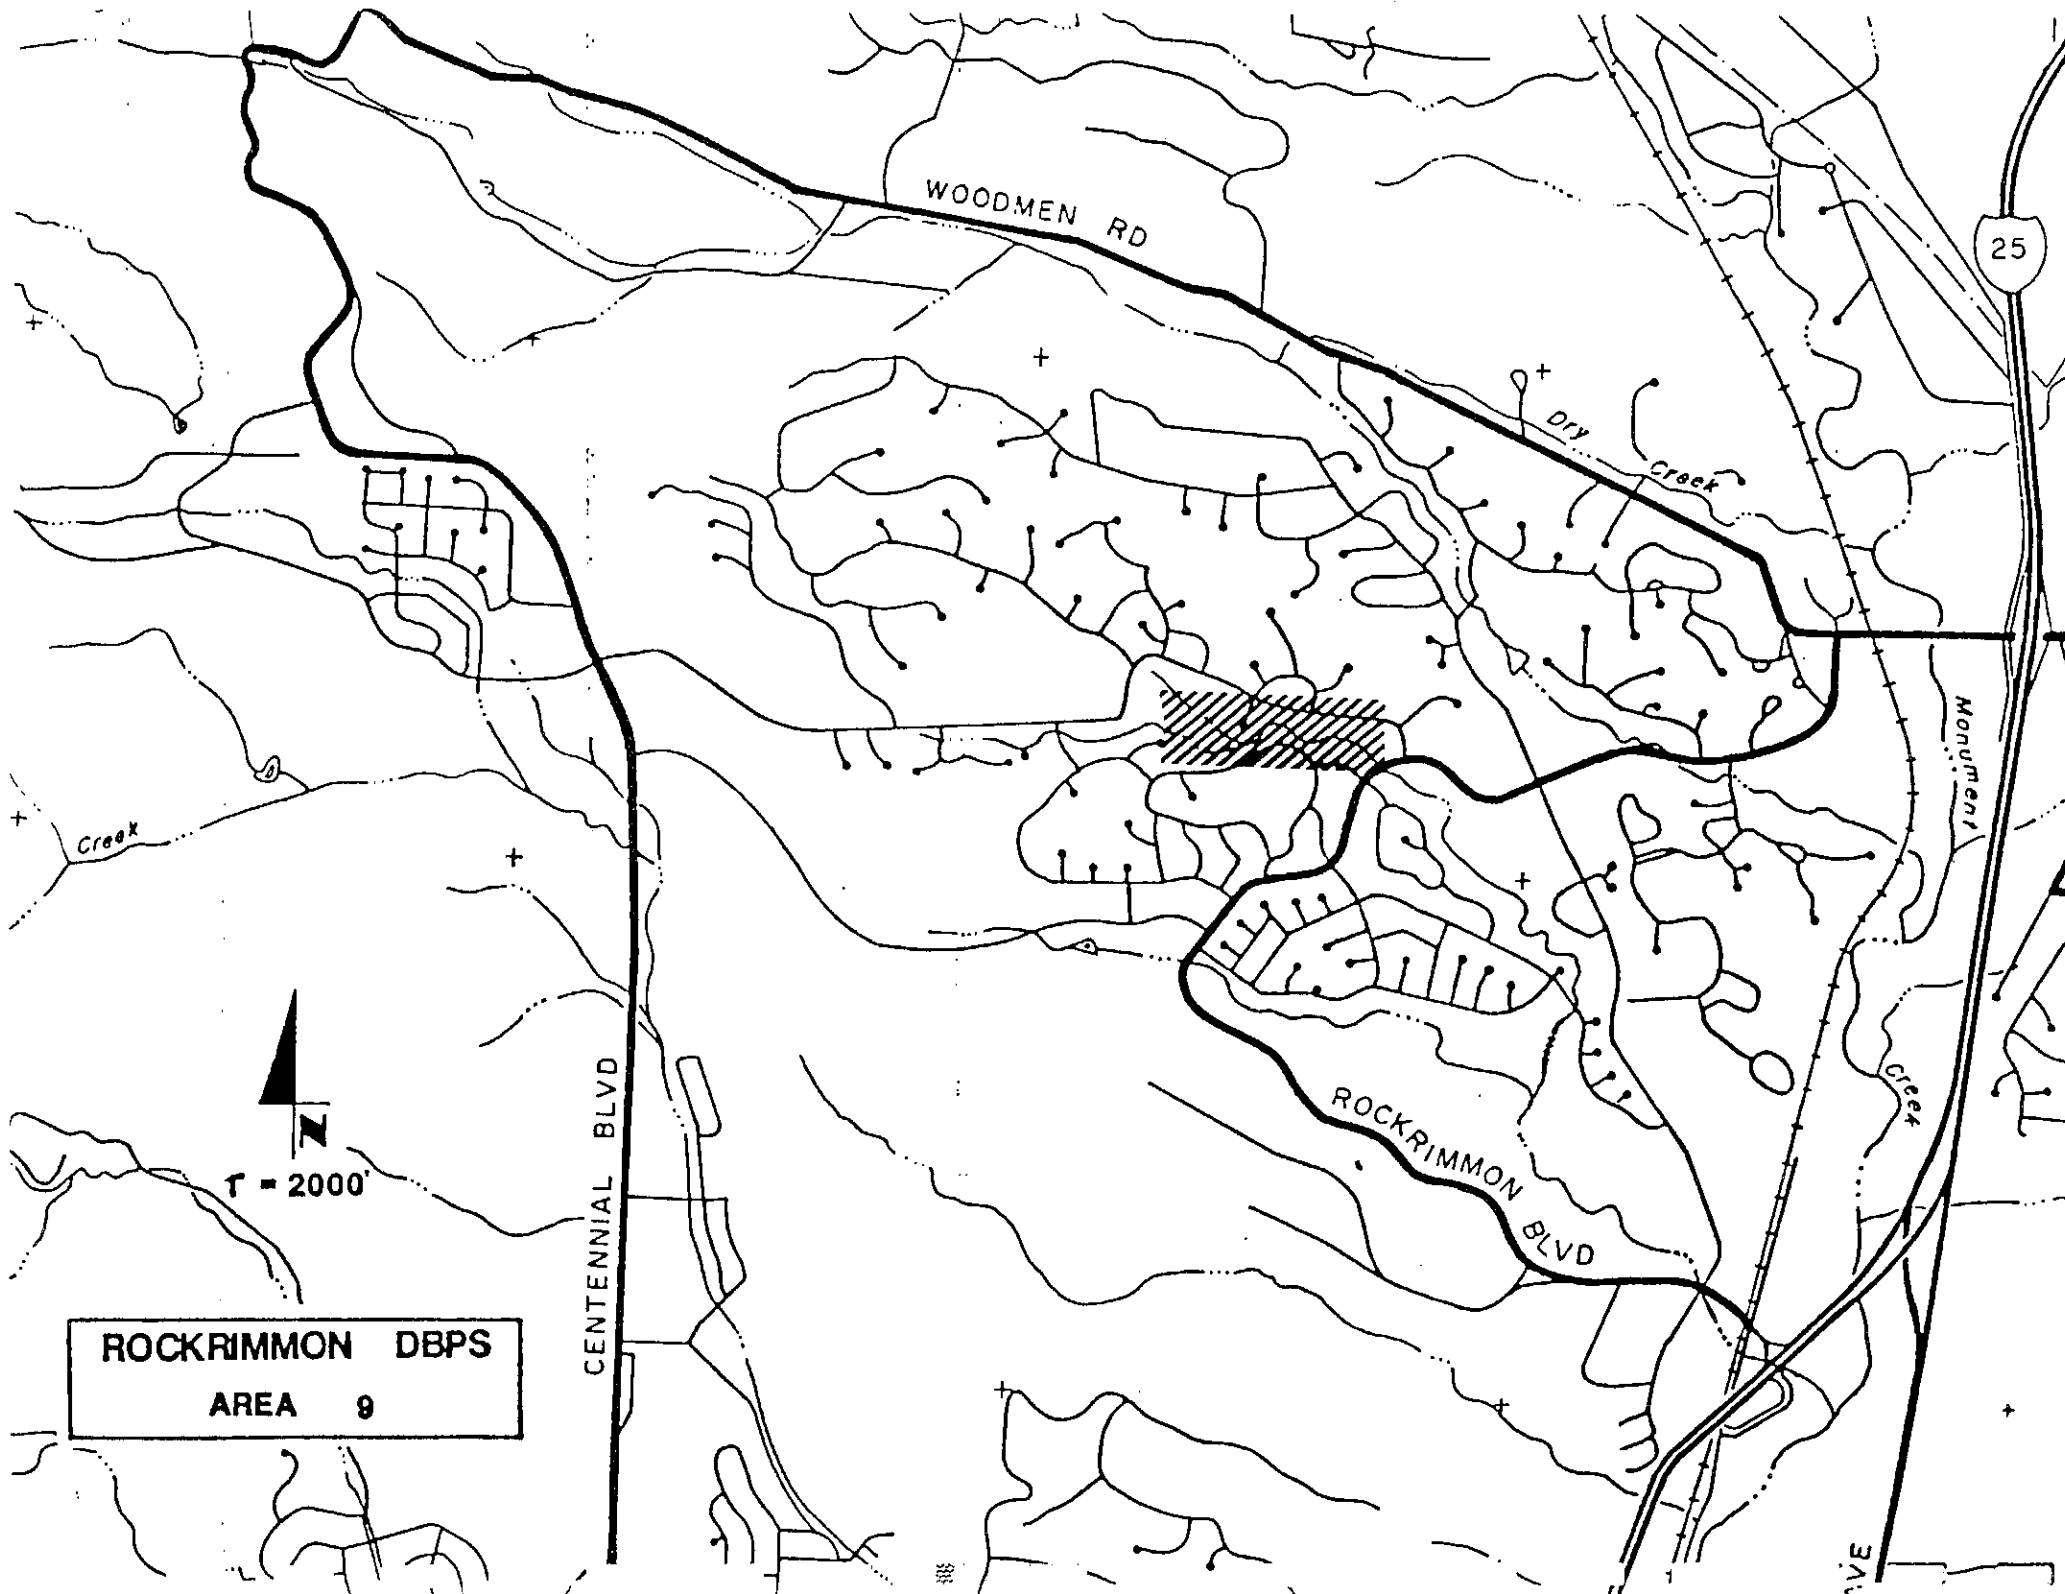
ROCKRIMMON DBPS  
AREA 9

Portions of this reach are shallow channels and other portions are deeply cut. Much of the reach has sharp bends with accompanying erosion. There is substantial erosion occurring throughout the entire length of this reach except in the lower 400 feet. The channel through this reach does not have the capacity to carry the 100-year flow, but it is contained within the available buffer area.

Alternative A is recommended for the lower portion of this reach (approximately 800'). Recommend straightening of S-turn approximately 500' northwest of Rockrimmon Blvd. and installation of a drop structure. Recommend Alternate A with drop structures for the remainder of this reach. In the first 500'+ of this section (800'-1300' northwest of Rockrimmon Blvd.), it is recommended that the channel be straightened. At the upper end of this reach, an energy dissipator is recommended at the discharge point of the concrete lined channel.

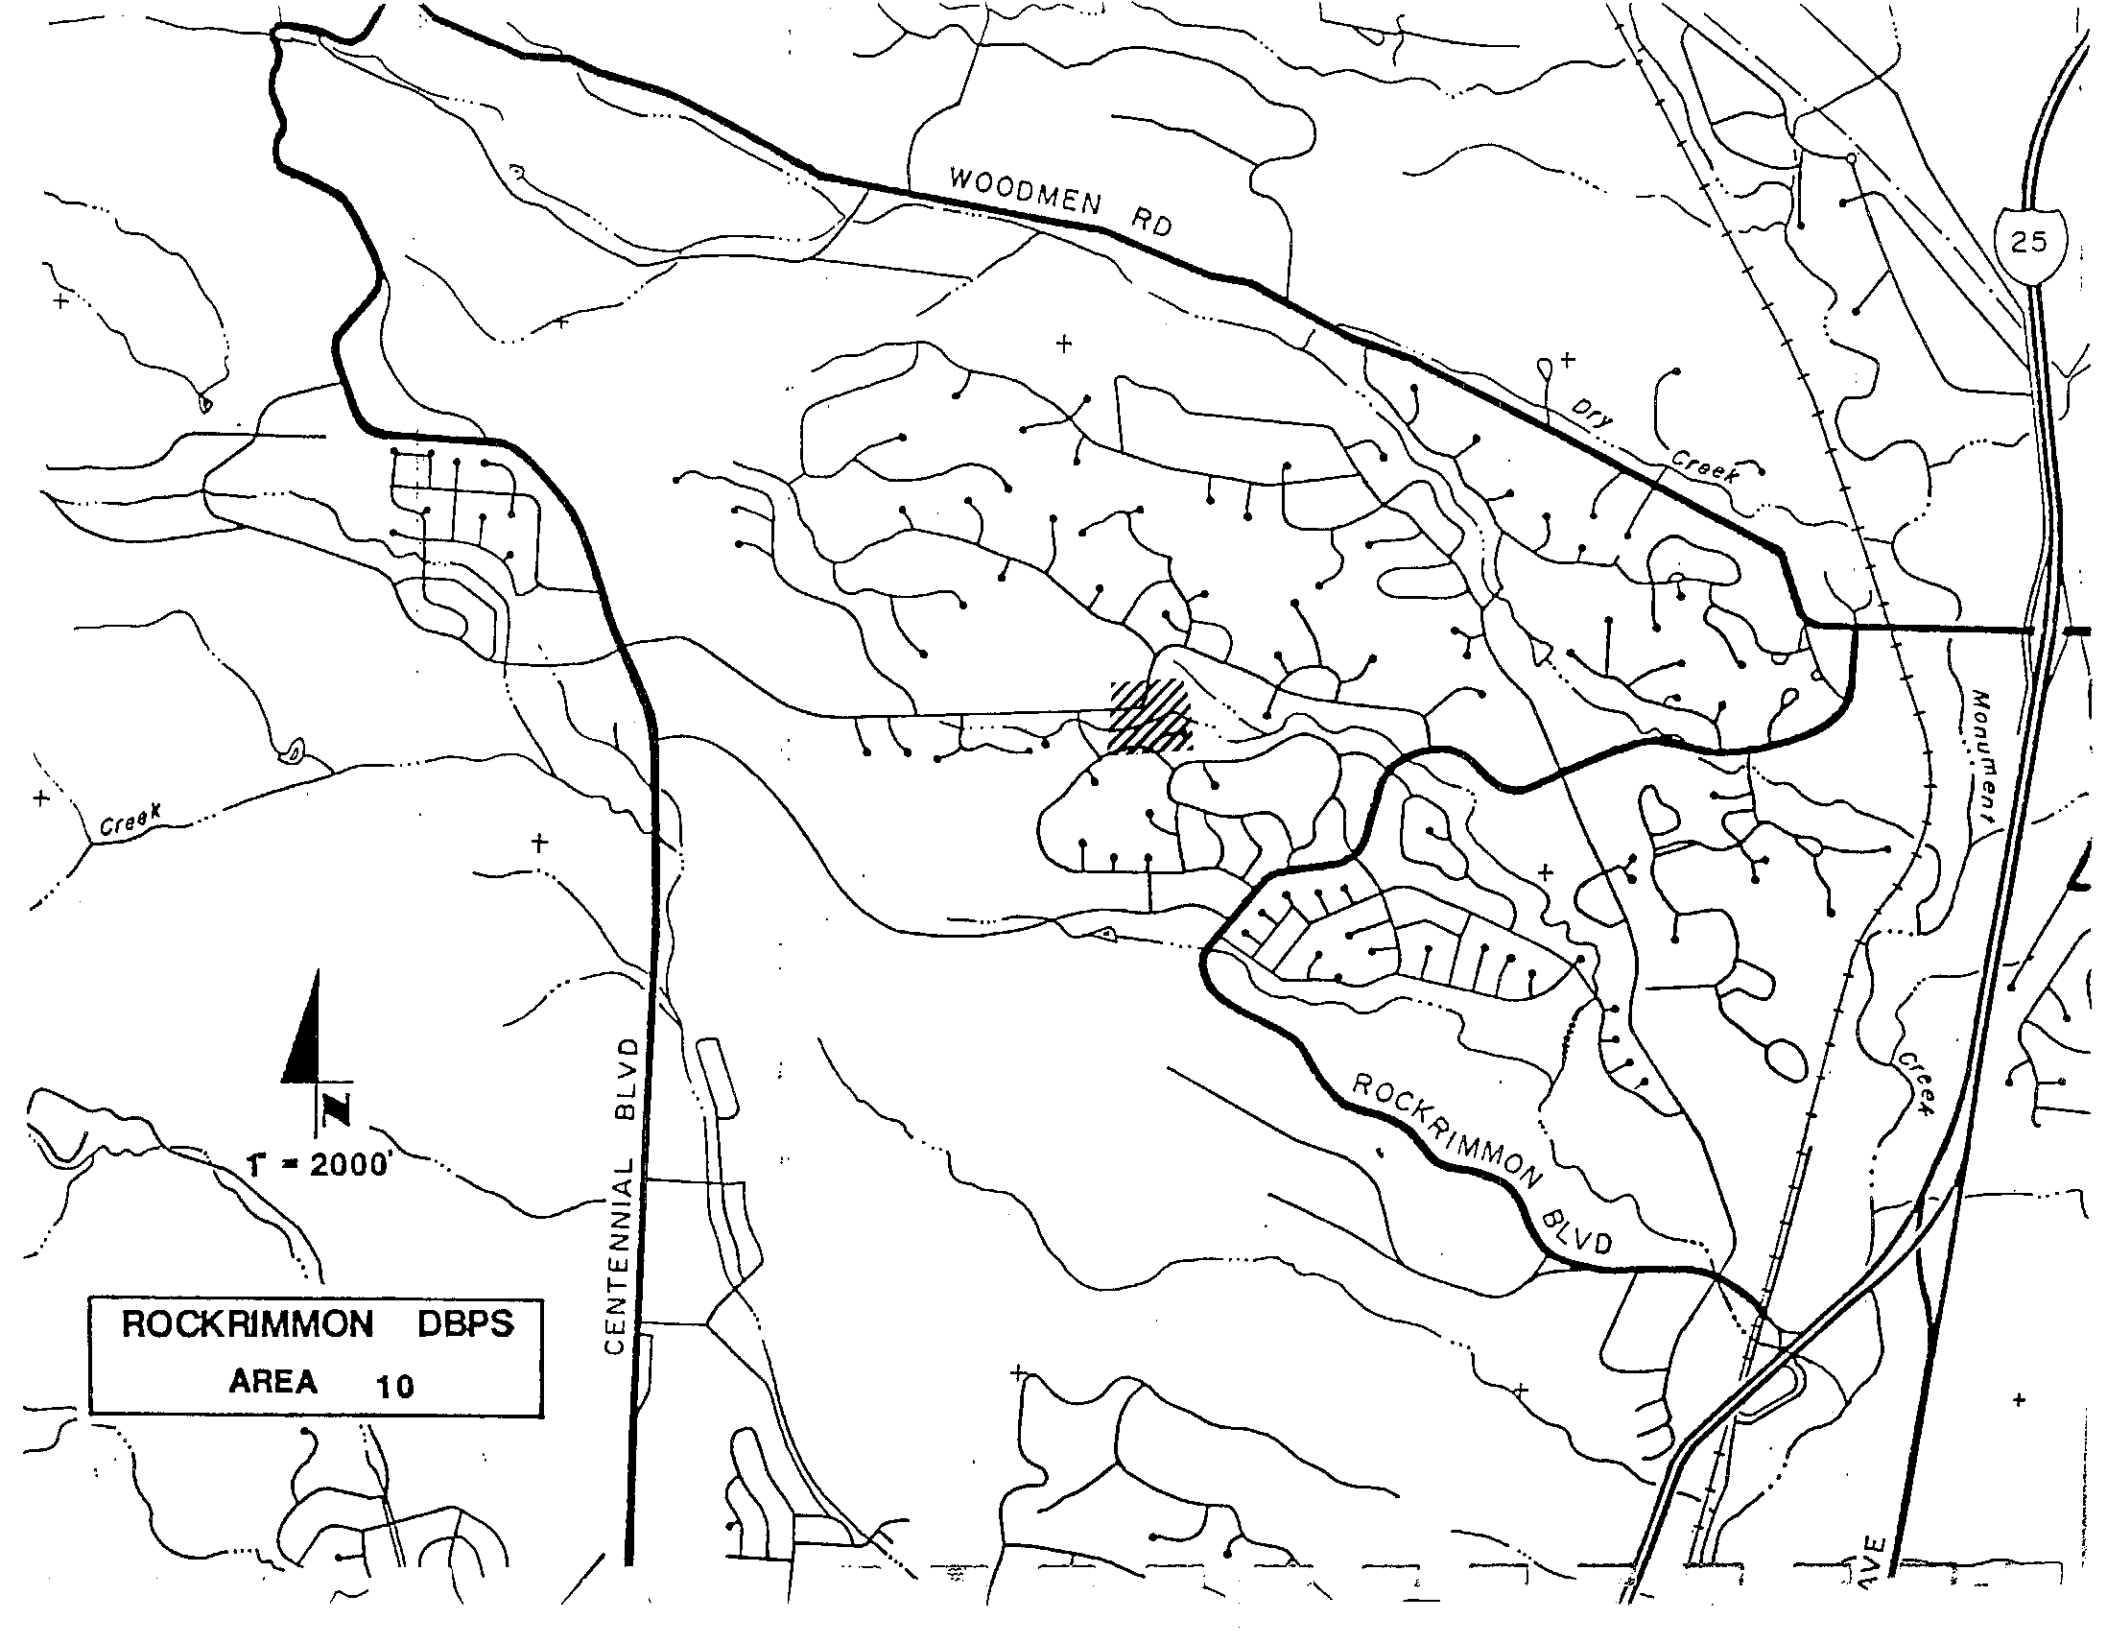
ROCKRIMMON DBPS  
AREA 10

This entire reach is presently concrete lined and is functioning well, except for two areas. The downstream end is head cutting and beginning to fail. Also, where the 42" RCP is connected, the bottom has been built up with mortar and aggregate and is creating sediment deposits upstream. The concrete channel is inadequate to convey the 100-year flow. However, the surrounding buffer area is sufficient to carry this runoff without threat to any private property, except two homes located northwest of the channel above the inflow from the 48" RCP. These two houses are very near, but outside the anticipated 100-year storm high water level.

Recommend no remedial action to this reach.

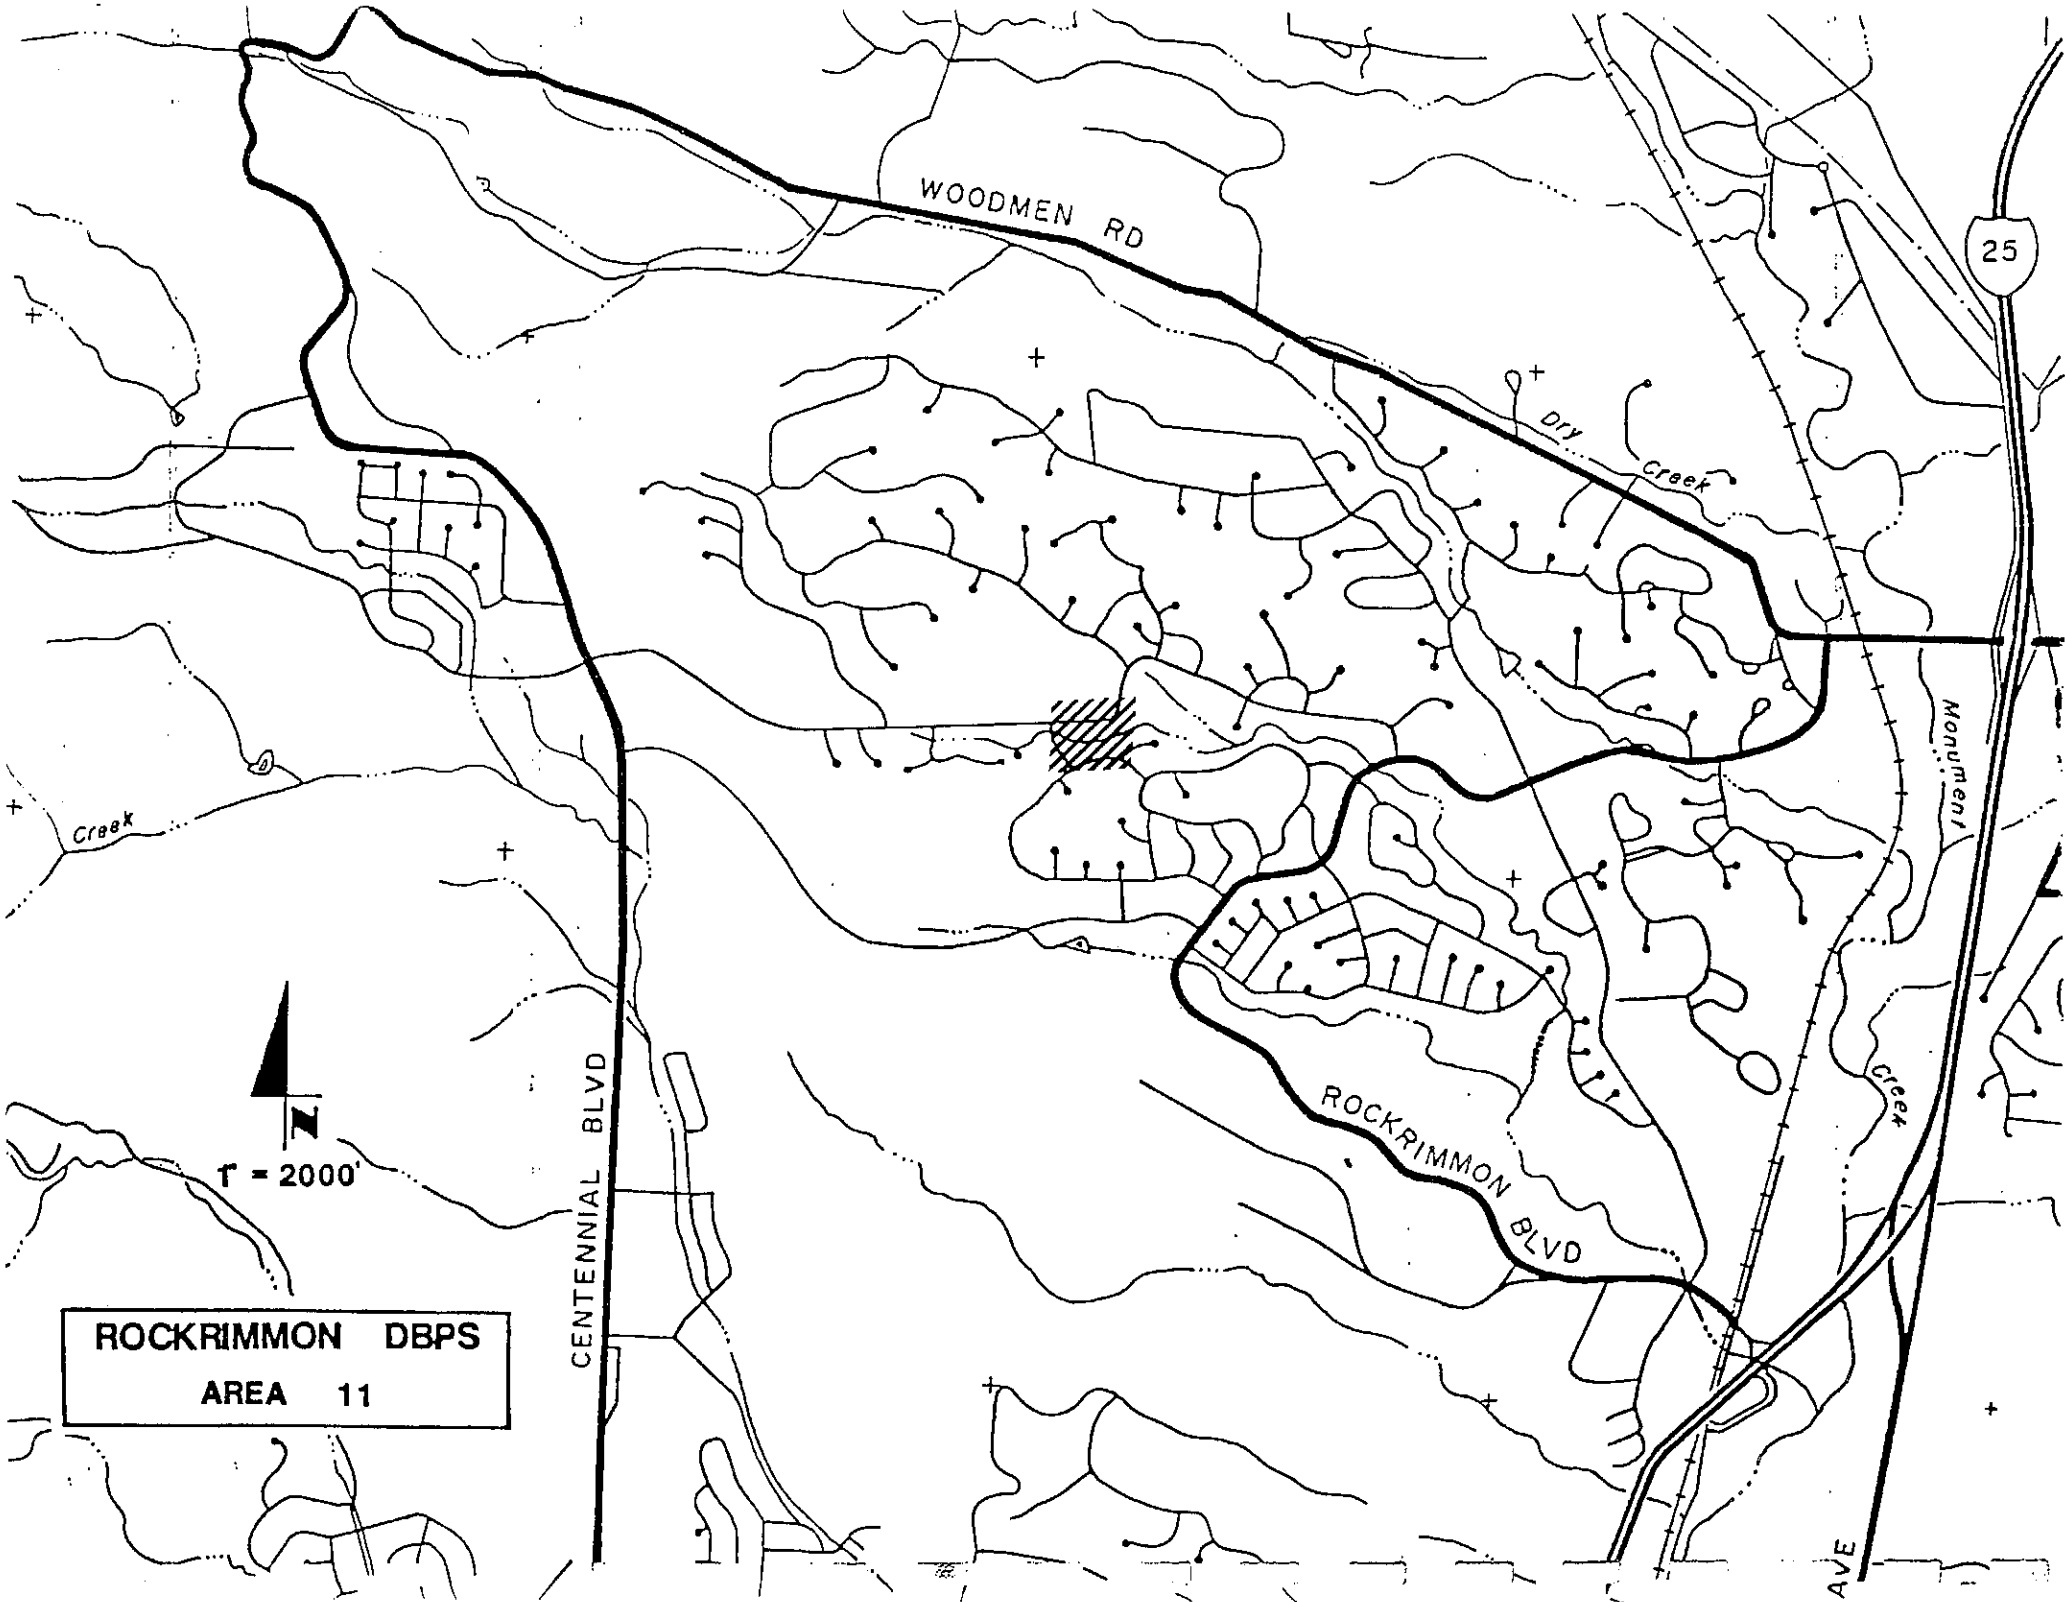
**ROCKRIMMON DBPS**  
**AREA 11**

Most of this reach is the detention facility which appears to be in good repair and functioning properly. The remaining 200 feet is a wide shallow area with a small meandering channel for low flows. Very minor erosion is occurring, except at the discharge of the 36" pipe culverts under War Eagle Lane. This area is predominantly wildlife habitat. The 100-year storm water level will encroach onto private property with a low velocity flow, but will not endanger any existing structures.

Alternative A is recommended through this reach from the spillway up to War Eagle Lane. Some erosion protection in the form of Alternative B is recommended at the discharge point of flow through the culvert under War Eagle Lane.

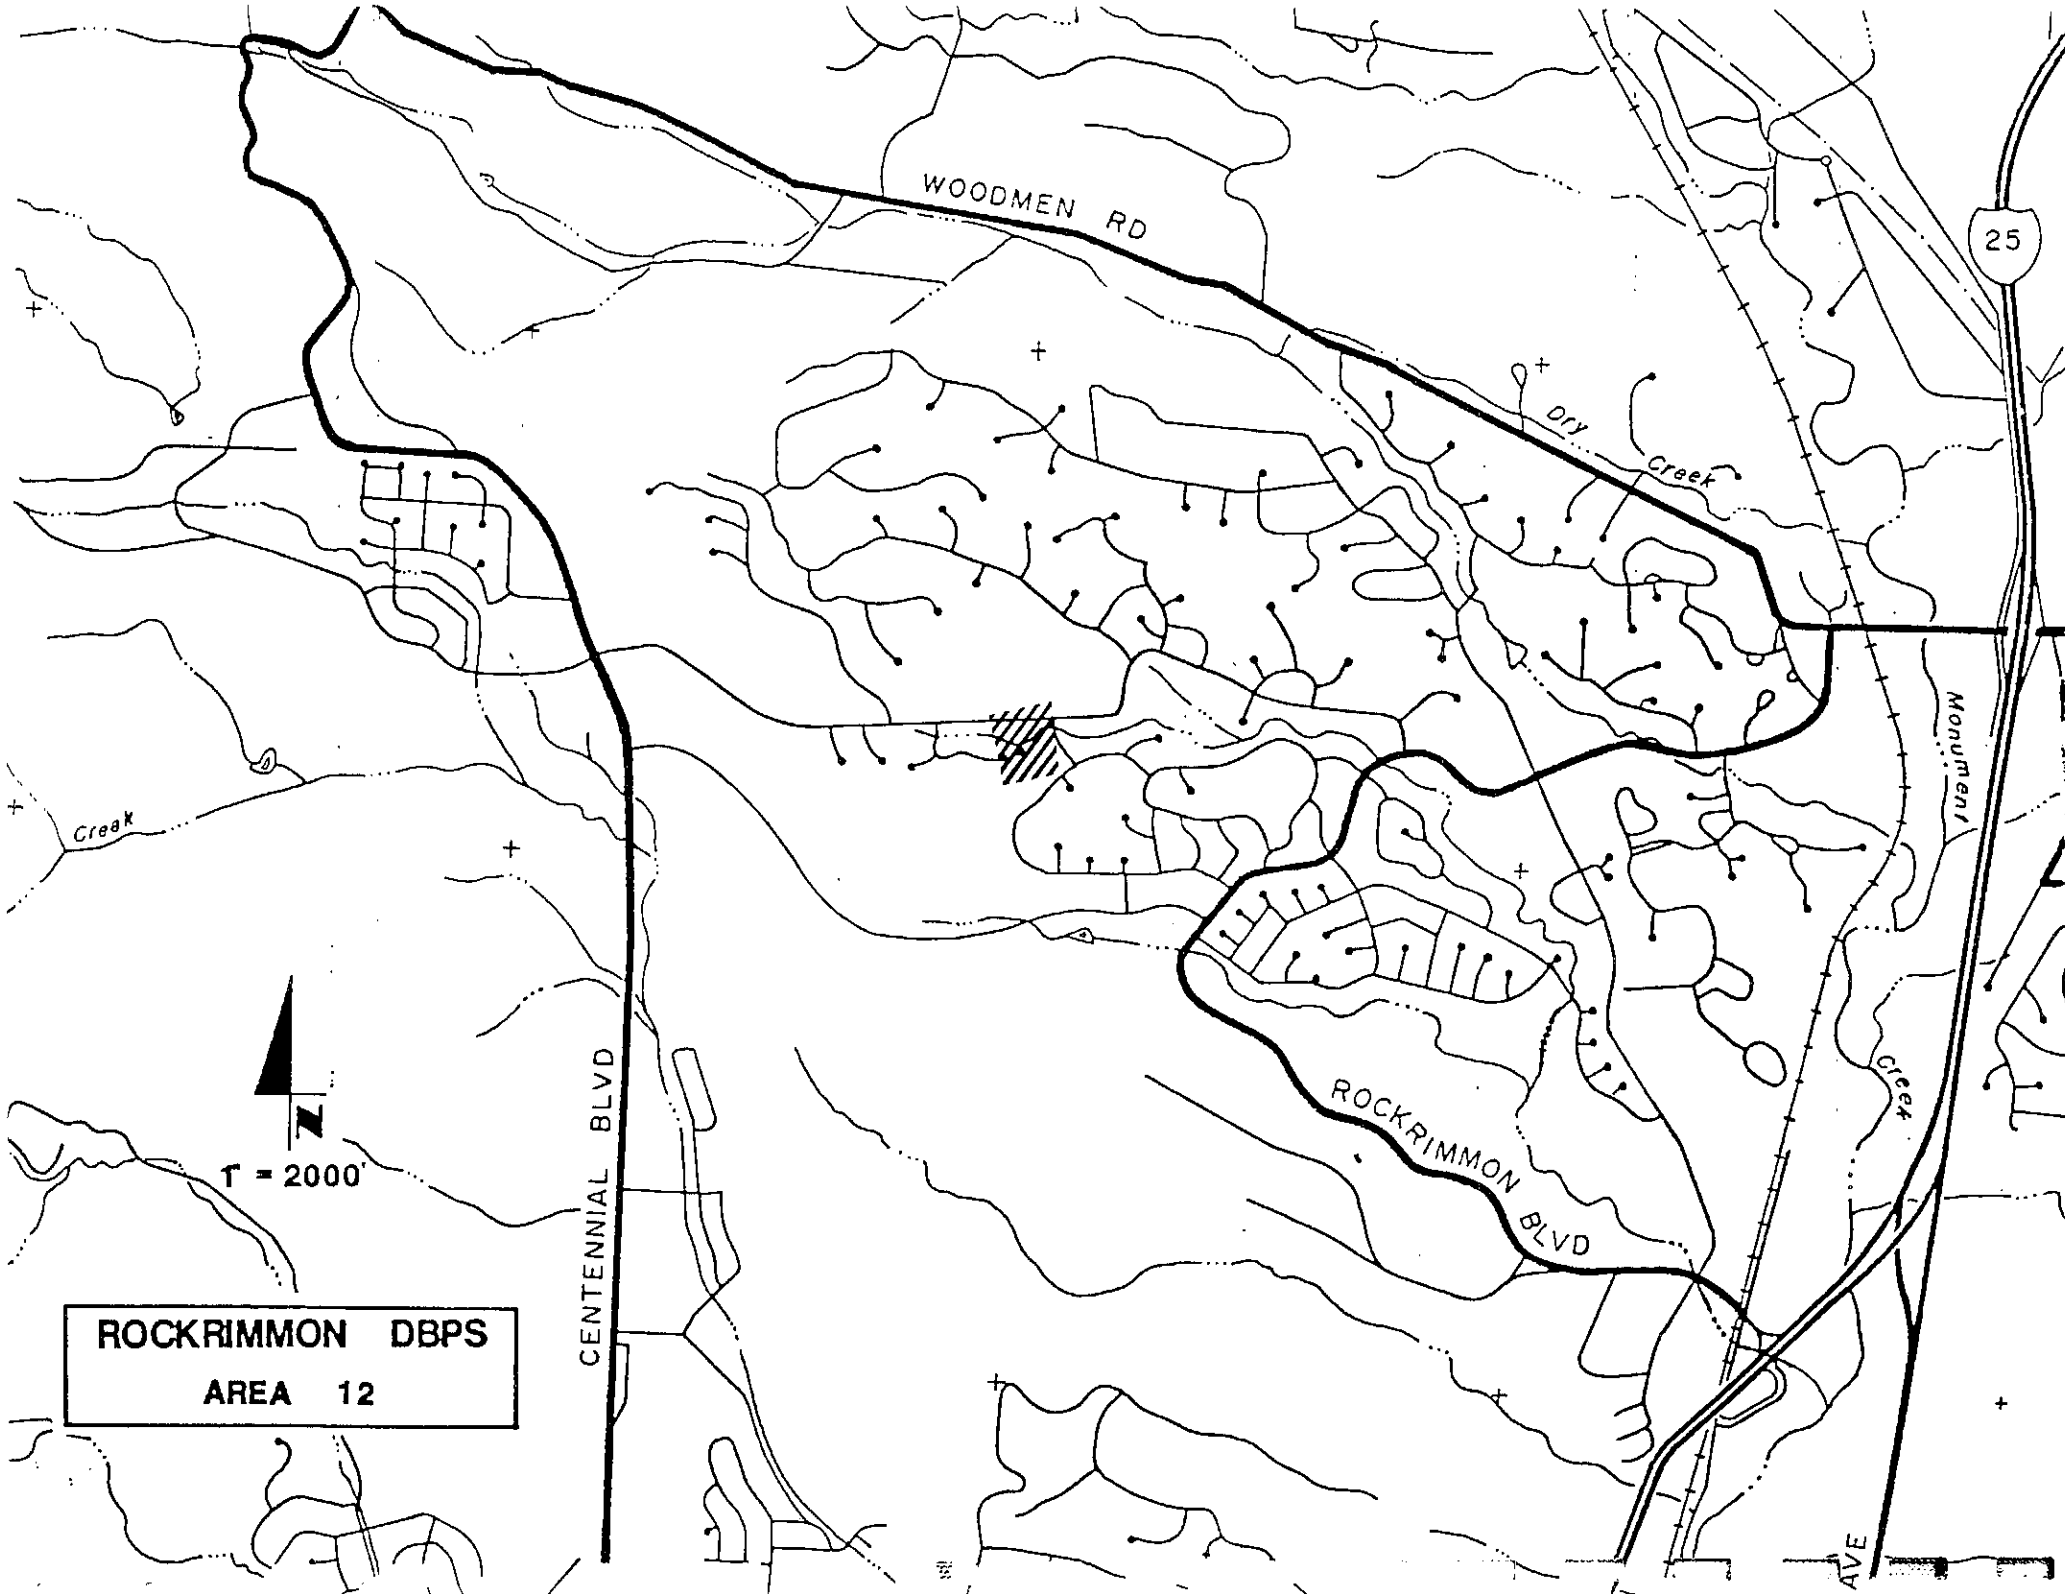
ROCKRIMMON DBPS  
AREA 12

This reach has a small well-defined channel that does not appear to be eroding past its present condition. The channel itself is inadequate to carry the 100-year flow, but the surrounding vegetated buffer area is large enough to serve this function without threat to any existing structures. Wildlife habitats in the upper end of this reach are predominant.

For this reach, Alternative A with a few judiciously placed drop structures is recommended.
