ROCKRIMMON DBPS  
ALTERNATIVE ANALYSIS

October 18, 1990

KLH Engineering, Inc.  
206-208 Sutton Lane  
Colorado Springs, CO 80907

ROCKRIMMON DBPS  
KLH NO. 88 548 00  
Summary of Alternatives

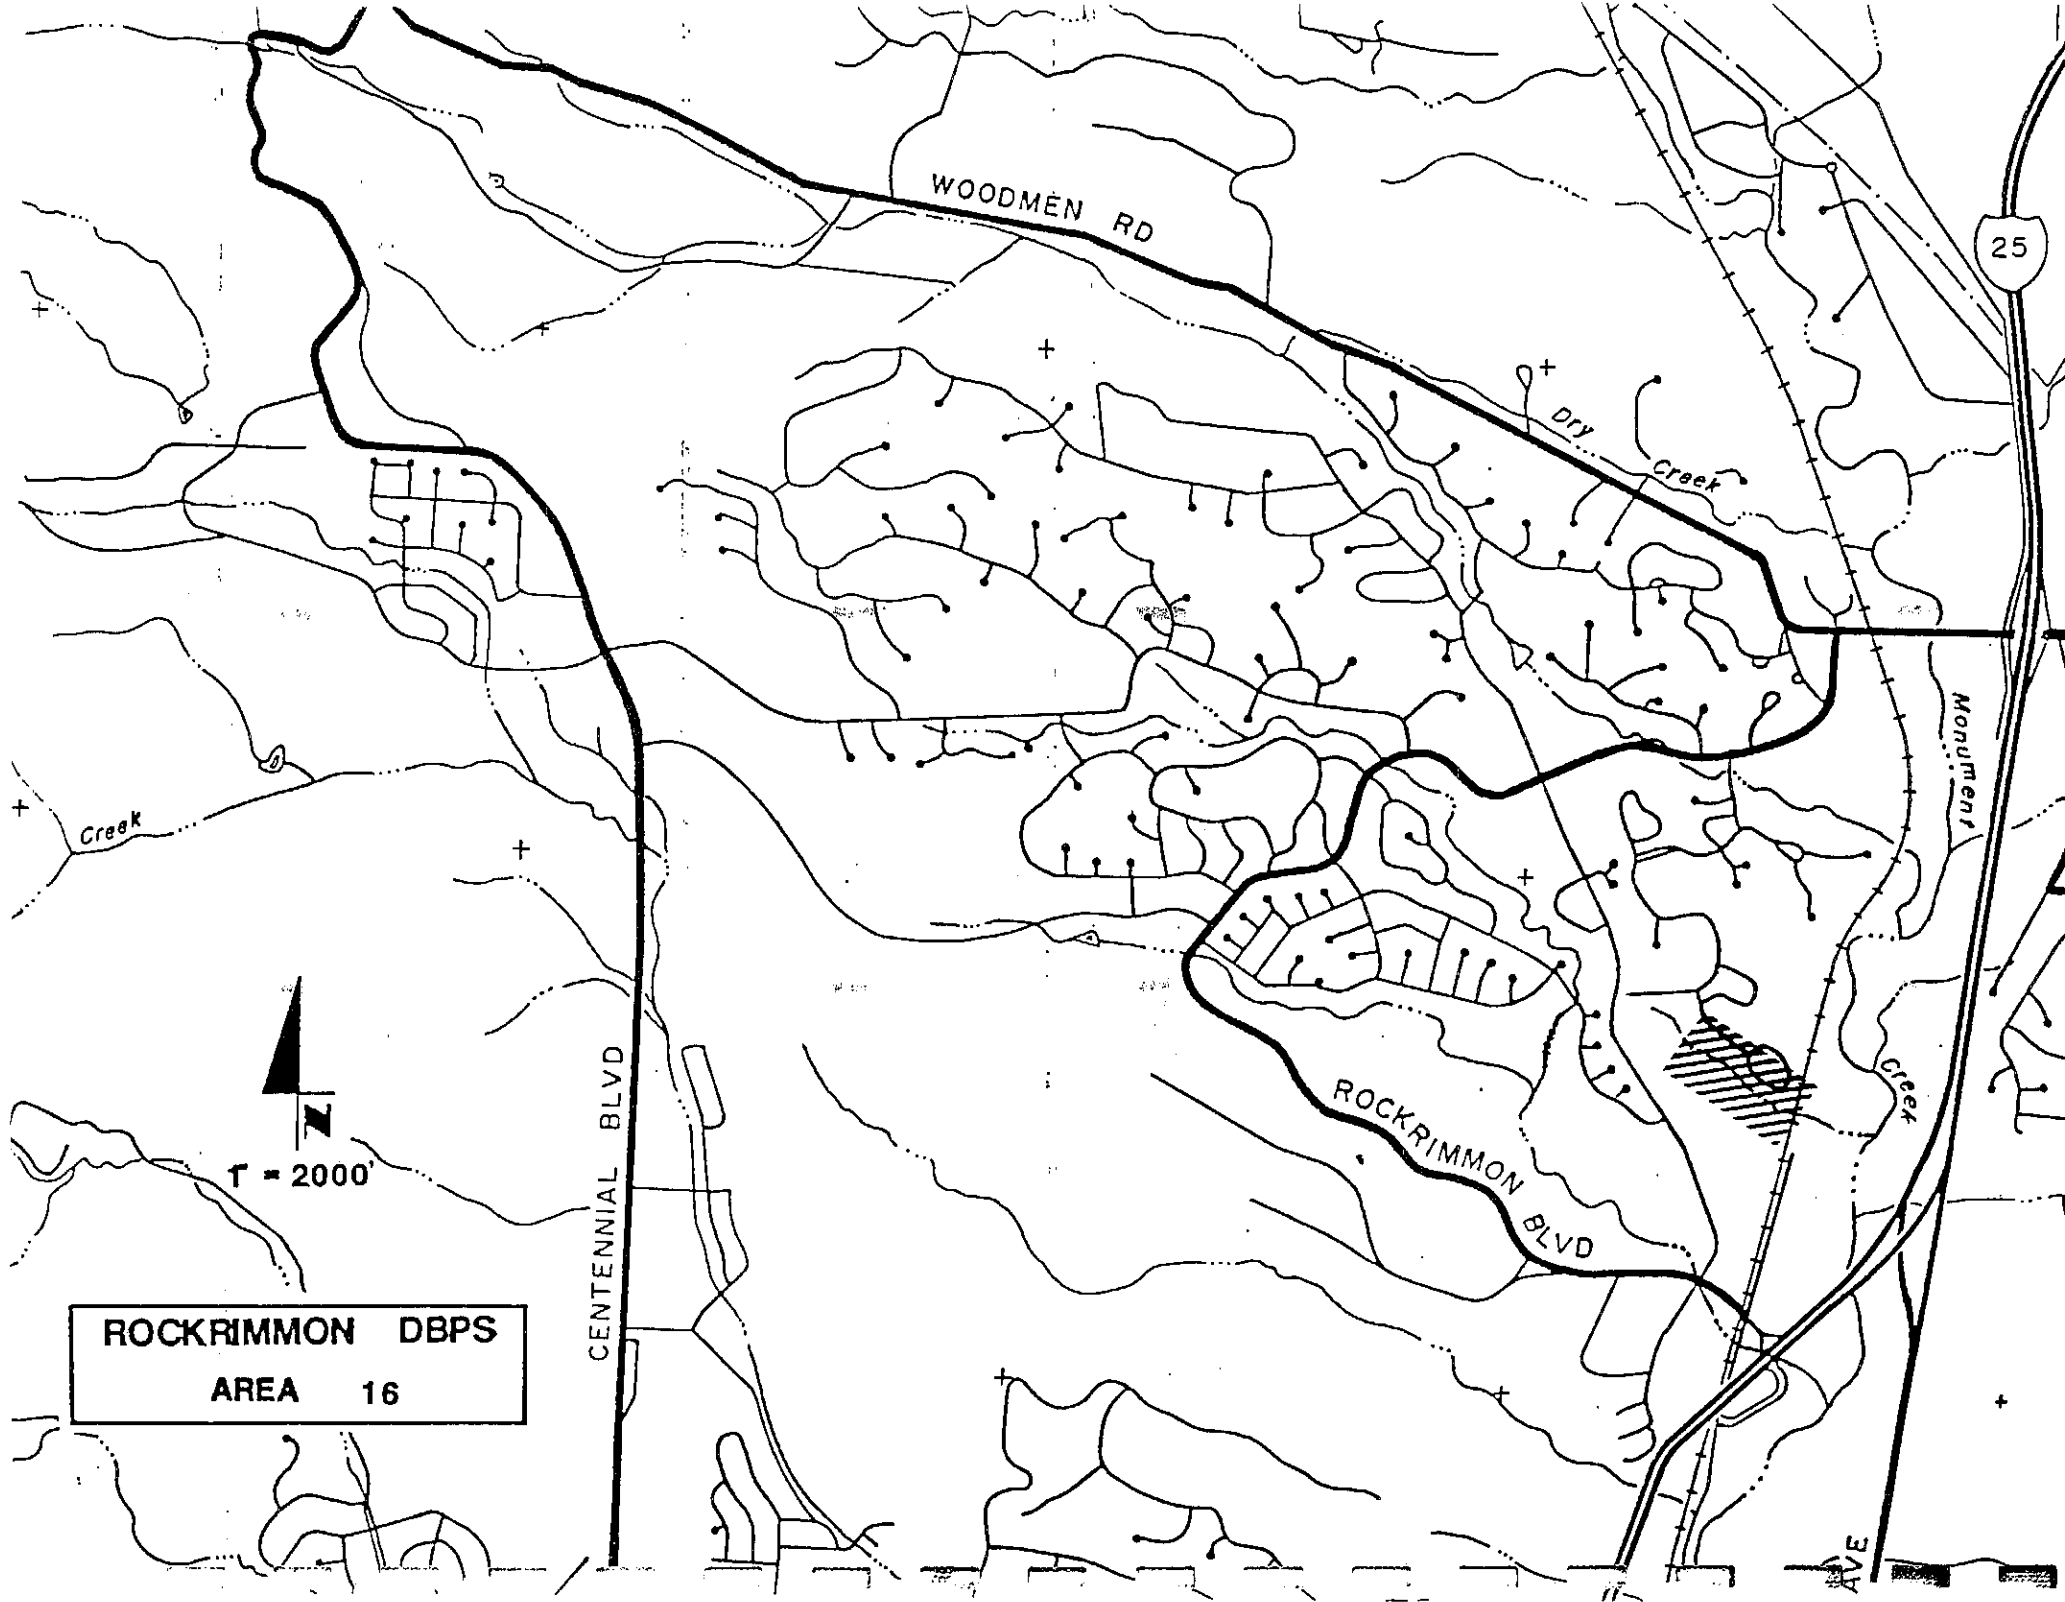
This reach is a small, incised channel generally straight with some meanders. There are very few points of ongoing erosion, but two of those are quite serious. A curve in the channel immediately upstream of the railroad culvert is eroding and should be repaired. The major erosion damage is from a diversion ditch across the property to the south that discharges high on the south bank of this channel approximately 400 feet west of the railroad culvert. This has created a very large erosion problem that is progressing rapidly. Several other locations are exhibiting minor erosion. The channel proper is inadequate to convey the 100 year flow, but the draw in which it is located is very adequate without threat to any private property.

For this reach, Alternative A is recommended with infrequent, judiciously placed drop structures. For a few isolated spots, Alternative B is recommended.
