SPRING CREEK

Drainage Basin Planning Study

City of Colorado Springs and El Paso County

**SPRING CREEK
DRAINAGE BASIN PLANNING STUDY
PRELIMINARY DRAFT REPORT**

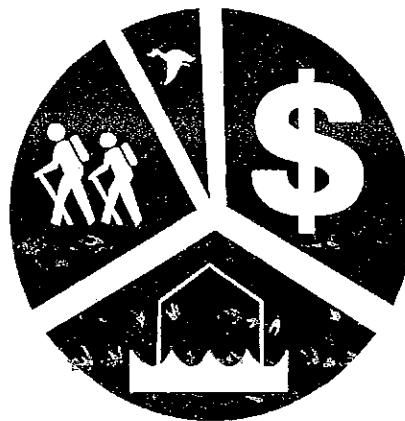
FIGURE 24

UNION BLVD. TO CIRCLE DRIVE

ENVIRONMENT (8%)

MULTI-USE (26%)

COST (33%)

SAFETY (33%)
