**MASTER DEVELOPMENT DRAINAGE PLAN
FOR
ALLISON VALLEY**

AUGUST 2004

**CLASSIC CONSULTING ENGINEERS & SURVEYORS, LLC
6385 CORPORATE DRIVE, SUITE 101
COLORADO SPRINGS, CO 80919**

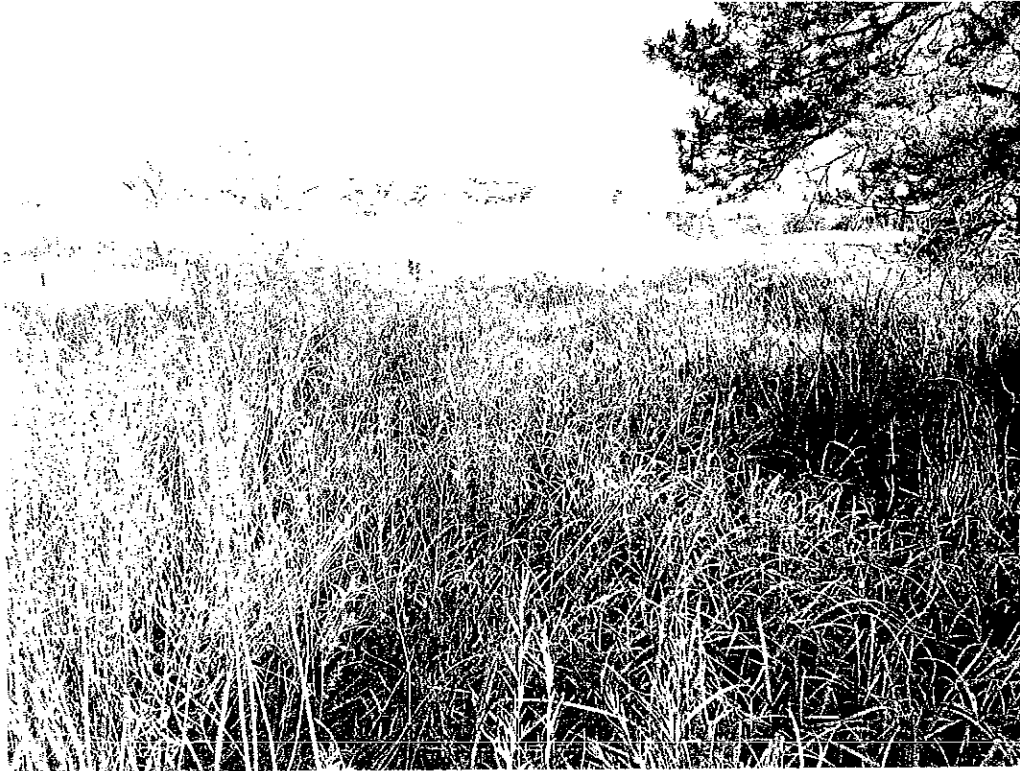
Area C: Black Squirrel Creek Tributary – Vegetated channel bounded by hayfields above Black Squirrel Creek

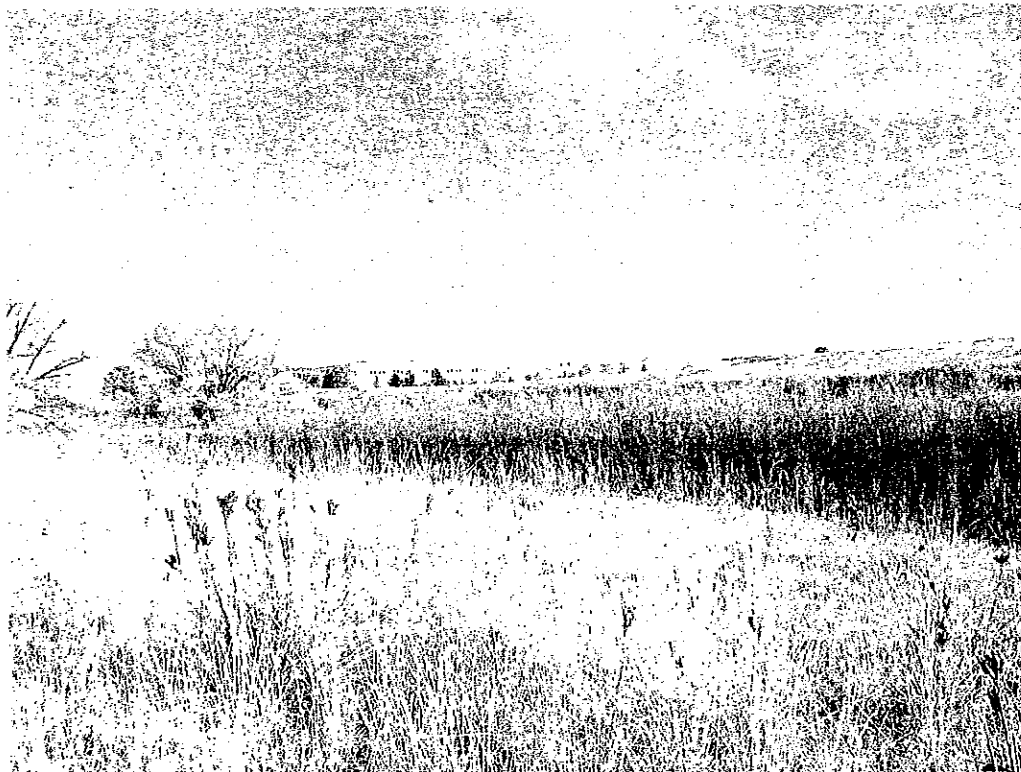
Area C: Black Squirrel Creek Tributary – Overview of channel bank willows near confluence with Black Squirrel Creek culvert

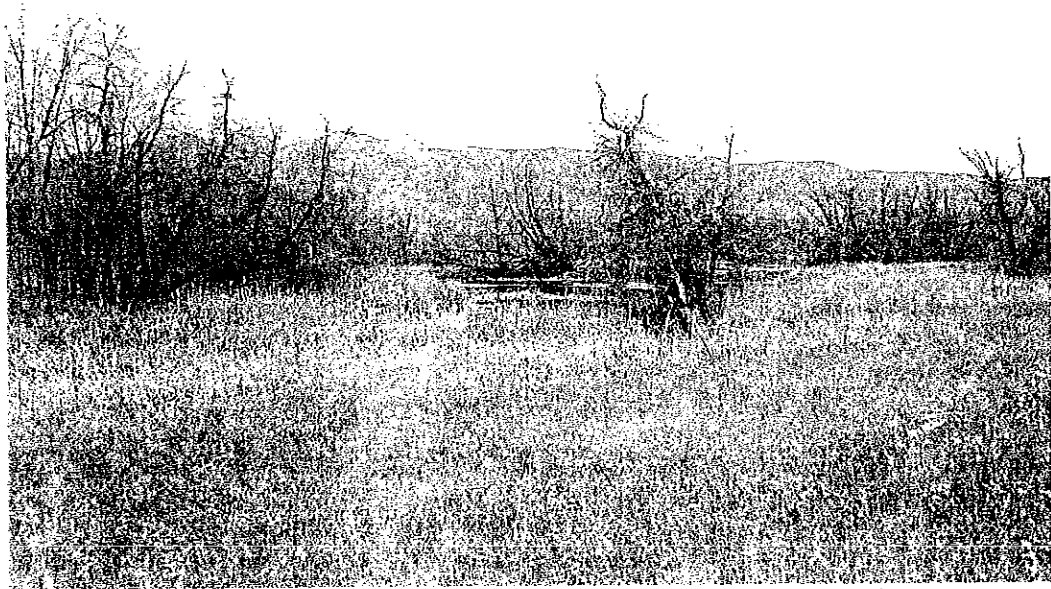
Area D: Wet Meadow above Black Squirrel Creek looking at pond

Area D: Isolated wet meadow (5.55-acres) - This area consists of an expansive, densely vegetated wet meadow and pond situated just north and slightly upslope of Black Squirrel Creek. The meadow is separated from the creek by uplands that support blue grama, smooth brome and other grasses, as well as earthen berms on the southern boundary. The meadow is composed of a mosaic of wetland plants dominated by coyote willow, short-awn foxtail, bentgrass, and sedges. The pond, which has formed at the lowest point of the meadow at the western end, is encircled with crack and coyote willows and a wide band of cattails. No hydrologic connections, including culverts, are present between this meadow and Black Squirrel Creek.

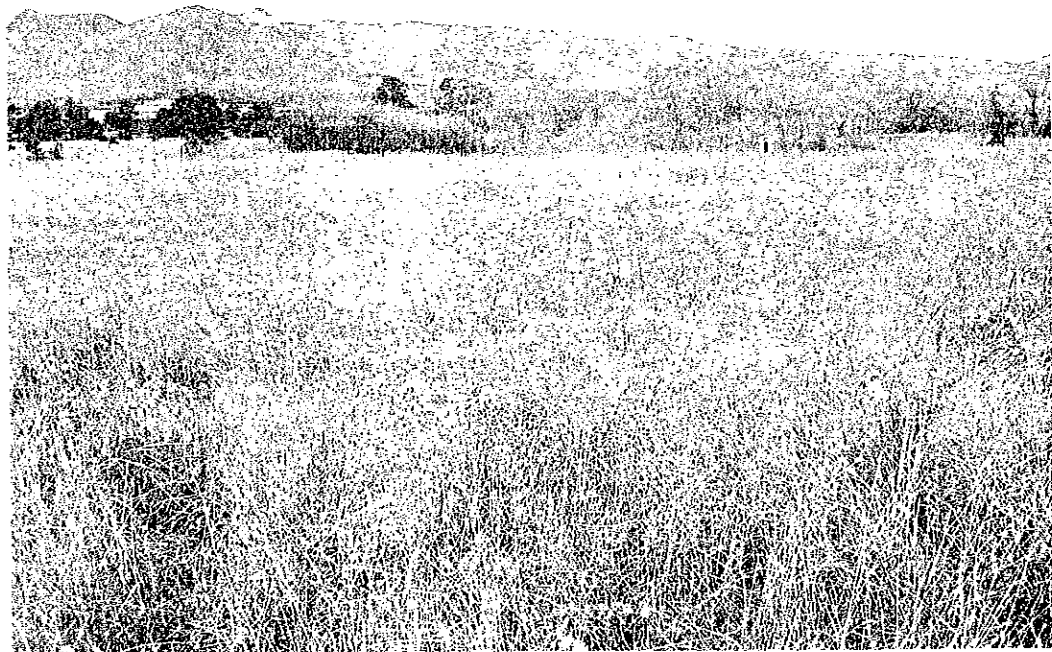
Area D – From east side of wet meadow looking west across grasses/sedges to coyote willow thickets

Remarks: The expansive meadow is densely vegetated and dominated by sedges and reedtop. Thickets of coyote willows are situated along the eastern and western boundaries, and the pond at the western end of the meadow (downslope from the willows) is ringed with crack and peach-leaf willows and a large cattail marsh.

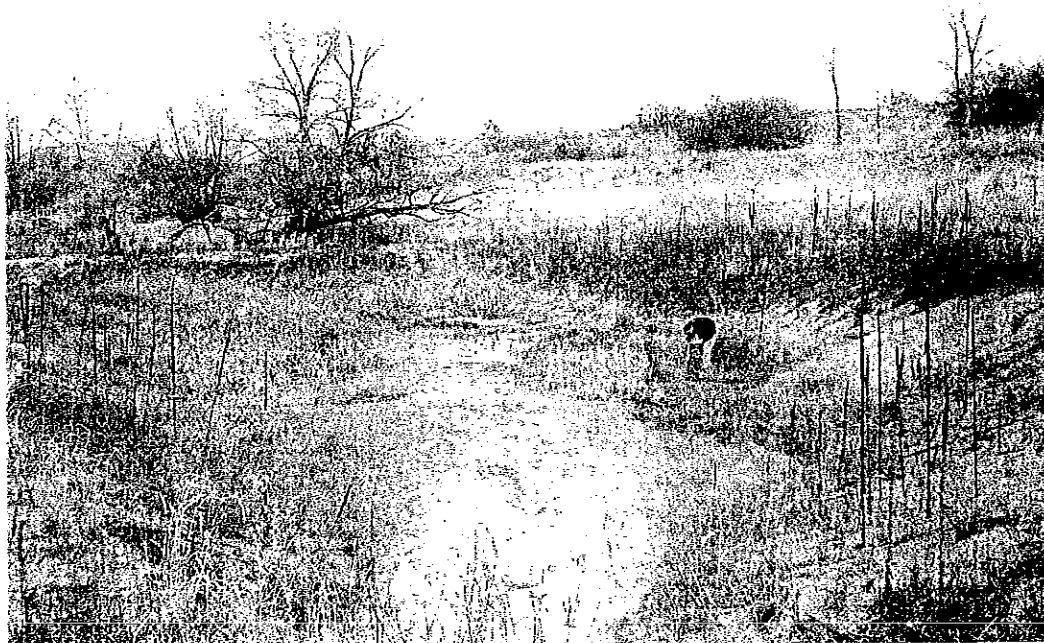
Area E: – Overview of isolated bench wetland and pond
