DOUGLAS CREEK DRAINAGE STUDY

JUNE 1974

THE LINCOLN DEVORE TESTING LABORATORY
COLORADO SPRINGS, COLORADO

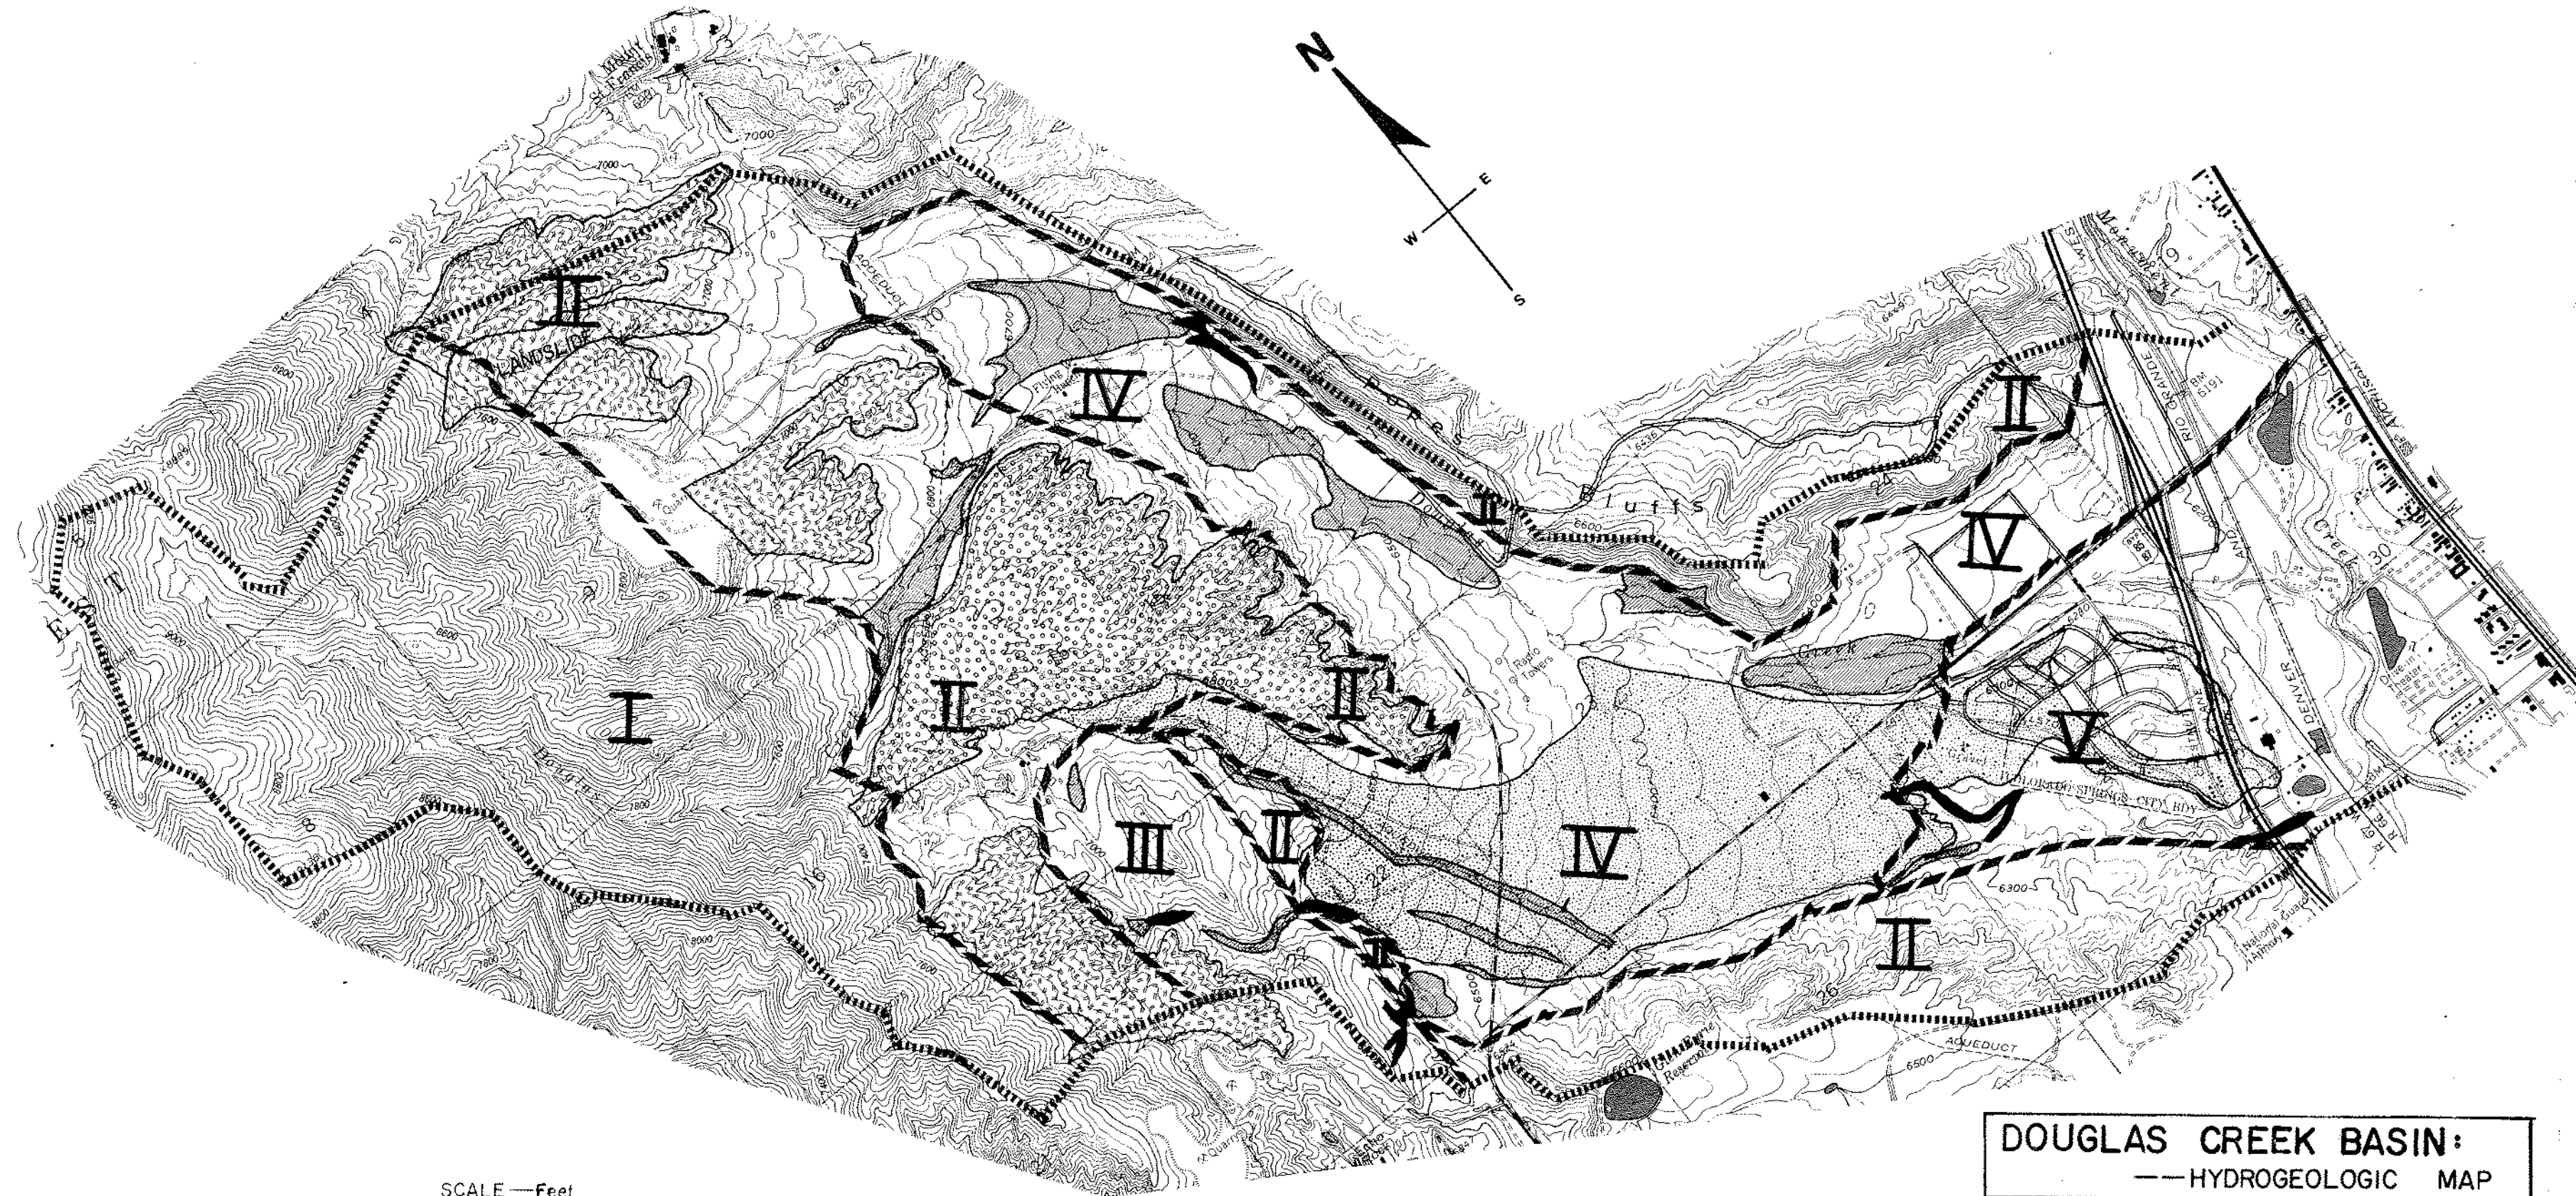
DOUGLAS CREEK BASIN: --HYDROGEOLOGIC MAP

Areas of Constricted, Incised, Channels , Very high stream velocities.
