**APPENDIX D**  
**EXISTING FACILITIES**  
**Facility Summary**  
**Photographs**

Table 1 Existing Major Drainageway Structure Inventory

JIMMY CAMP CREEK DBPS  
OLD PUEBLO ROAD BRIDGE  
JIMMY CAMP CREEK  
EL PASO COUNTY, COLORADO  
BRIDGE PROFILE

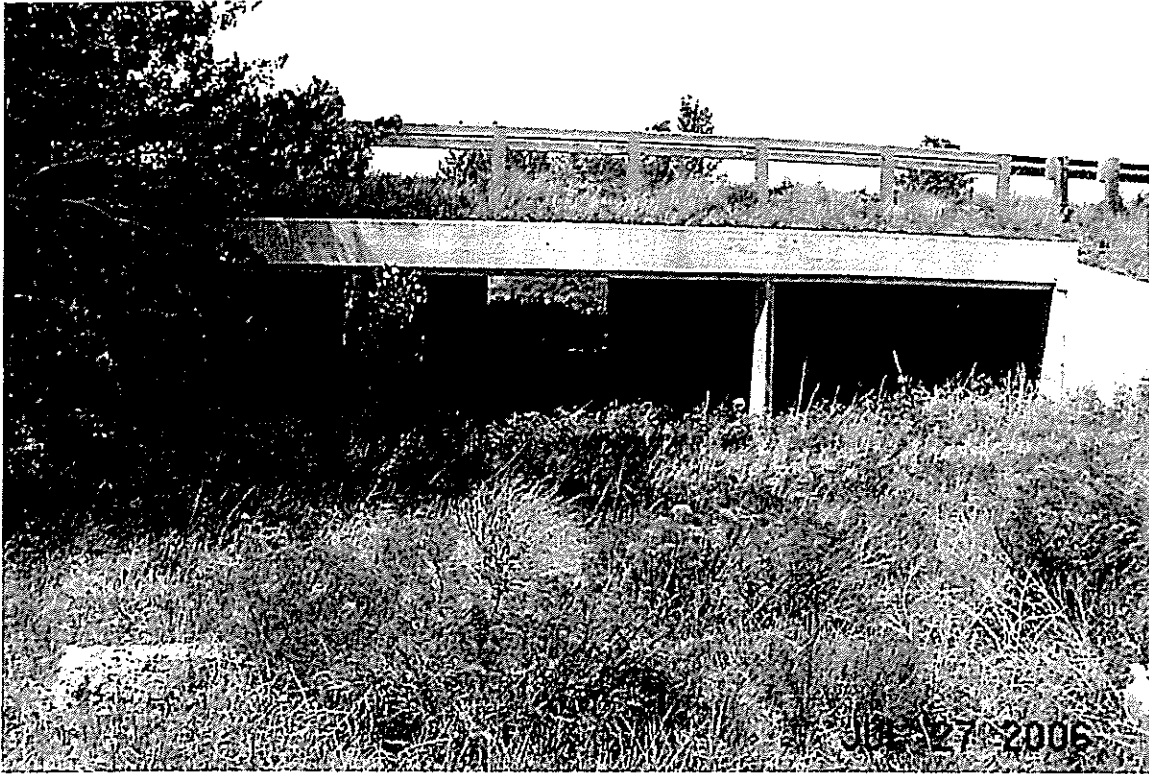
Bradley Road, 40'w x 7' h Concrete Bridge Outlet Channel in Good Condition.

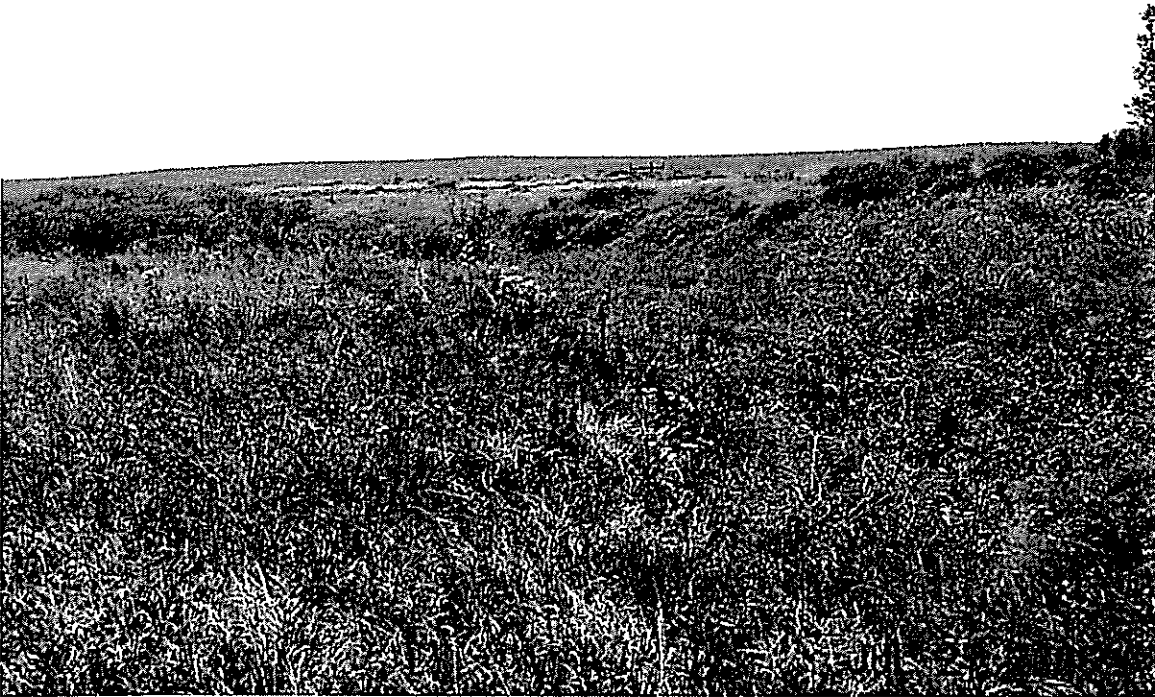
Bradley Road, 40'w Concrete Bridge Inlet Channel in Good Condition.

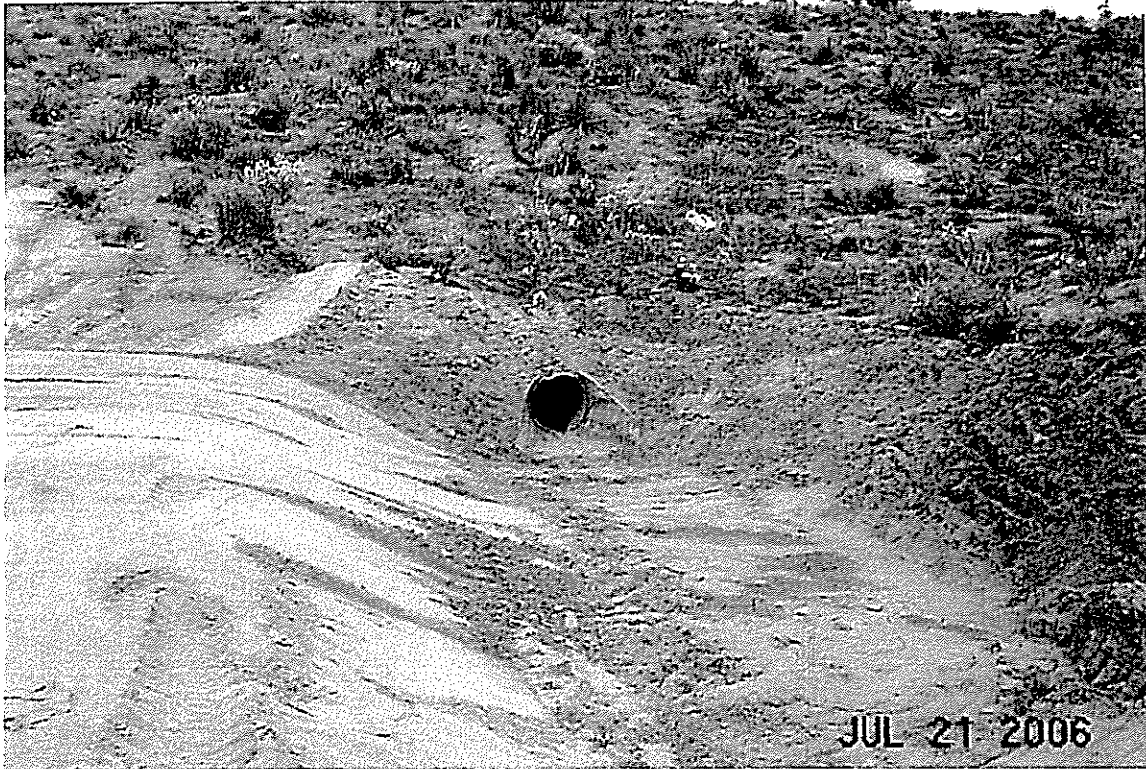
Space Village, 28" CMP Outlet, bent.

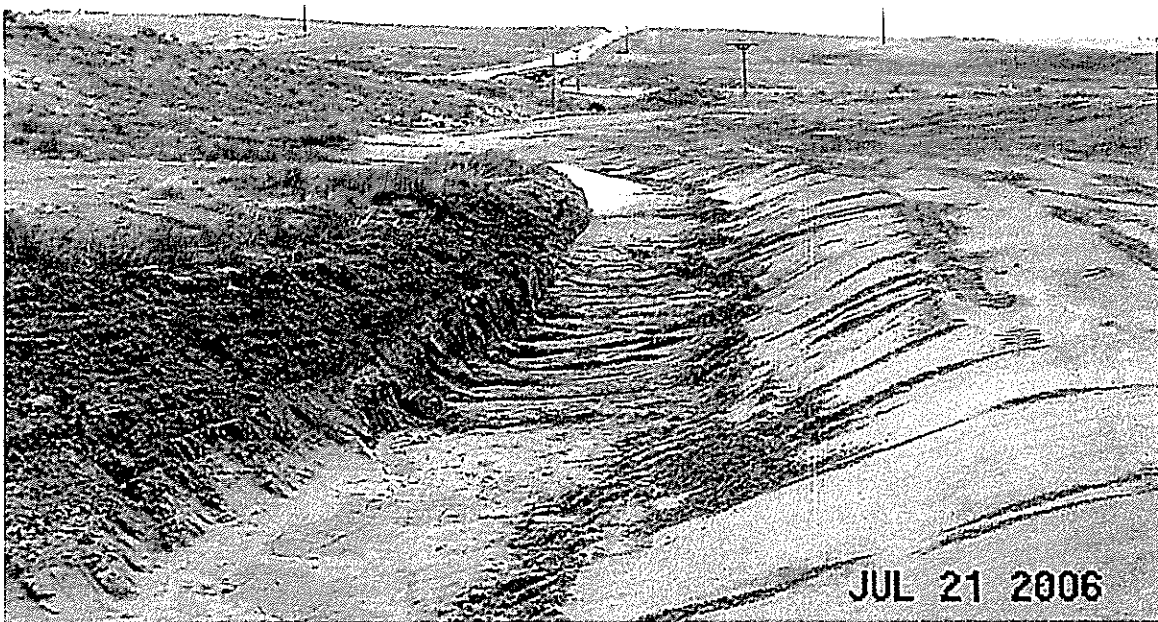
Space Village, 28" CMP, Outlet Channel in Fair Condition. Appears to be drainage.

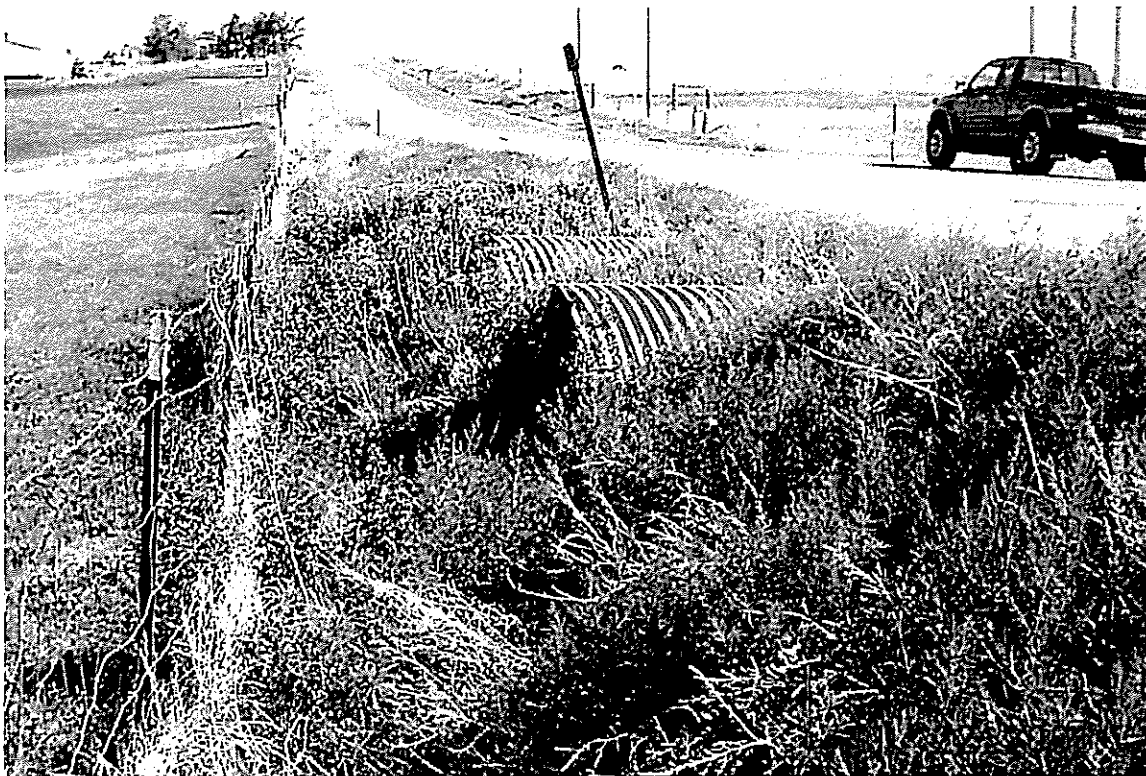
M4

Meridian Road, Two 64" w x 42" h CMPs Inlet channel in Good Condition.

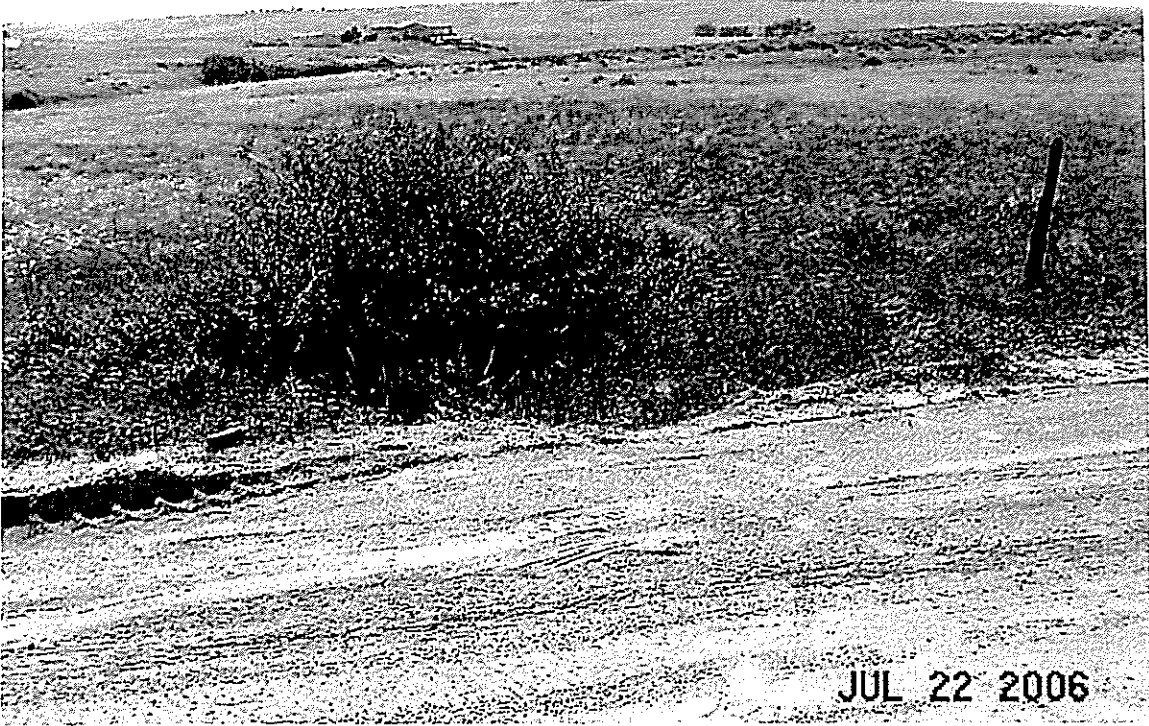
m6

Meridian Road, 18" CMP Outlet, bent.

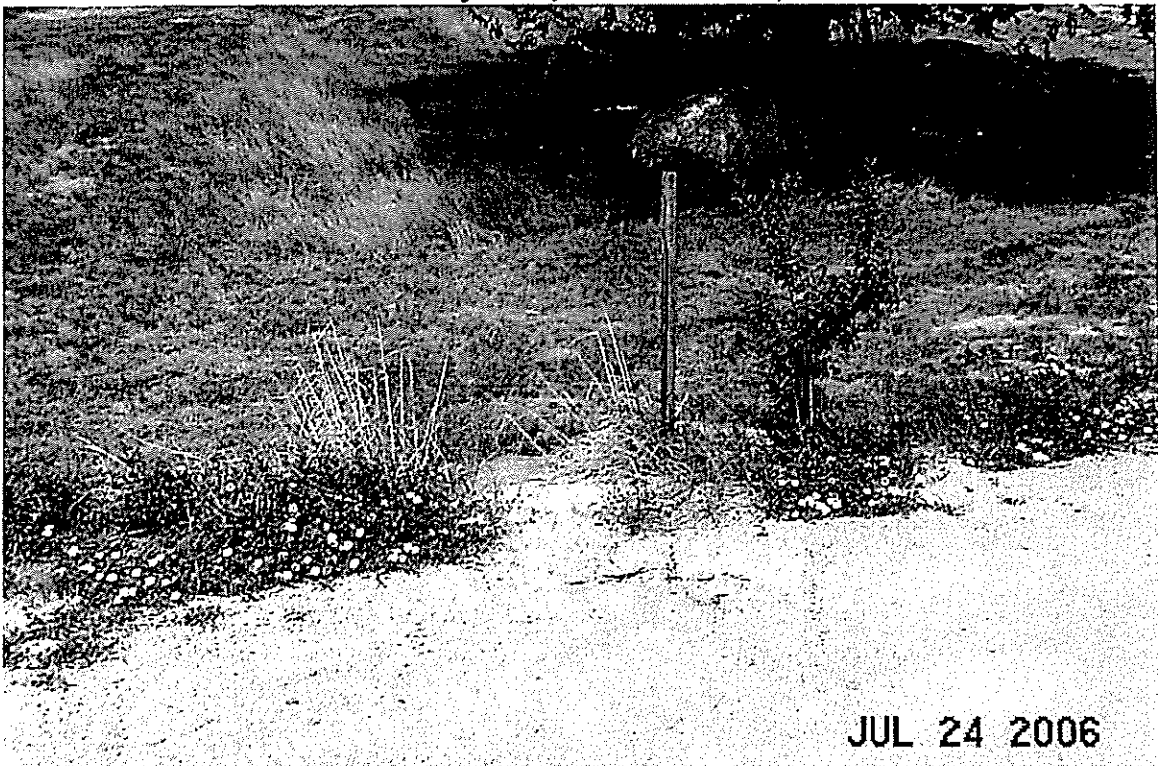
C3

Corral Valley Road, 24" CMP Outlet, bent.

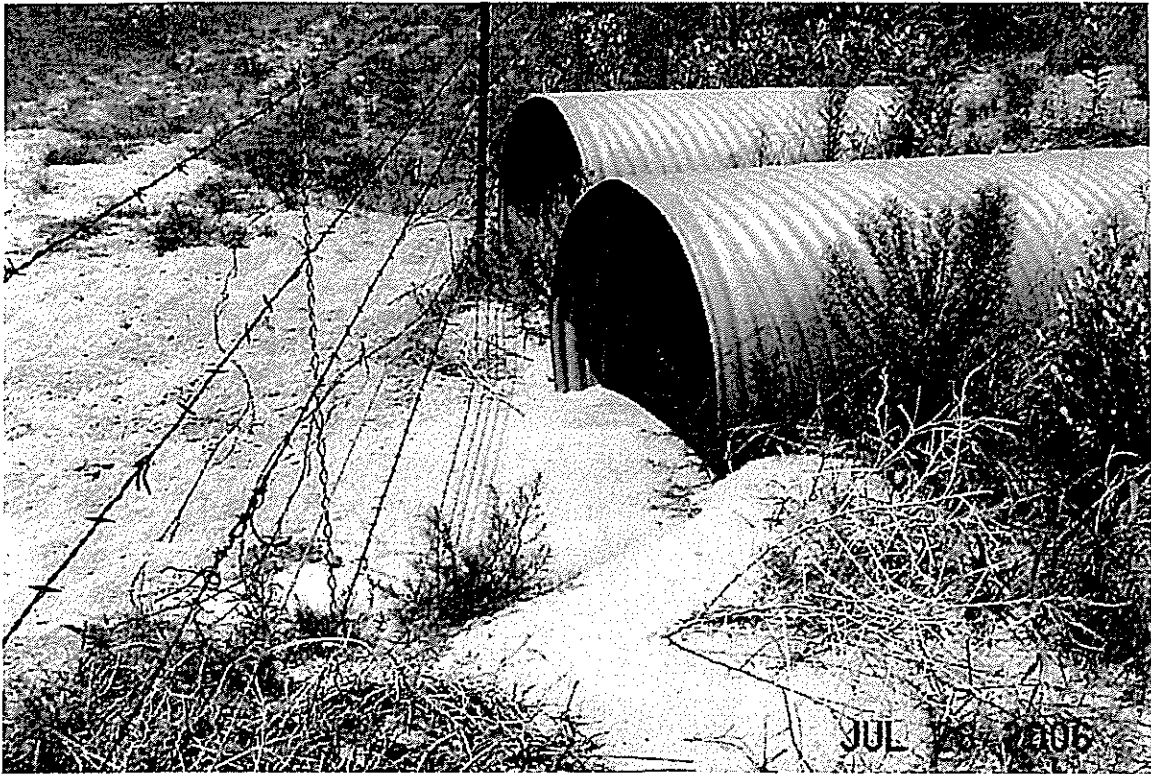
F9

Franceville Coal Mine Road, Two 42" CMPs Inlet.
