**APPENDIX D**  
**EXISTING FACILITIES**  
**Facility Summary**  
**Photographs**

Table 1 Existing Major Drainageway Structure Inventory

JIMMY CAMP CREEK DBPS  
OLD PUEBLO ROAD BRIDGE  
JIMMY CAMP CREEK  
EL PASO COUNTY, COLORADO  
BRIDGE PROFILE

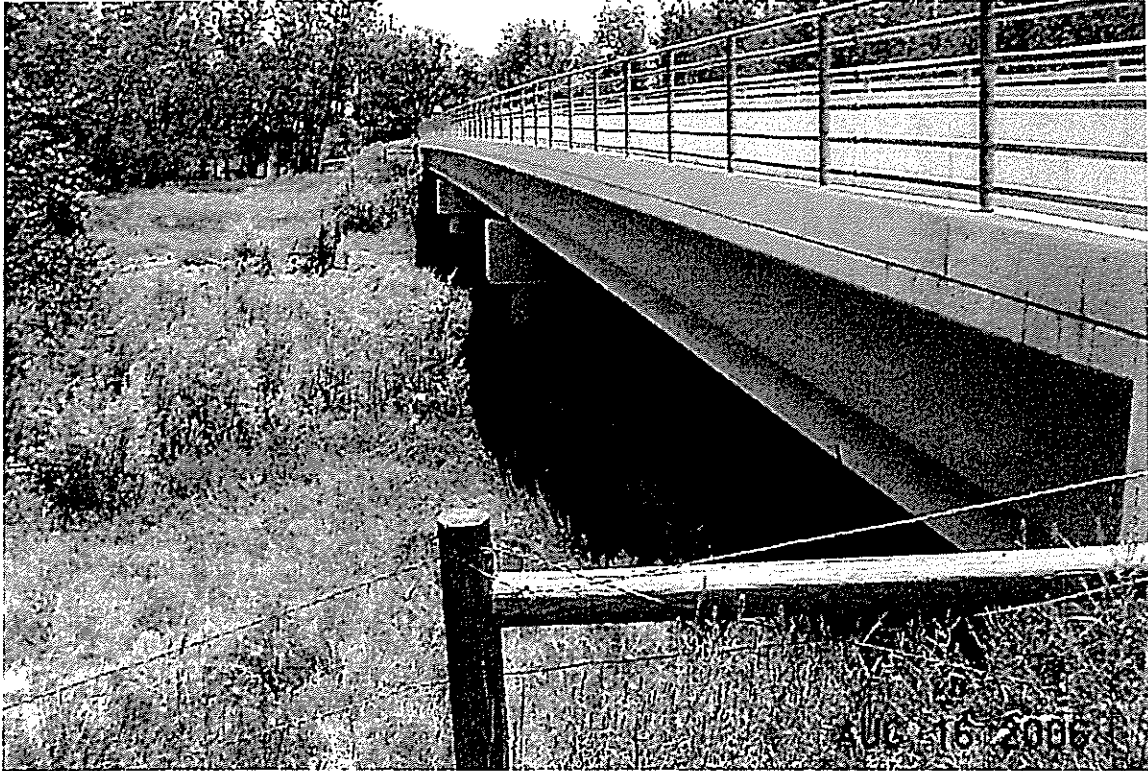
PR 1

Old Pueblo Road Bridge.

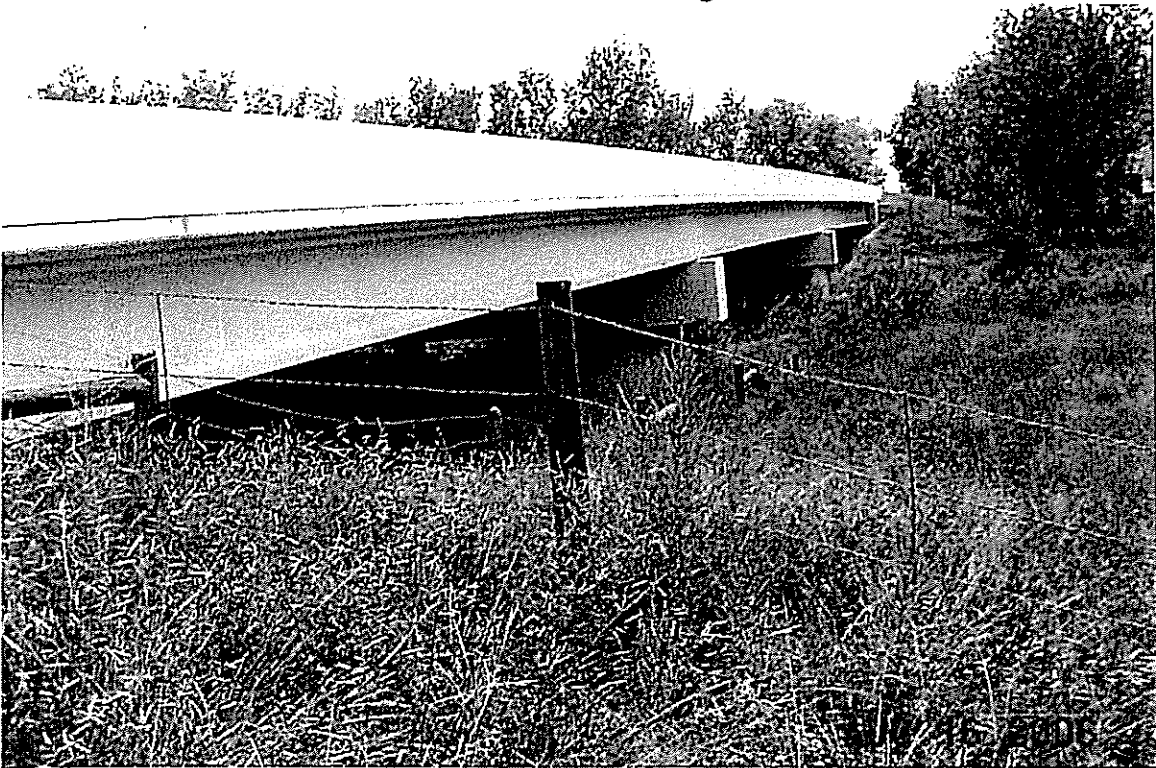
PR 1

Old Pueblo Road Bridge.

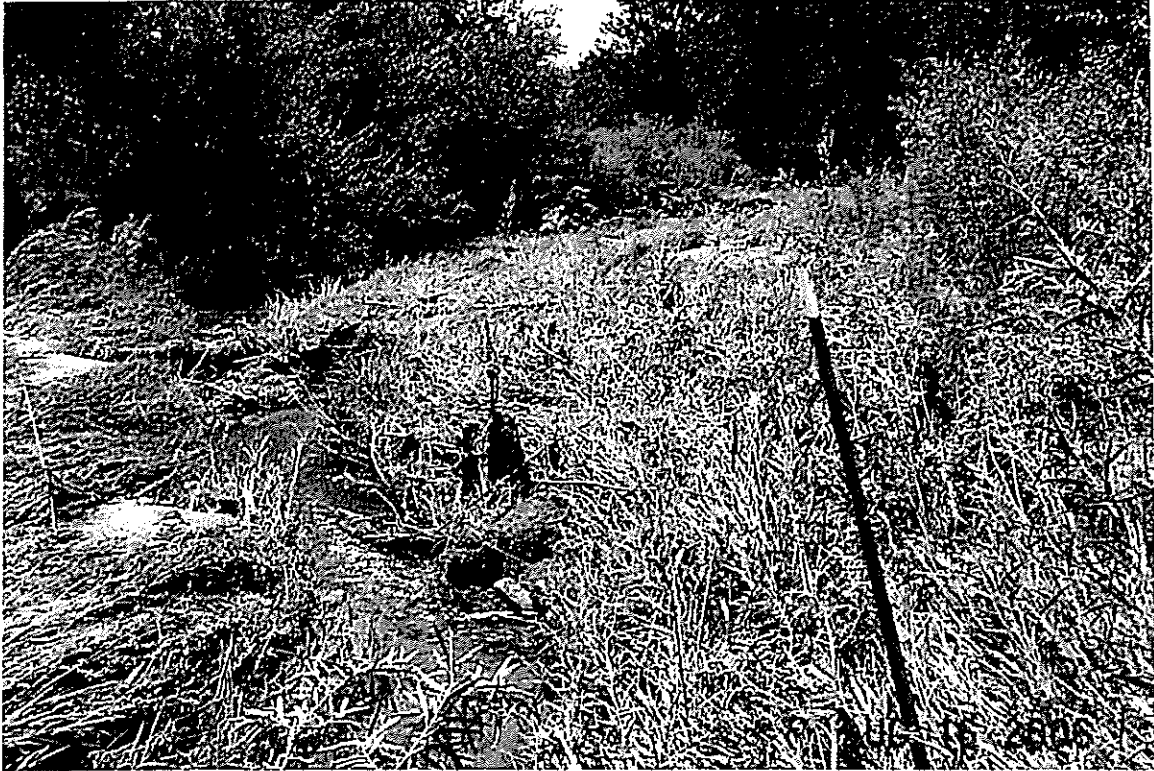
PR 1

Old Pueblo Road Bridge, Outlet Channel.

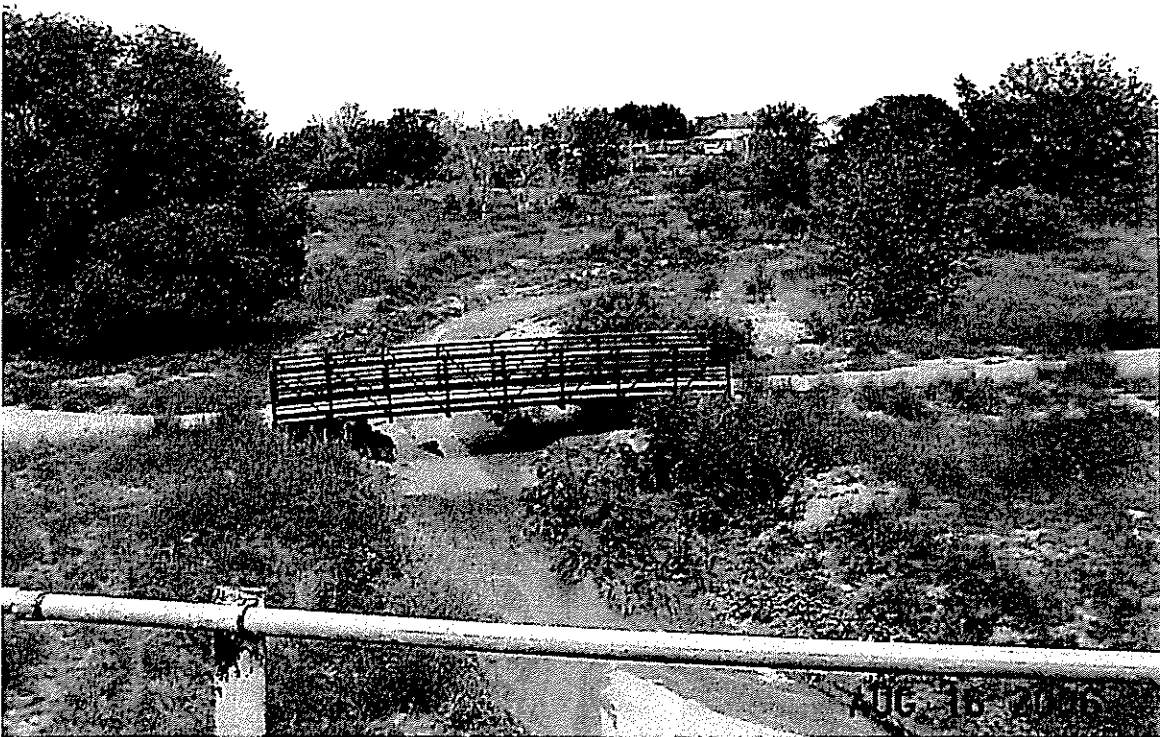
| Drainageway | Drainage Structure Description | Structure Inventory # | Roadway | Structure Condition | Inlet Channel Condition | Outlet Channel Condition | Existing 100-year (cfs) | Structure Capacity (cfs) | % of Existing 100-year Q |
|---|---|---|---|---|---|---|---|---|---|
| | 244' Bridge Mult-span | RR1 | D & RGW RR | Good to Fair | Good to Fair | Good to Fair | 22,100 | >>24000 | 100 |

Rail Road Bridge, Inlet Channel.

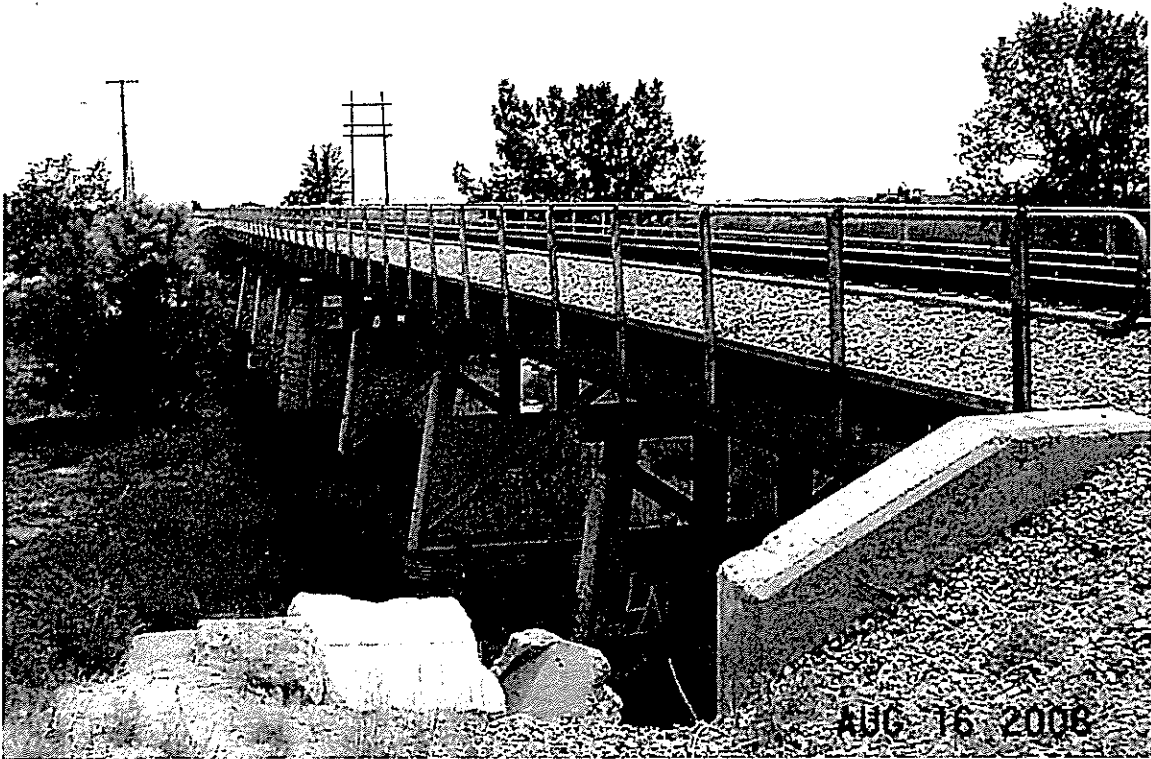
RR1

Rail Road Bridge.

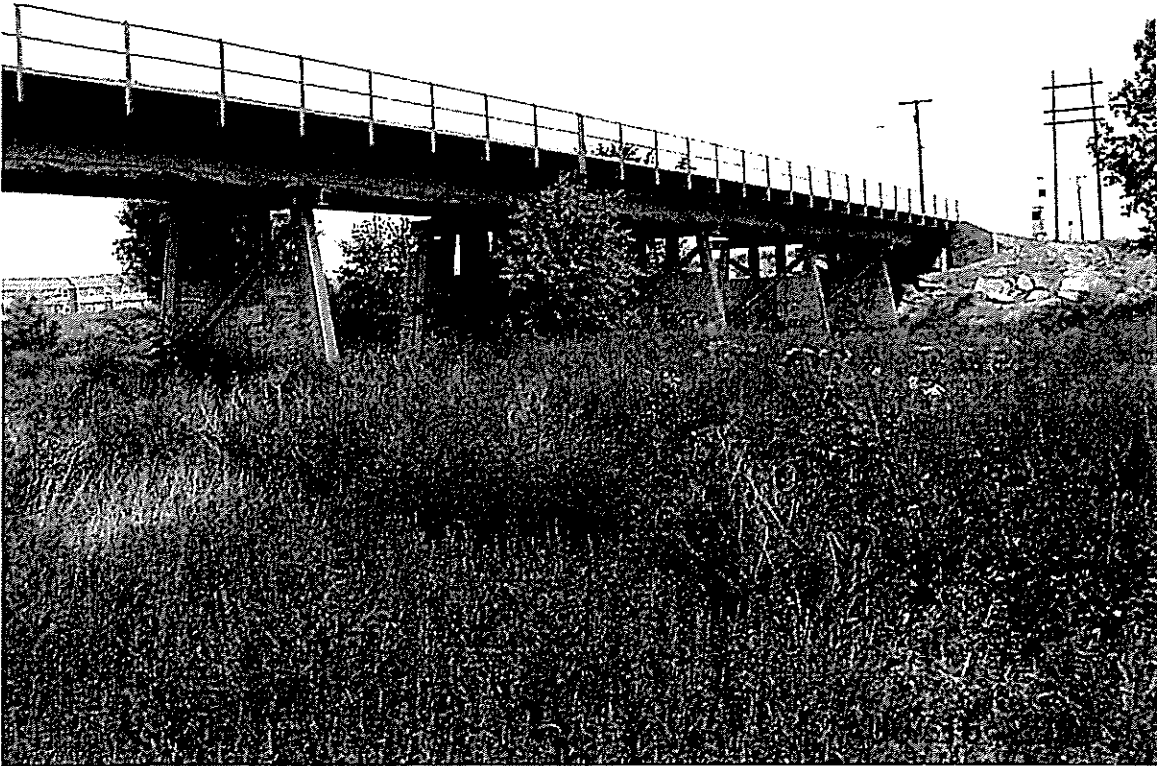
RR1

Rail Road Bridge.

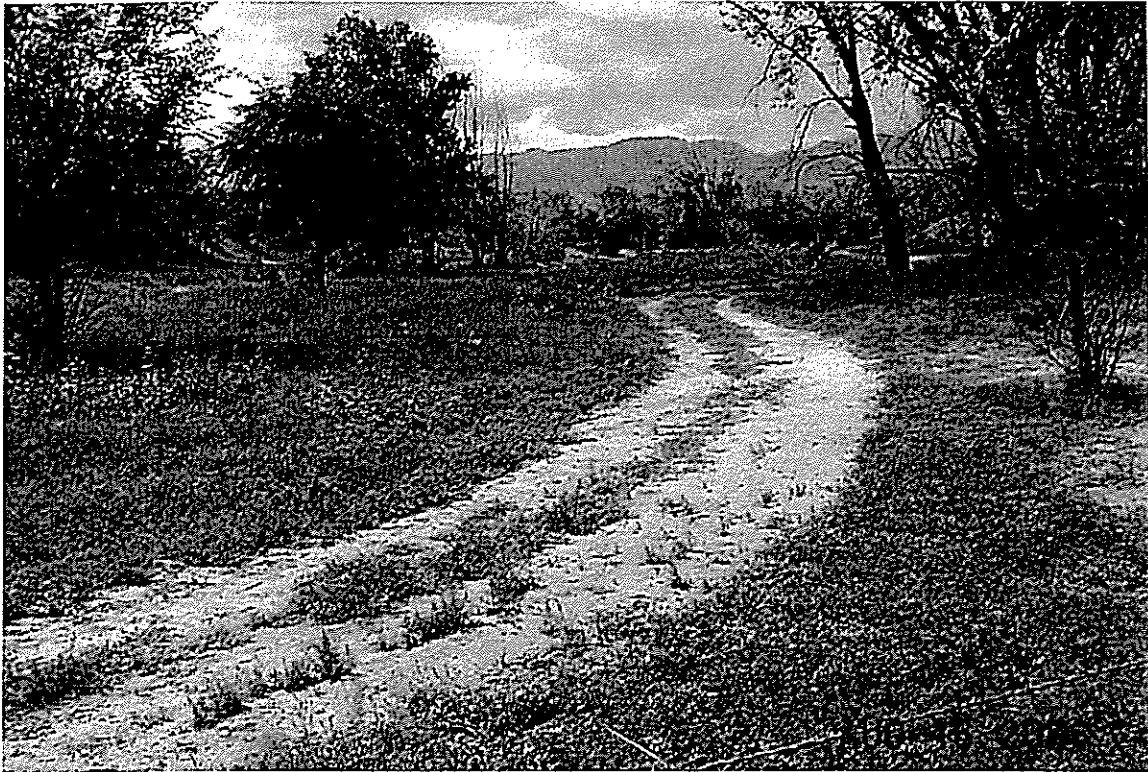
RR1

Rail Road Bridge, Outlet Channel.

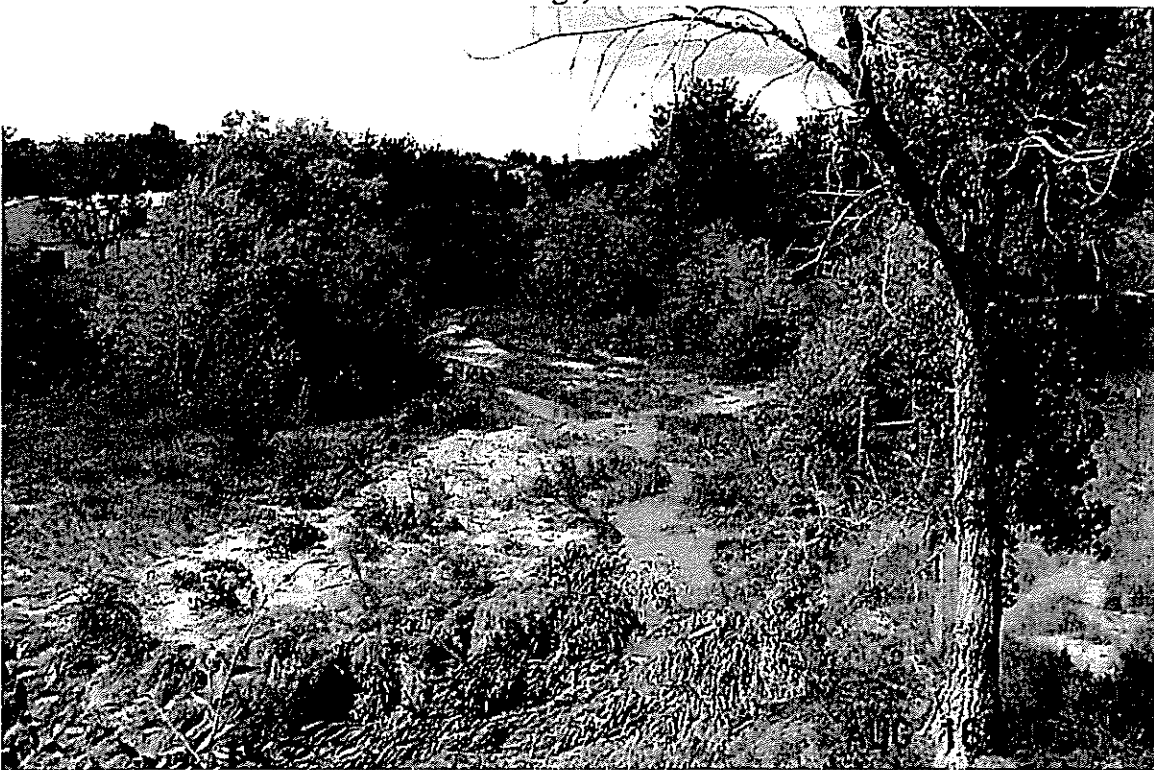
01

Ohio Ave. Bridge Inlet Channel. Iowa Ave. has been closed west of Rail Road and Ohio Ave. veers northwest to what used to be Iowa Ave.

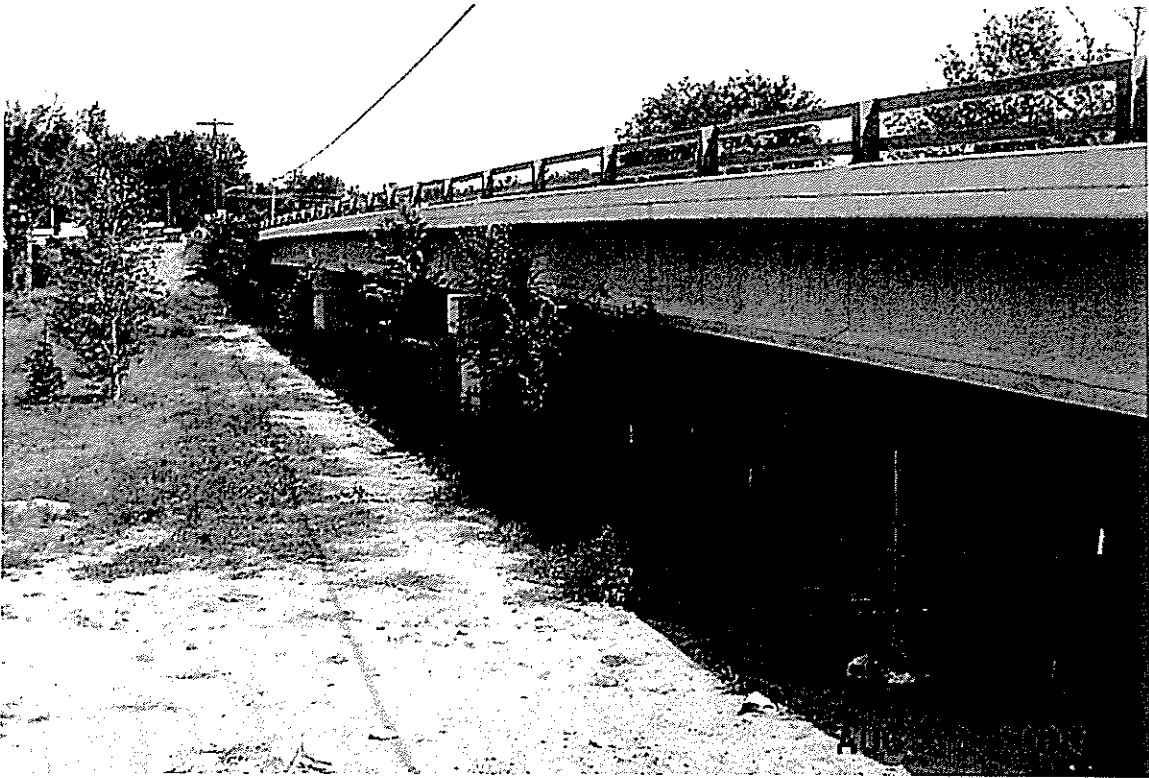
01

Ohio Ave. Bridge.

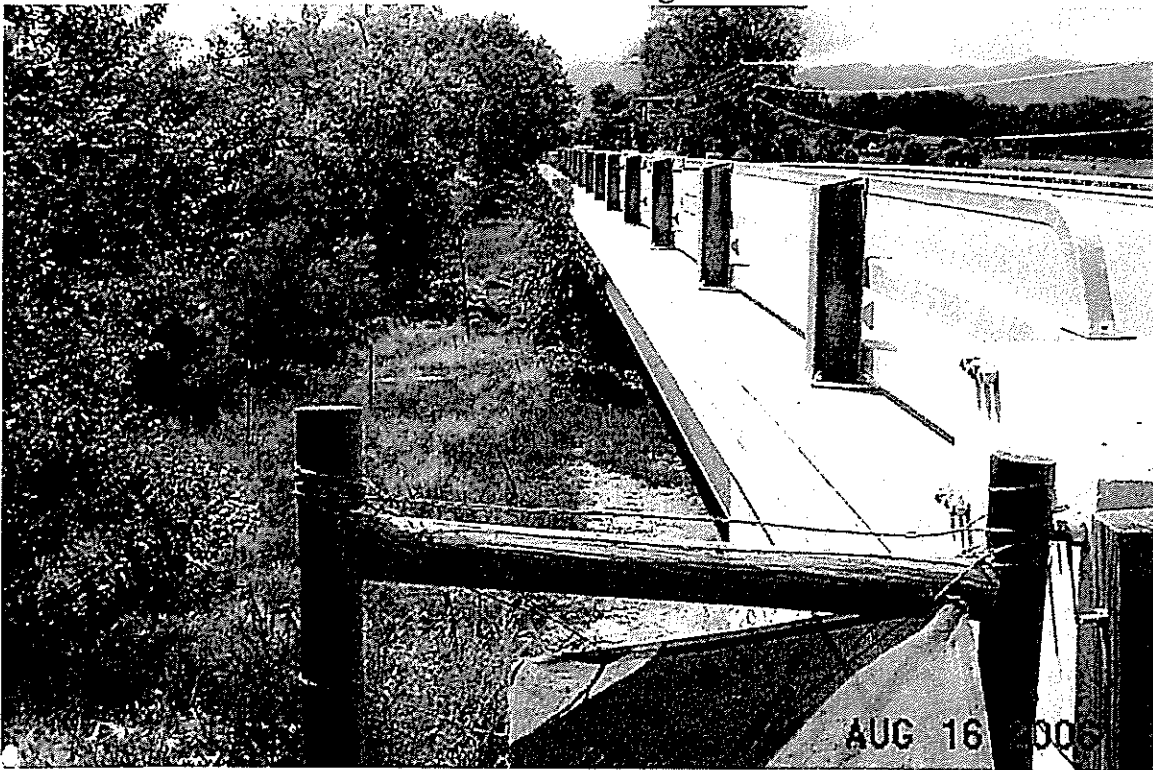
01

Ohio Ave. Bridge.

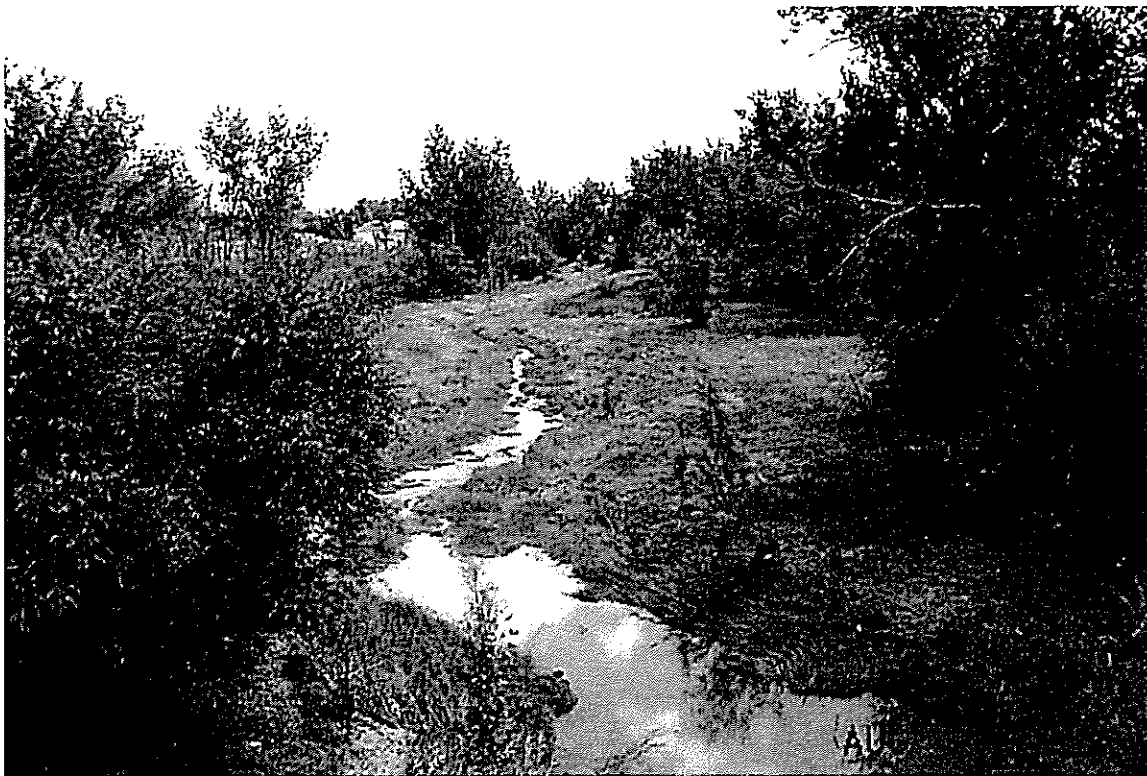
01

Ohio Ave. Bridge Outlet Channel.

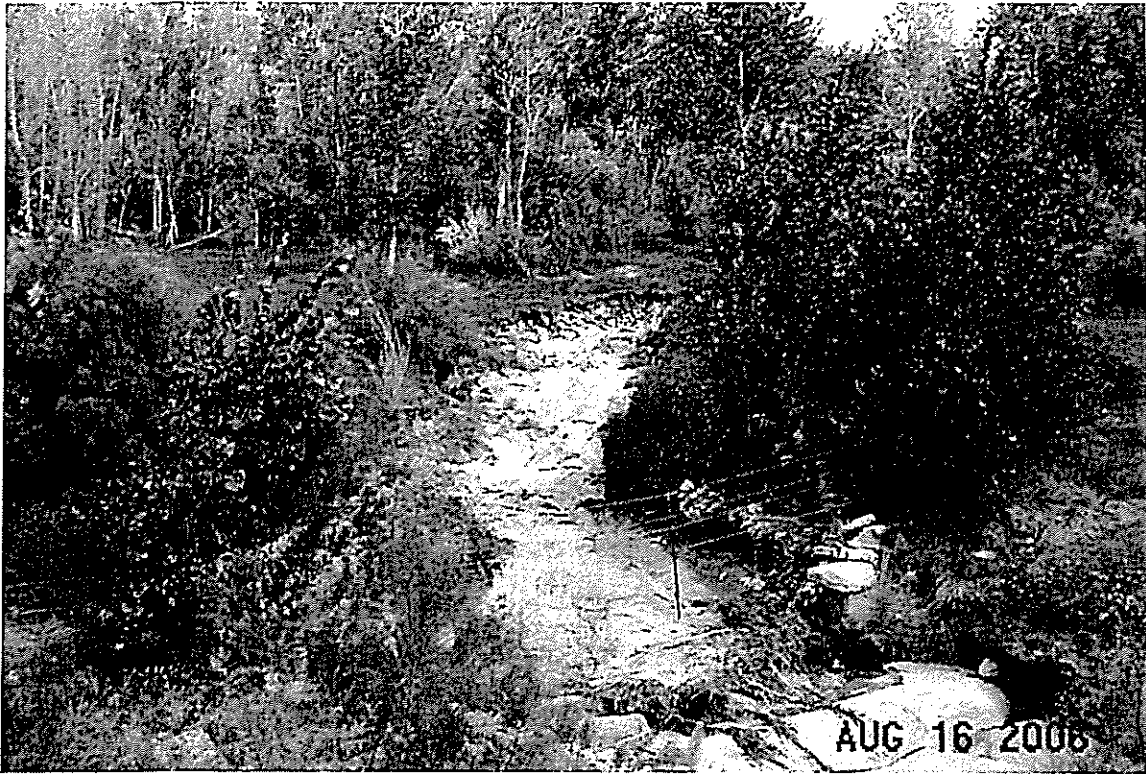
LR1

Link Road Bridge, inlet channel.

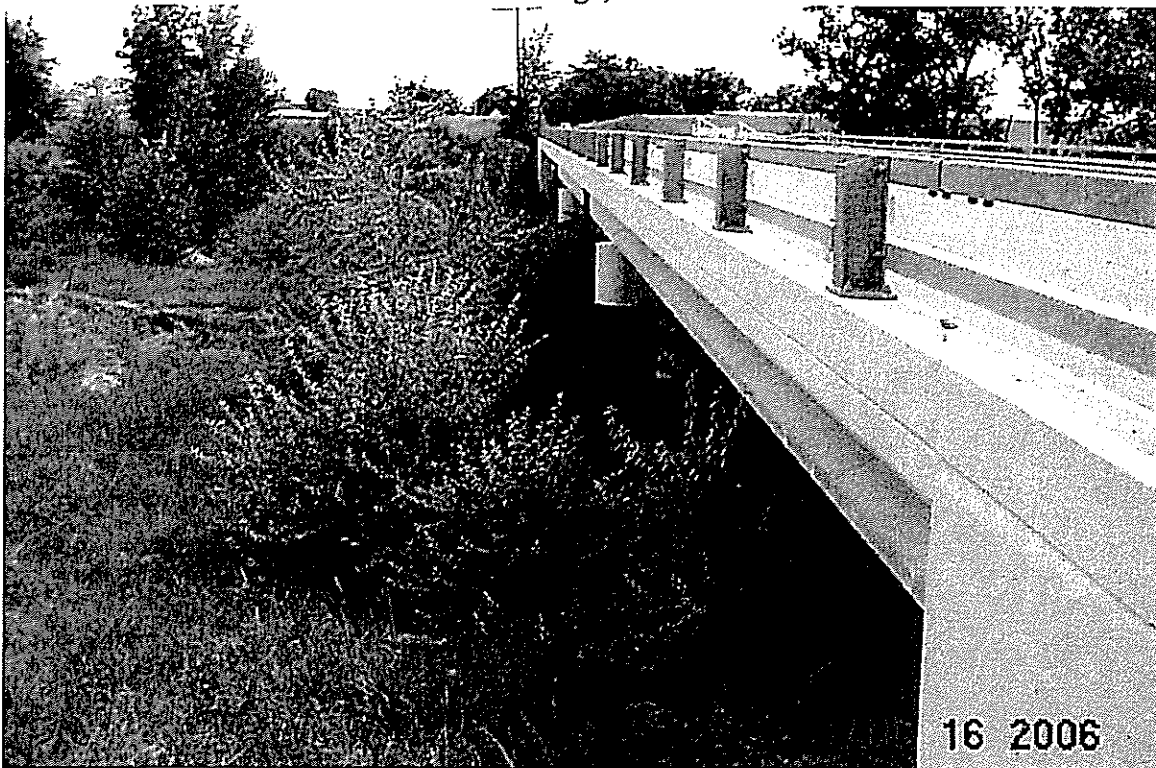
LR1

Link Road Bridge.

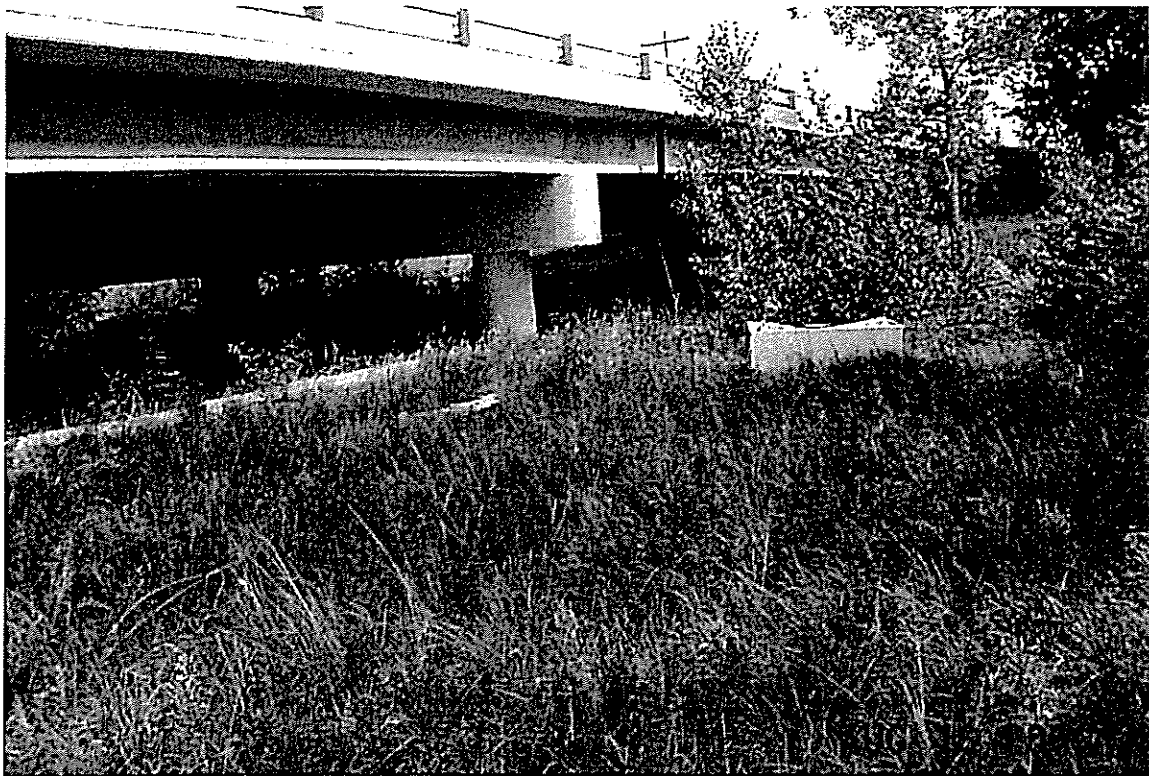
LR1

Link Road Bridge.

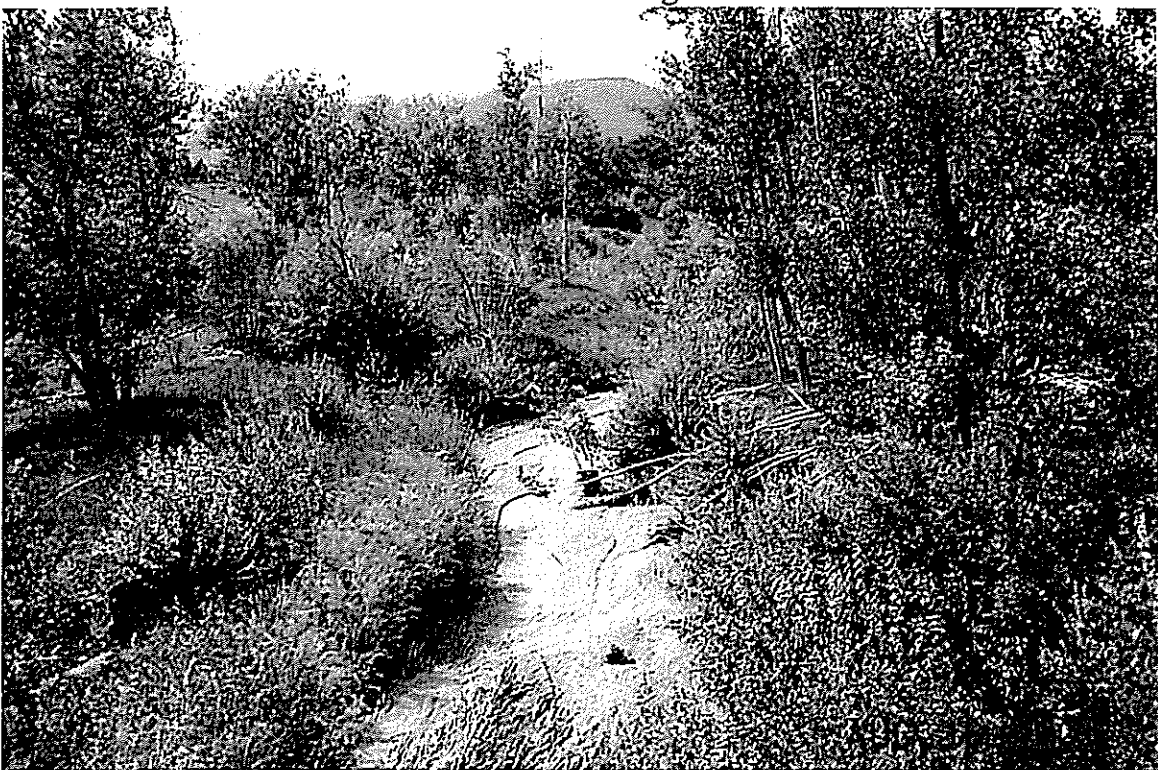
| Drainageway | Drainage Structure Description | Structure Inventory # | Roadway | Structure Condition | Inlet Channel Condition | Outlet Channel Condition | Existing 100-year (cfs) | Structure Capacity (cfs) | % of Existing 100-year Q |
|---|---|---|---|---|---|---|---|---|---|
| | 190' Bridge 3-spans | LR1 | Link Road | Good | Good<br>Floodplain well vegetated | Poor<br>Headcut at outlet | 21,880 | 26000 | 100 |

Link Road Bridge, outlet channel.

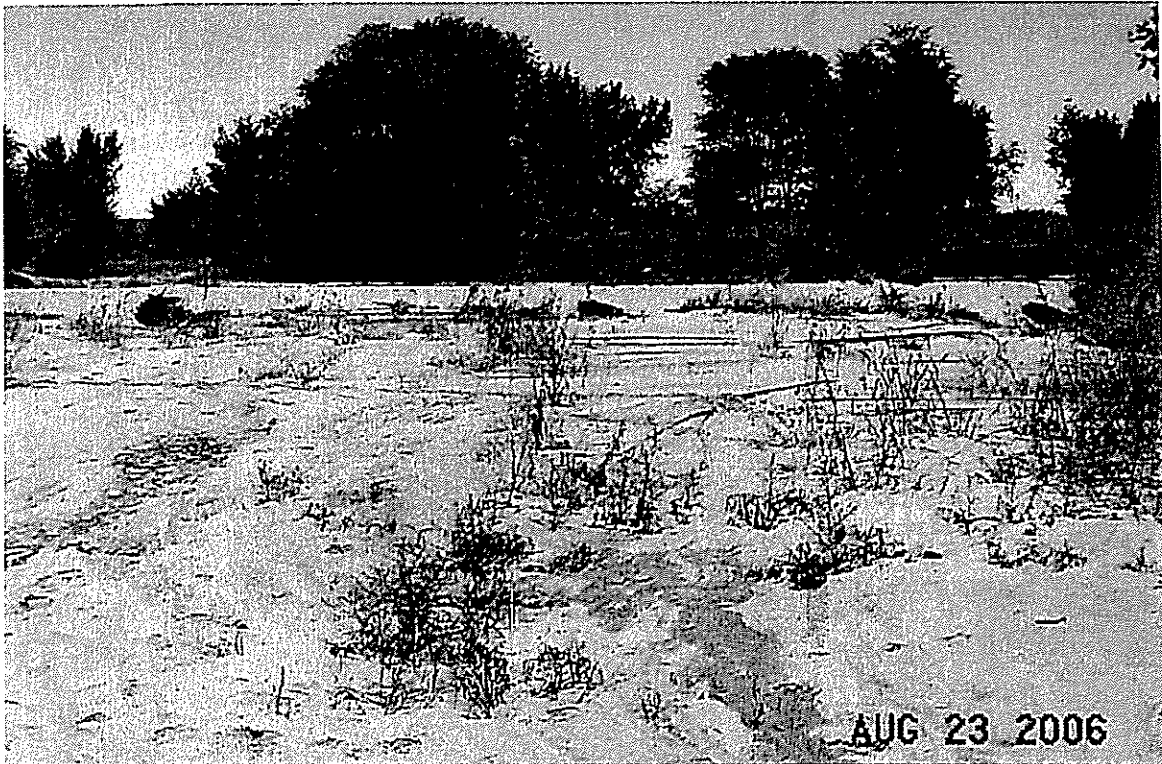
| Drainageway | Drainage Structure Description | Structure Inventory # | Roadway | Structure Condition | Inlet Channel Condition | Outlet Channel Condition | Existing 100-year (cfs) | Structure Capacity (cfs) | % of Existing 100-year Q |
|---|---|---|---|---|---|---|---|---|---|
| | 4-48" X 29" CMP | PV1 | Peaceful Valley Road | Poor<br>Mostly clogged | Poor | Poor | 17,360 | < 200 | <5 |

Peaceful Valley Road, Four 42" x 29" CMPs looking at inlet.

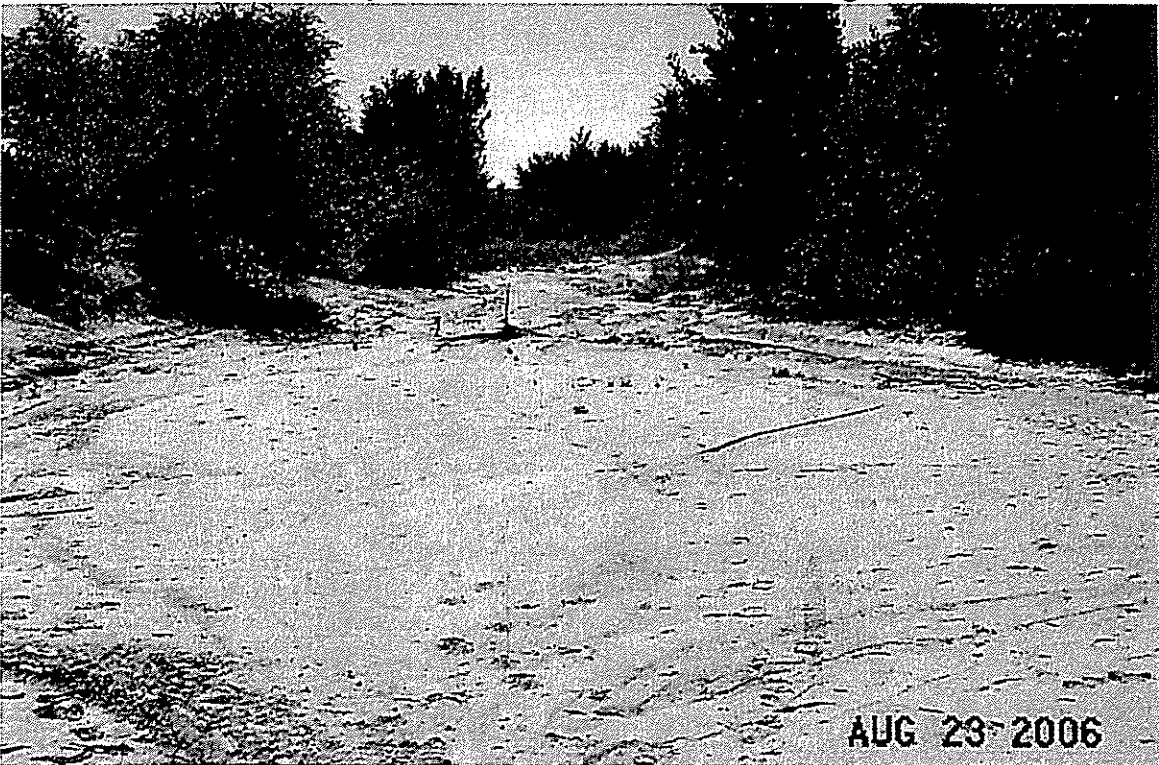
PV1

Peaceful Valley Road, Four 42" x 29" CMPs looking upstream from inlet.

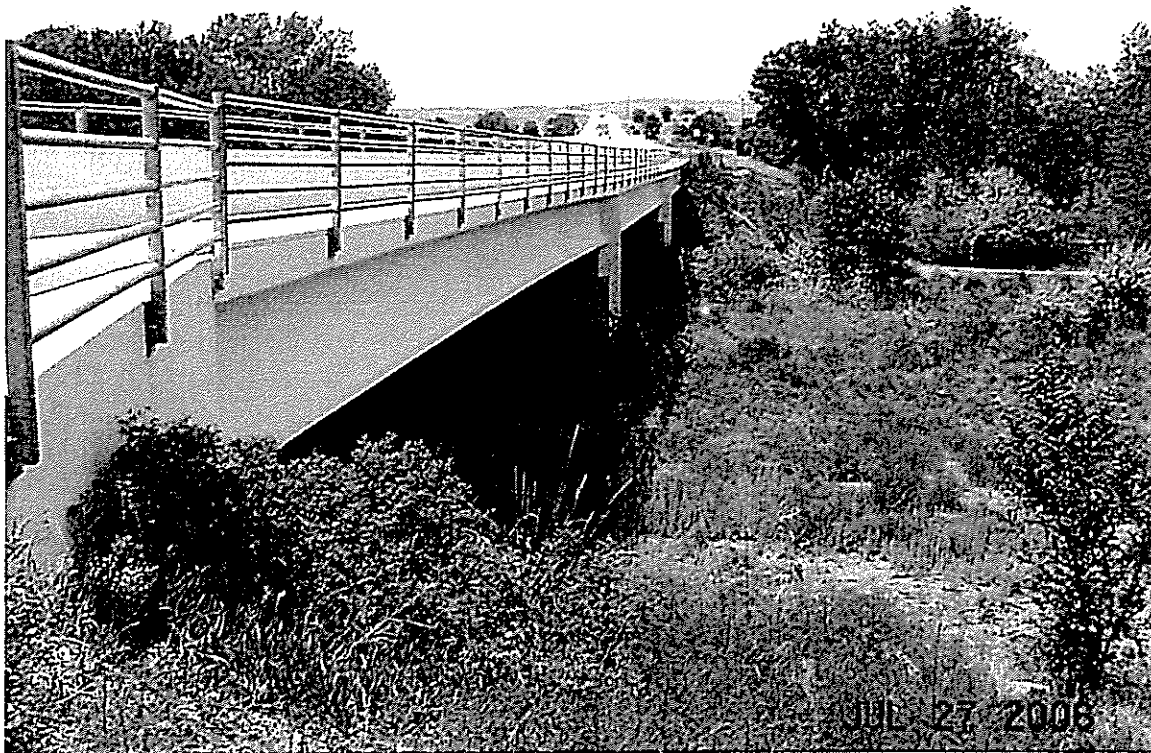
| Drainageway | Drainage Structure Description | Structure Inventory # | Roadway | Structure Condition | Inlet Channel Condition | Outlet Channel Condition | Existing 100-year (cfs) | Structure Capacity (cfs) | % of Existing 100-year Q |
|---|---|---|---|---|---|---|---|---|---|
| | 360' Bridge 3-spans | B2 | Bradley Road | Good | Fair | Fair<br>Bank sloughing along west bank | 15,380 | >18000 | 100 |

Bradley Road, 360'w x 12' h Concrete Bridge.

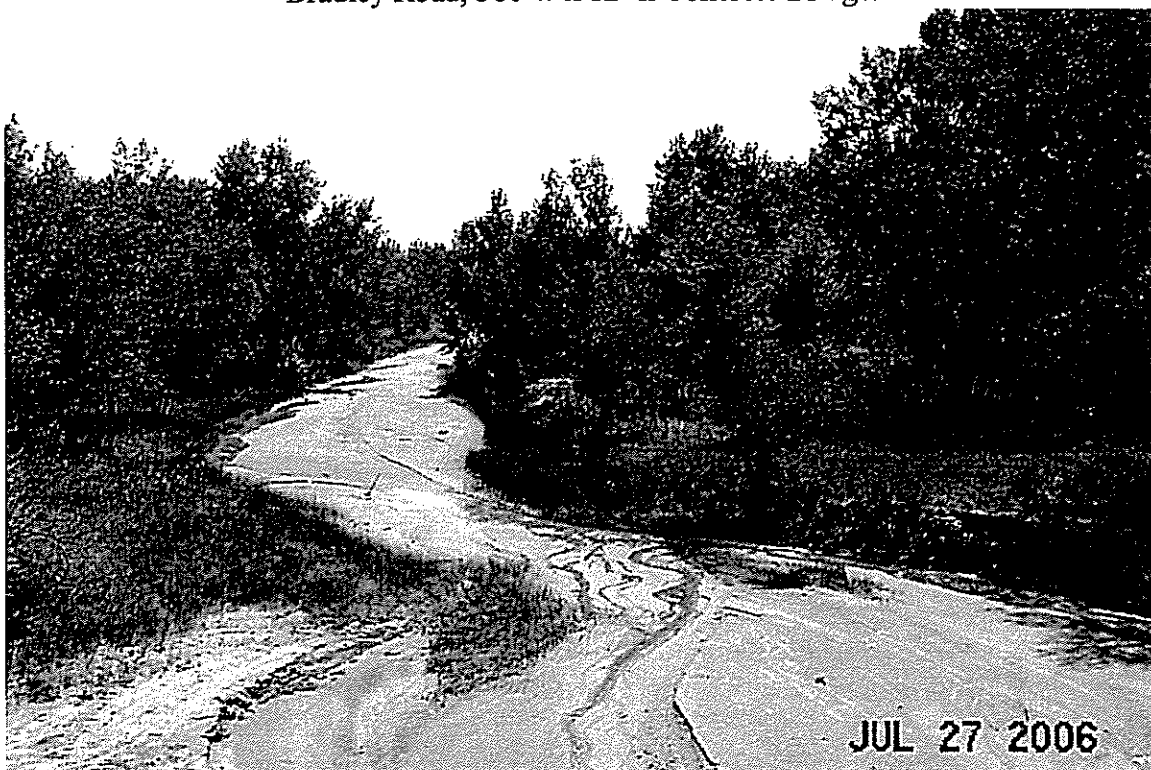
B2

Bradley Road, 360'w x 12' h Concrete Bridge Outlet Channel in Good Condition.

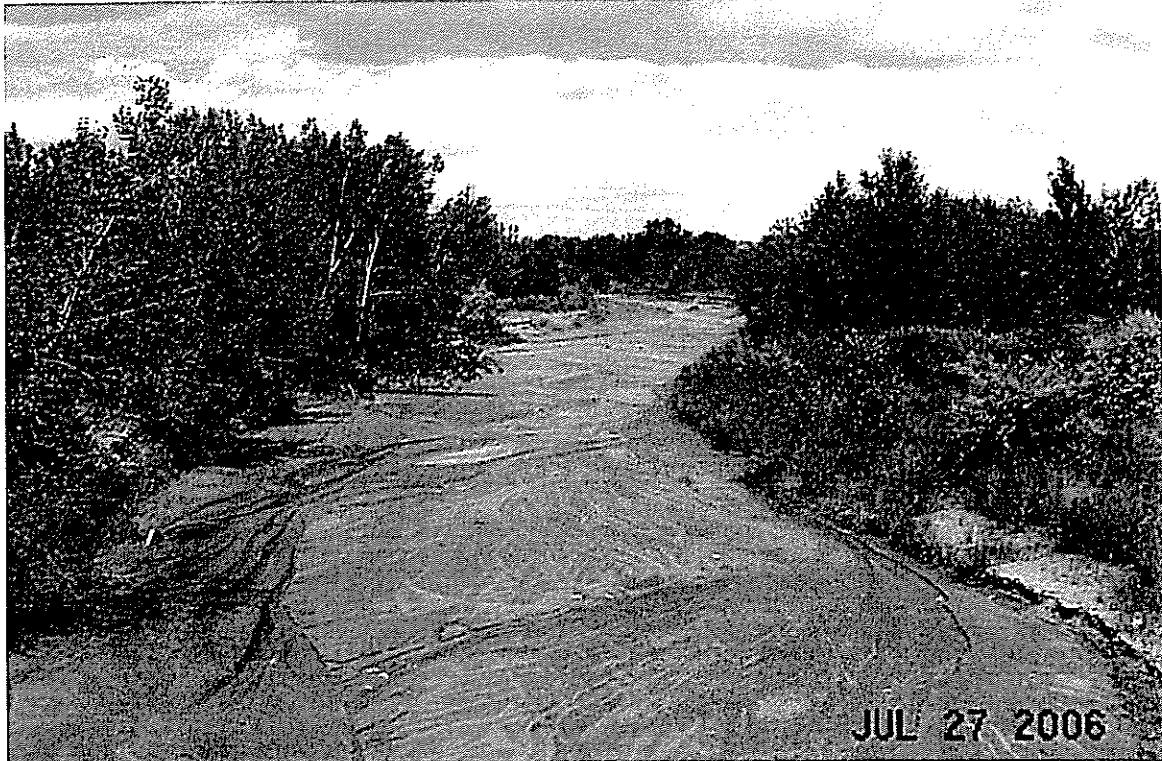
B2

Bradley Road, 360'w x 12' h Concrete Bridge Inlet Channel in Good Condition.

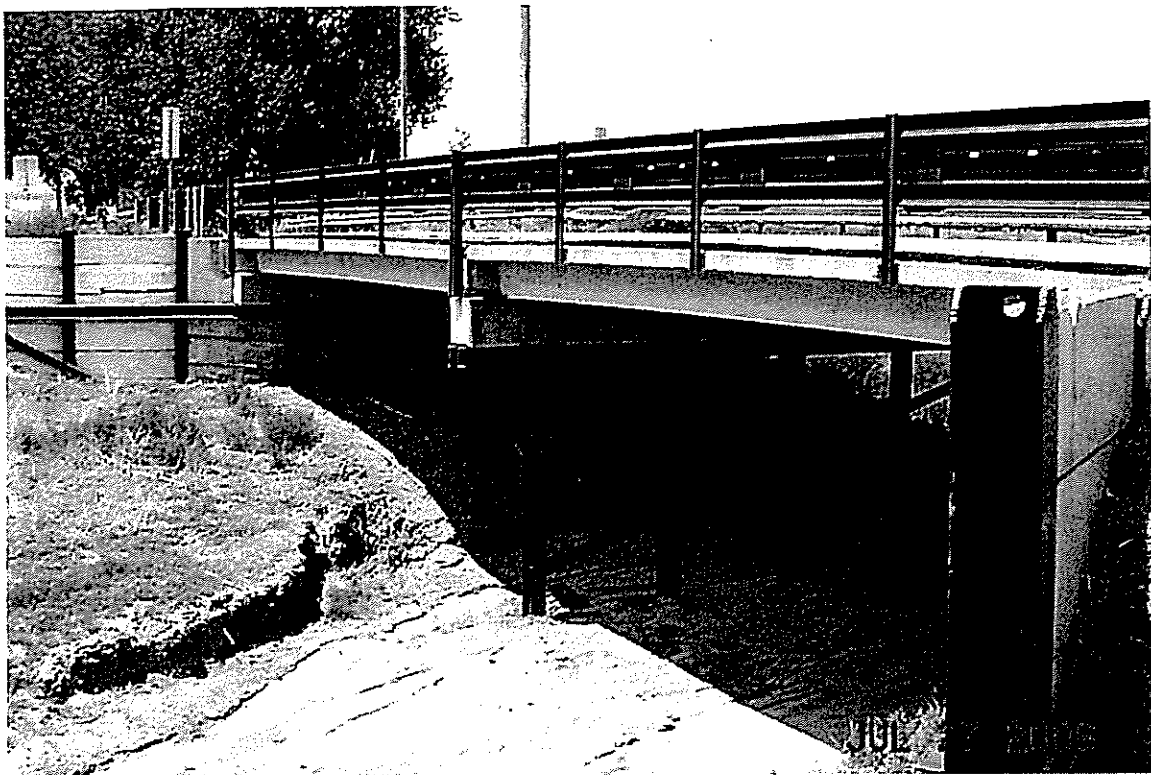
DRZ

Drennan Road, 54'w x 12'h Concrete and Steel Bridge Outlet.

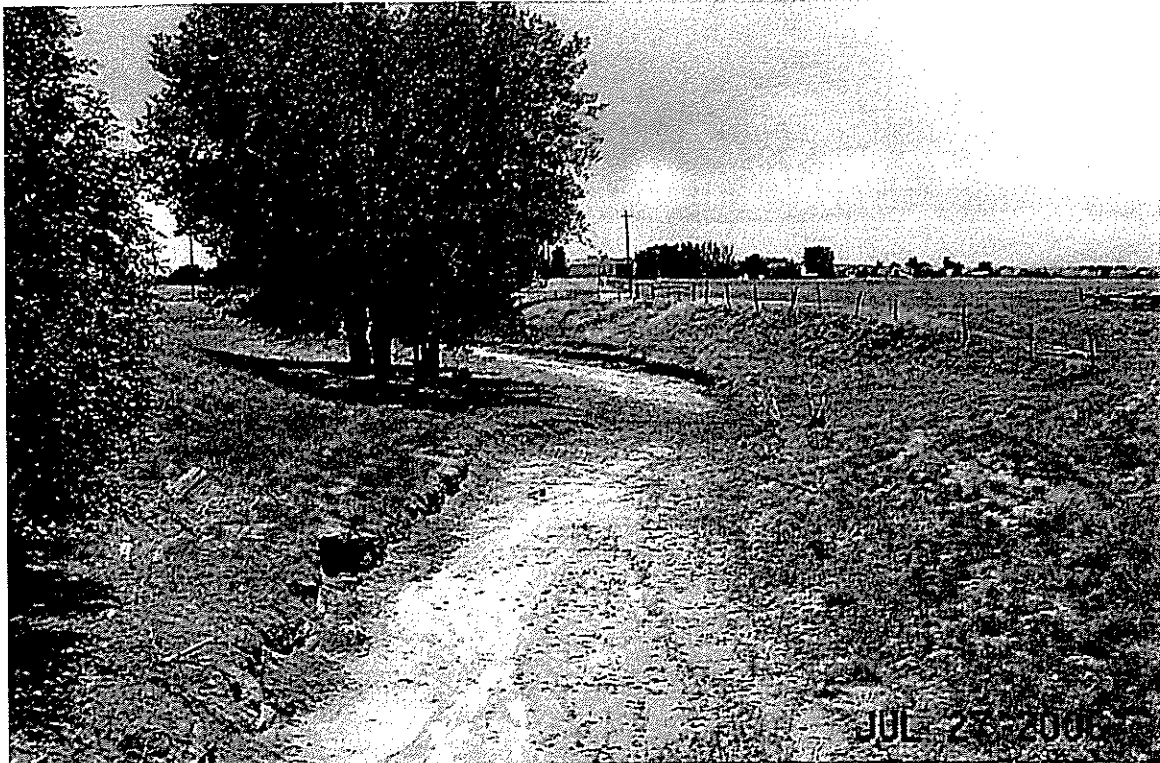
DRZ

Drennan Road, 54'w x 12'h Concrete and Steel Bridge Outlet Channel in Good Condition.

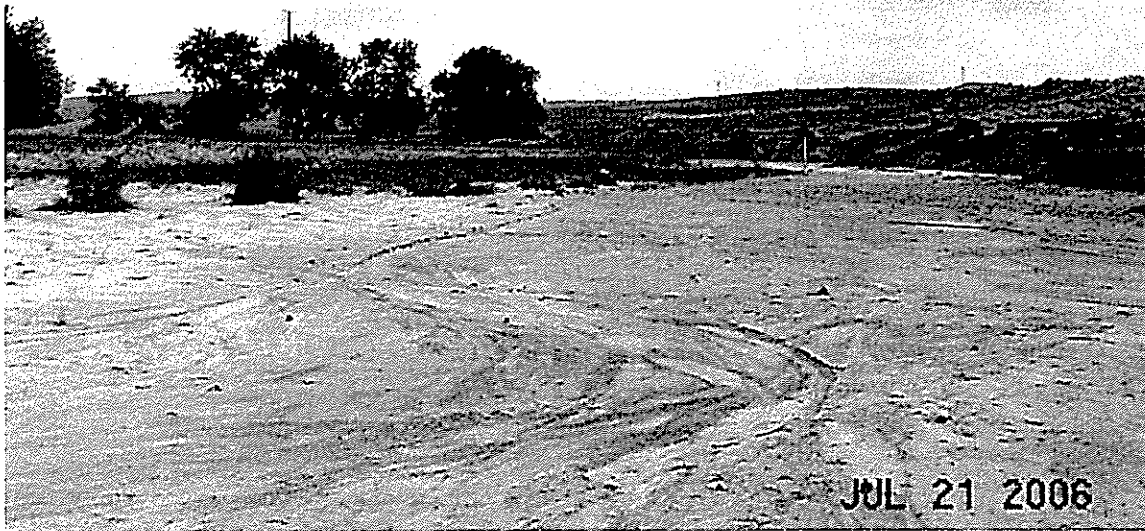
NF2

State Hwy 94, Concrete Bridge Inlet Channel in Fair Condition looking towards the north.

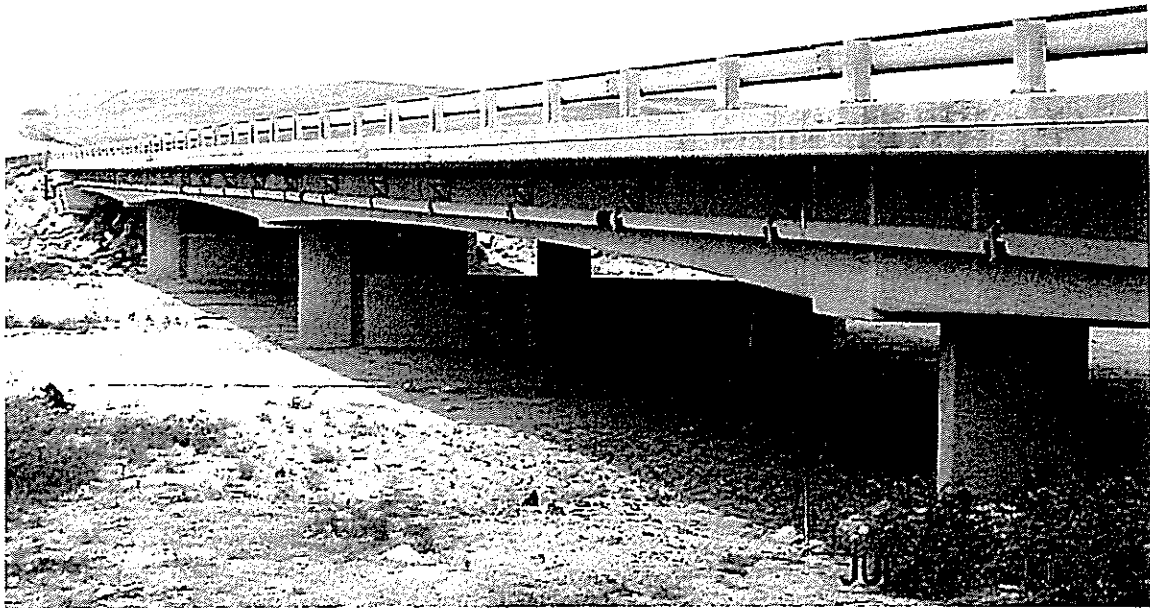
NF2

State Hwy 94 Concrete Bridge looking towards the west.

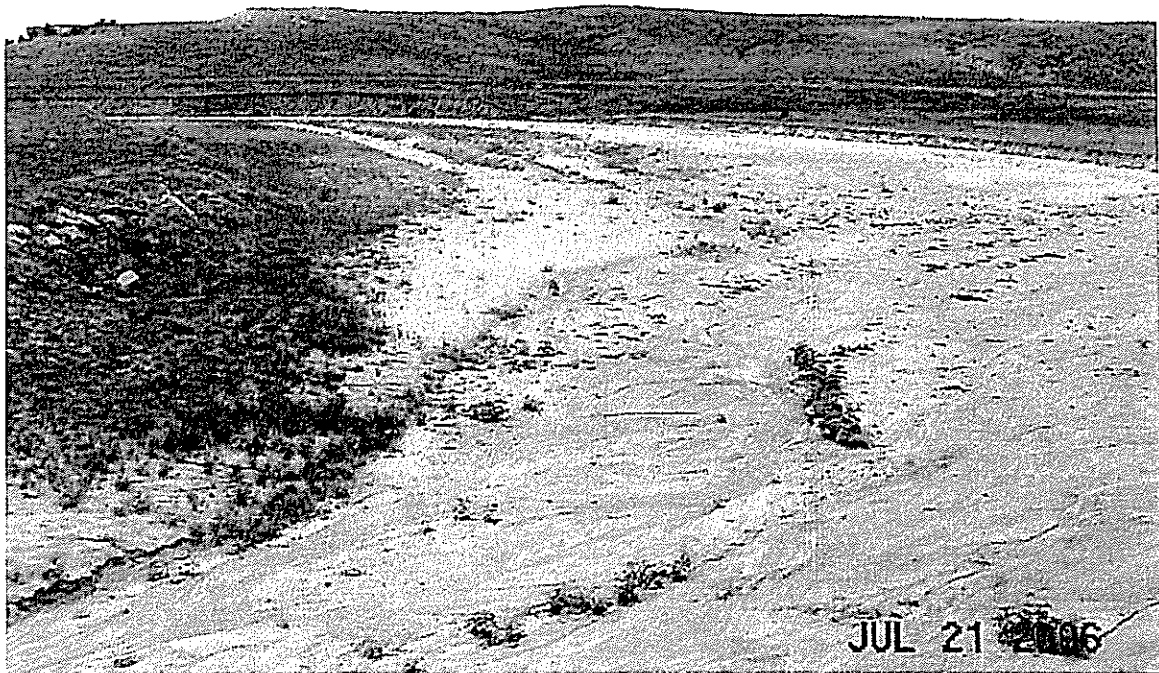
| Drainageway | Drainage Structure Description | Structure Inventory # | Roadway | Structure Condition | Inlet Channel Condition | Outlet Channel Condition | Existing 100-year (cfs) | Structure Capacity (cfs) | % of Existing 100-year Q |
|---|---|---|---|---|---|---|---|---|---|
| | 160' Bridge 4-spans | NF2 | State Highway 94 | Good | Good to Fair | Fair<br>Bank sloughing along west bank | 4,760 | 15000 | 100 |

State Hwy 94 flow channel from Concrete Bridge looking towards the south.
