**APPENDIX D**  
**EXISTING FACILITIES**  
**Facility Summary**  
**Photographs**

Table 1 Existing Major Drainageway Structure Inventory

JIMMY CAMP CREEK DBPS  
OLD PUEBLO ROAD BRIDGE  
JIMMY CAMP CREEK  
EL PASO COUNTY, COLORADO  
BRIDGE PROFILE

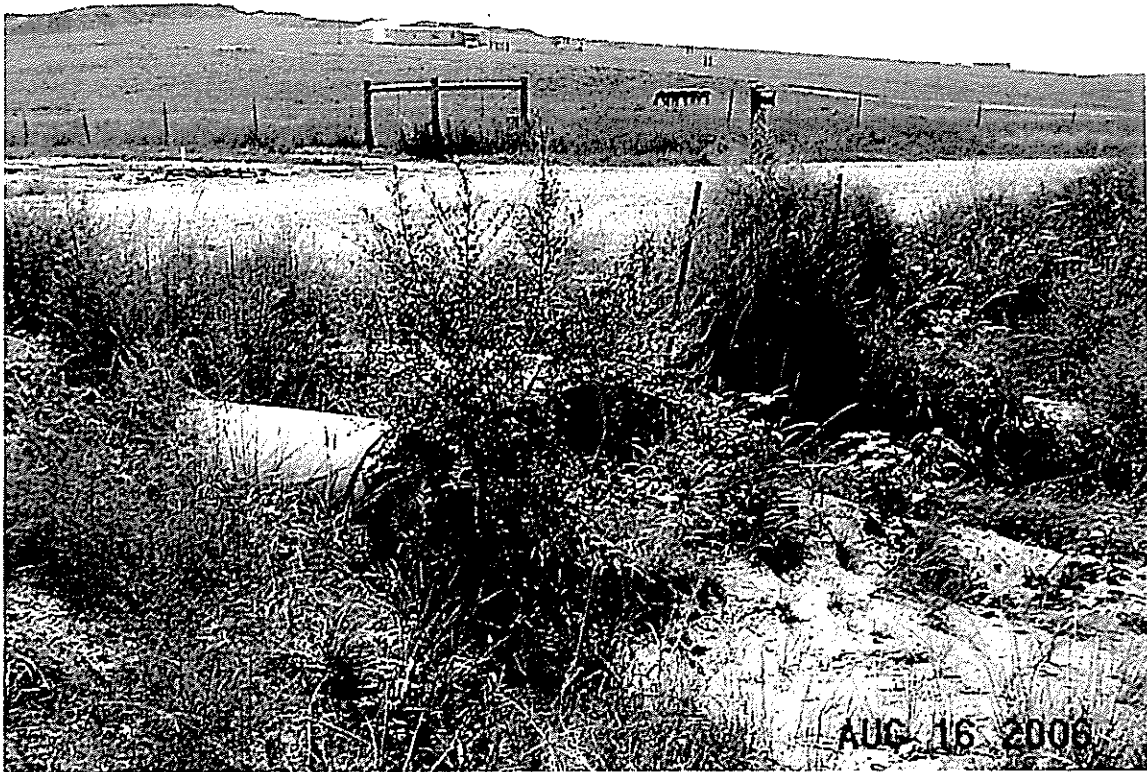
| Drainageway | Drainage Structure Description | Structure Inventory # | Roadway | Structure Condition | Inlet Channel Condition | Outlet Channel Condition | Existing 100-year (cfs) | Structure Capacity (cfs) | % of Existing 100-year Q |
|---|---|---|---|---|---|---|---|---|---|
| | 2-43" X 29" CMP | M7 | Meridian Road | Inlet bent<br>Outlet rusted | Poor | Poor | 1,610 | 140 | <10 |

Meridian Road, two 43" w x 27" h CMPs and two 30" RCPS inlet.

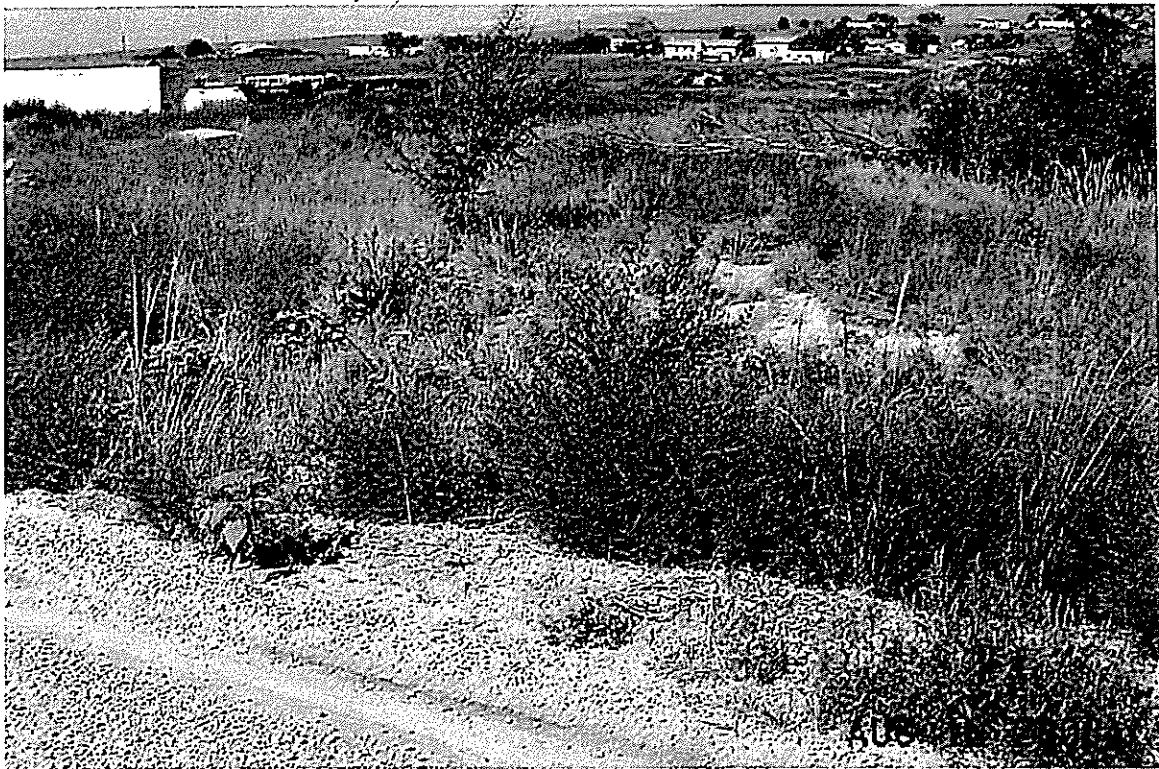
M7

Meridian Road, two 43" w x 27" h CMPs and two 30" RCPS outlet channel.

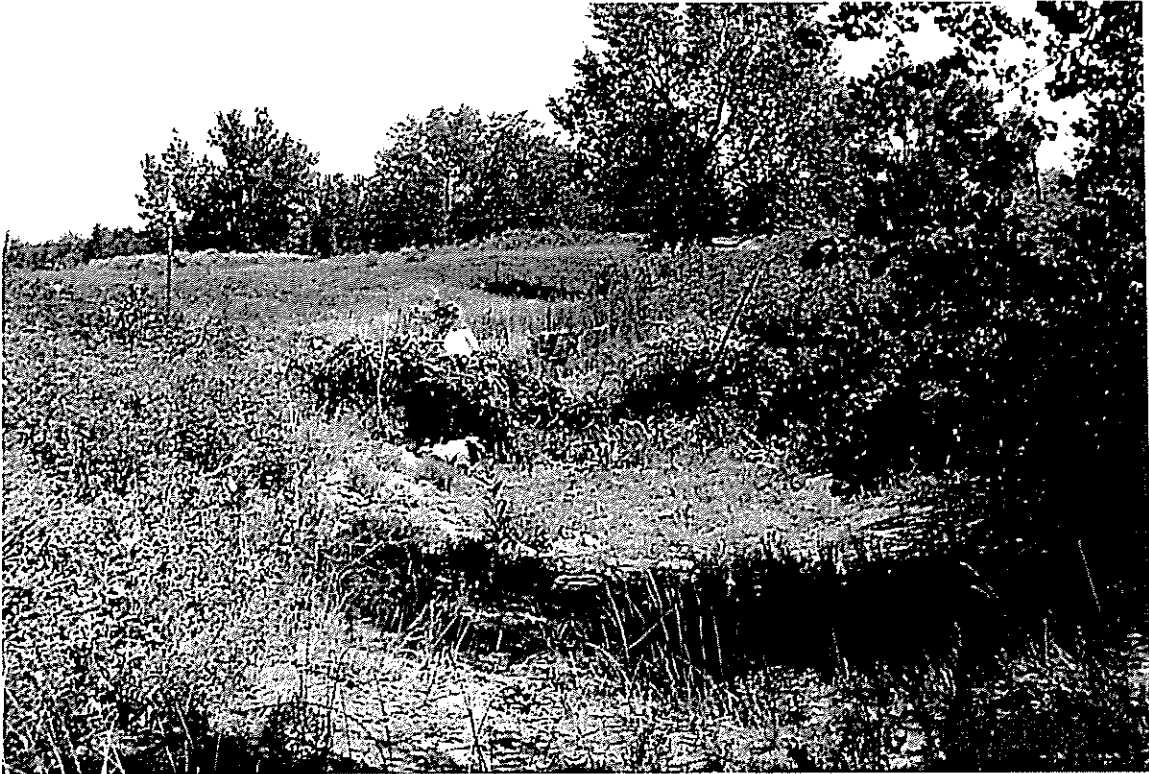
MS2

Marksheffel Road, Two 72" CMPs outlet Channel.

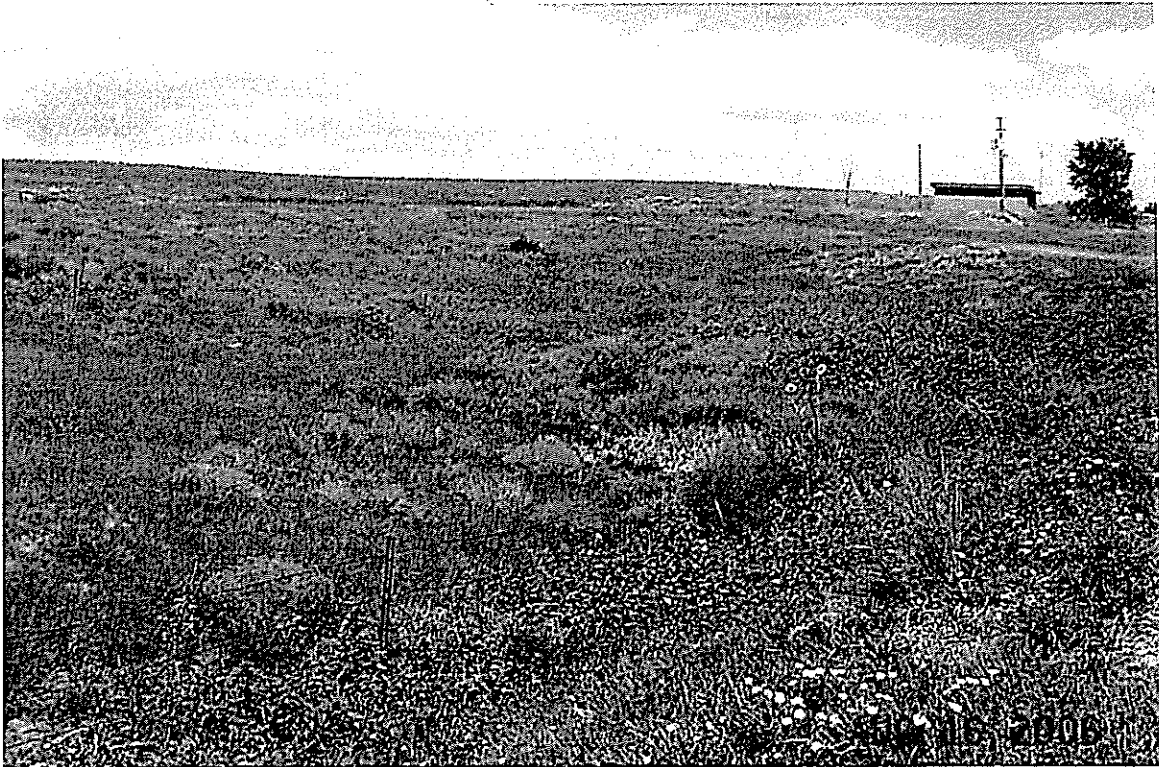
MS3

Marksheffel Road, 72" CMP inlet Channel.

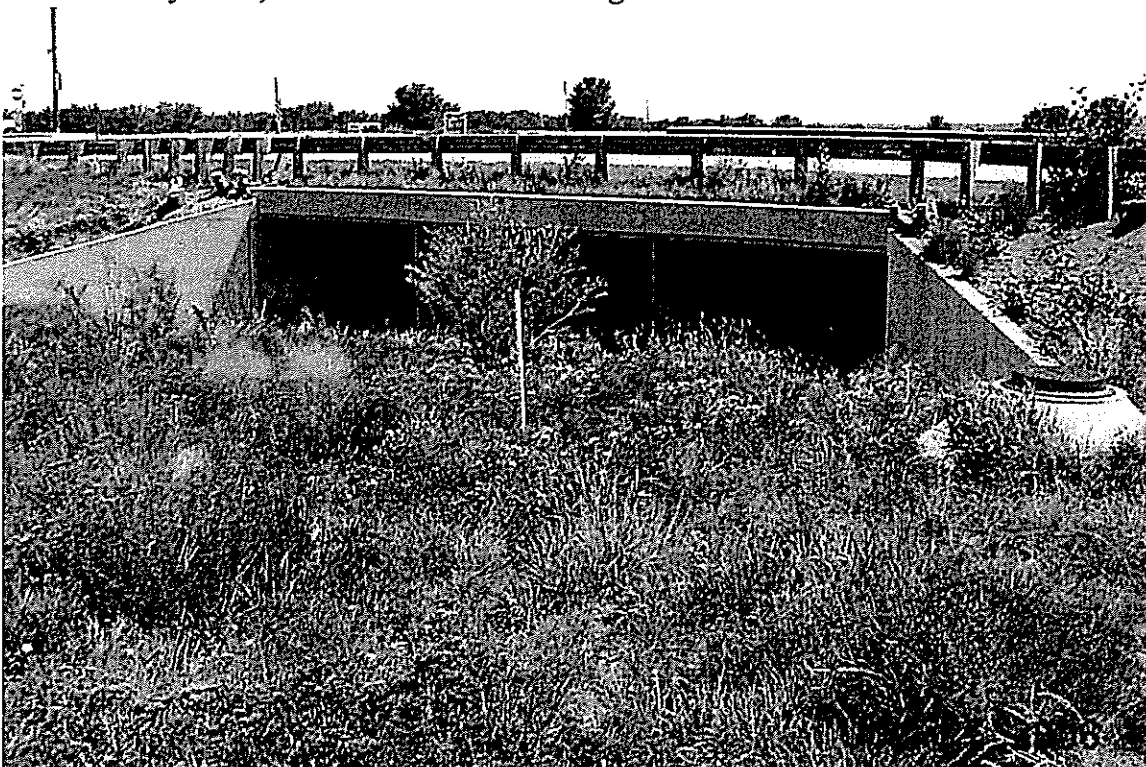
Bradley Road, 40'w x 7' h Concrete Bridge Outlet.

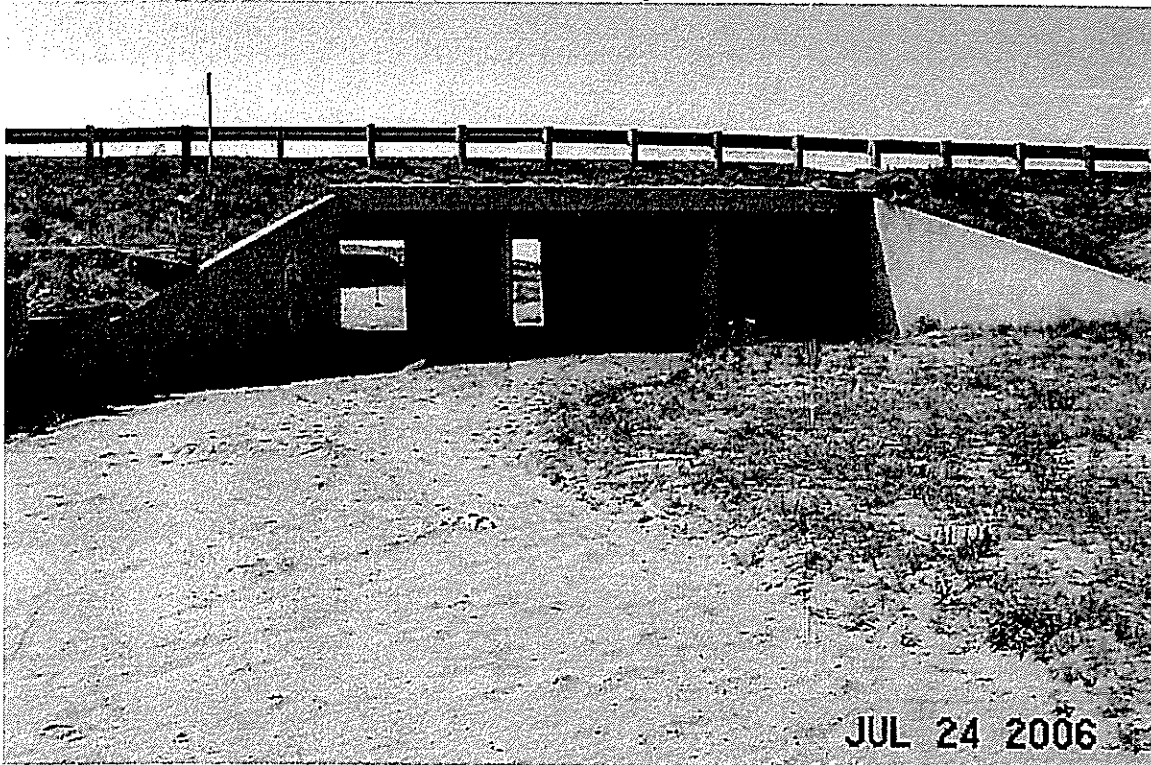
NF-12

State Hwy 94, 37'3"w x 10'h Concrete Bridge Outlet.

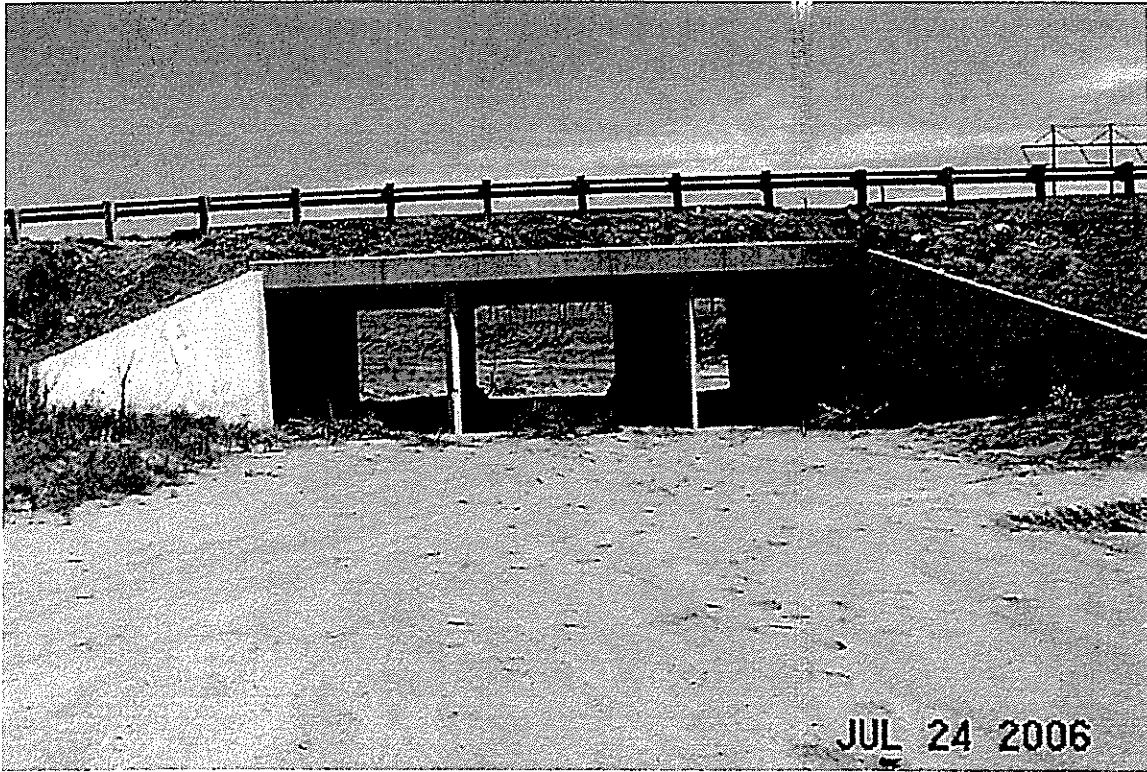
NF-12

State Hwy 94, 37'3"w x 10'h Concrete Bridge Outlet Channel in Fair Condition.

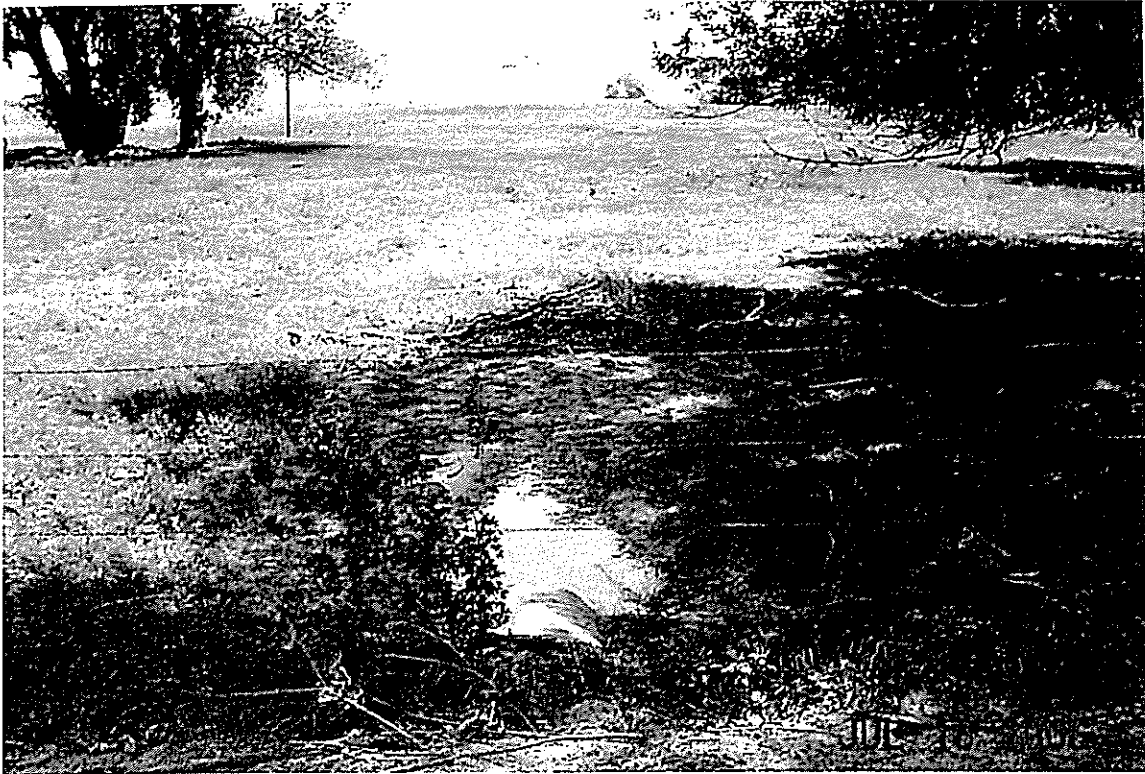
01

Dodge Circle, 24" CMP Outlet Channel, Outlet Channel Fair. Appears to be drainage.

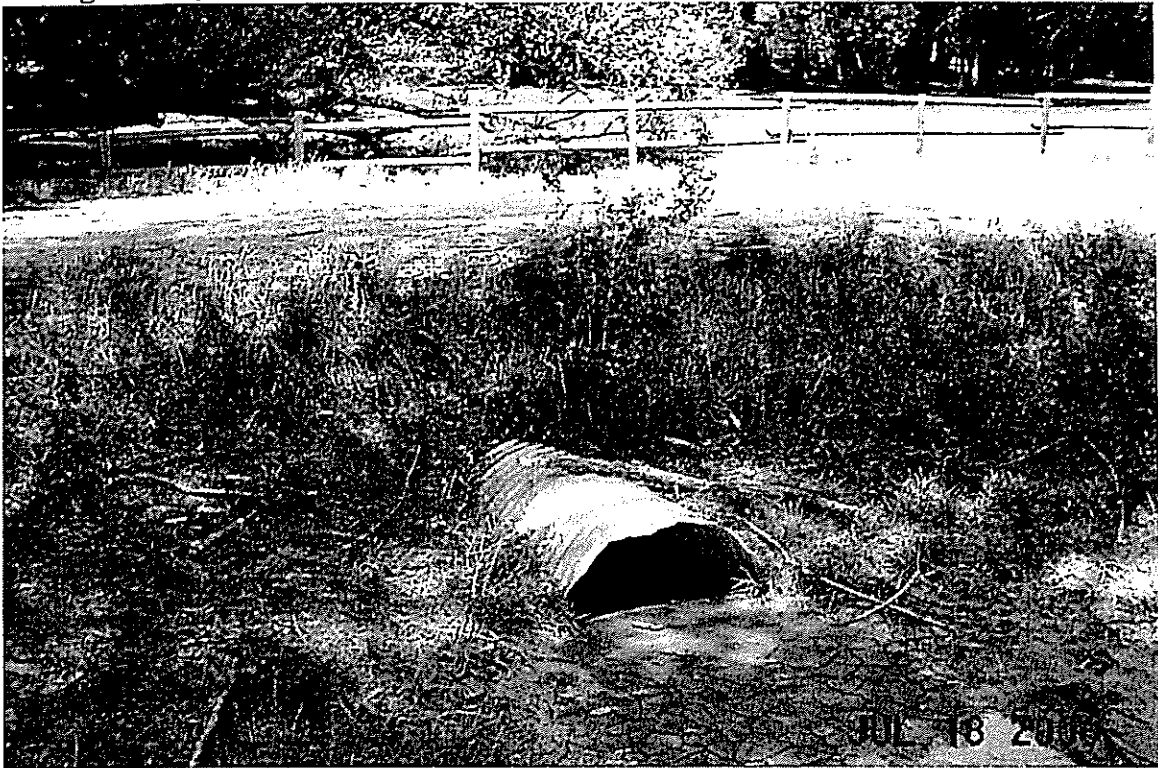
02

Dodge Circle, 24" CMP Outlet, bent at outlet.

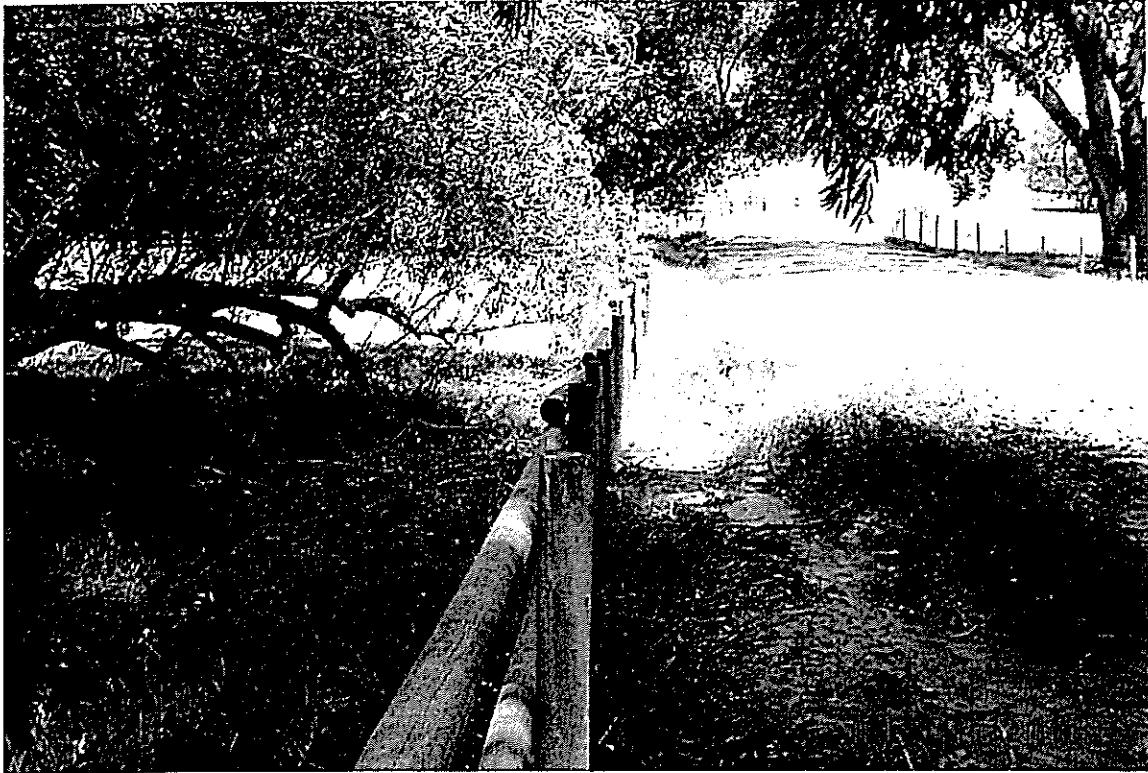
01

Dodge Circle, 24" Inlet Channel, Inlet Channel Fair, 24" CMP not visible.

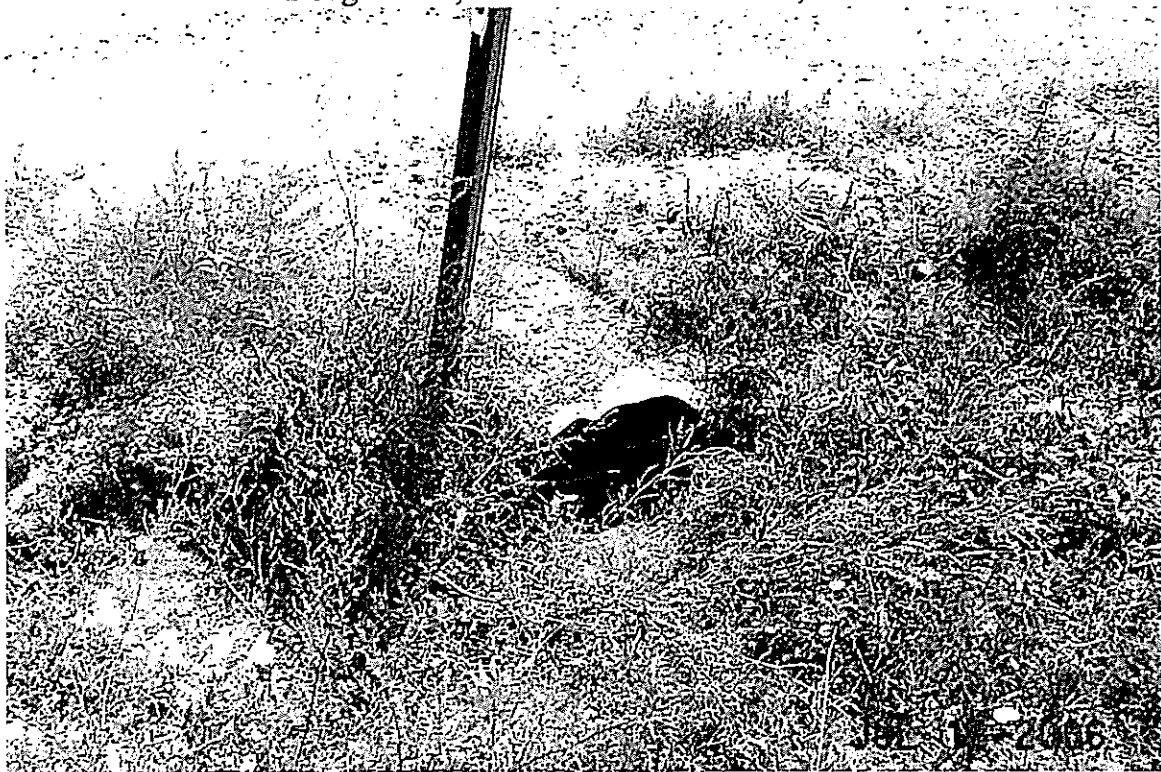
D3

Dodge Circle, 21" CMP Inlet, bent. Inlet Channel Fair.

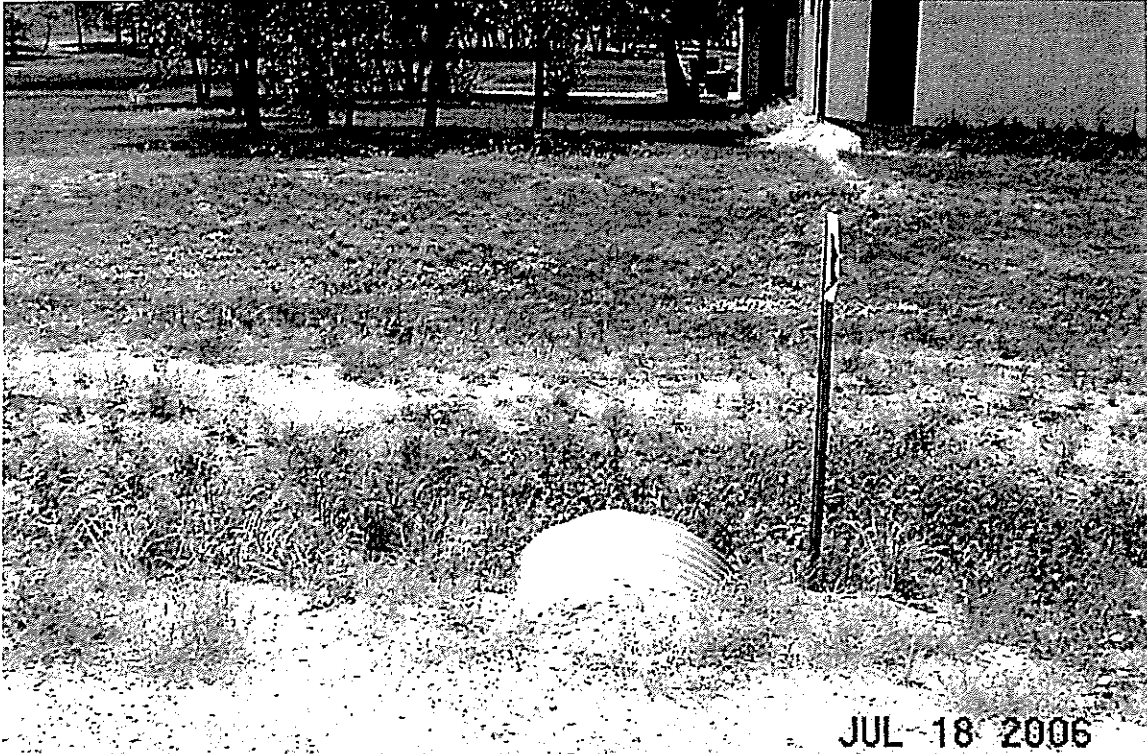
D4

Dodge Circle, 36" CMP Inlet Channel in Fair Condition.

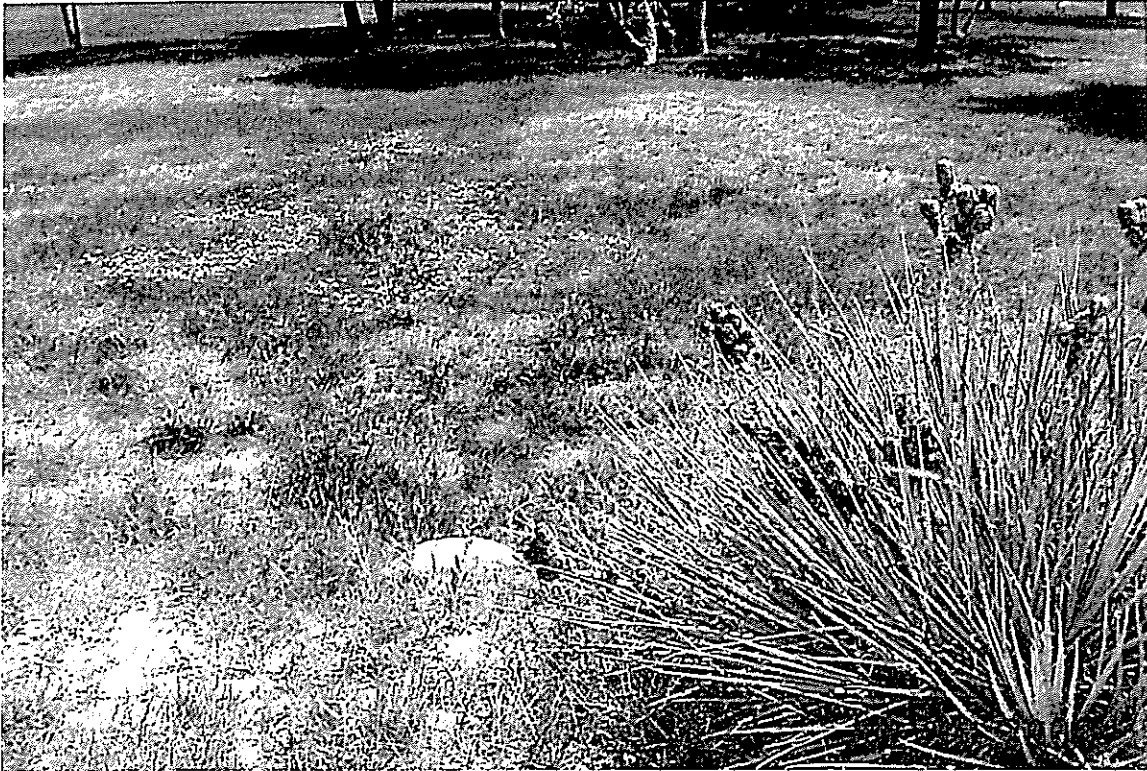
D5

Dodge Circle, 24" CMP Outlet Channel in Good Condition. Appears to be a drainage channel.

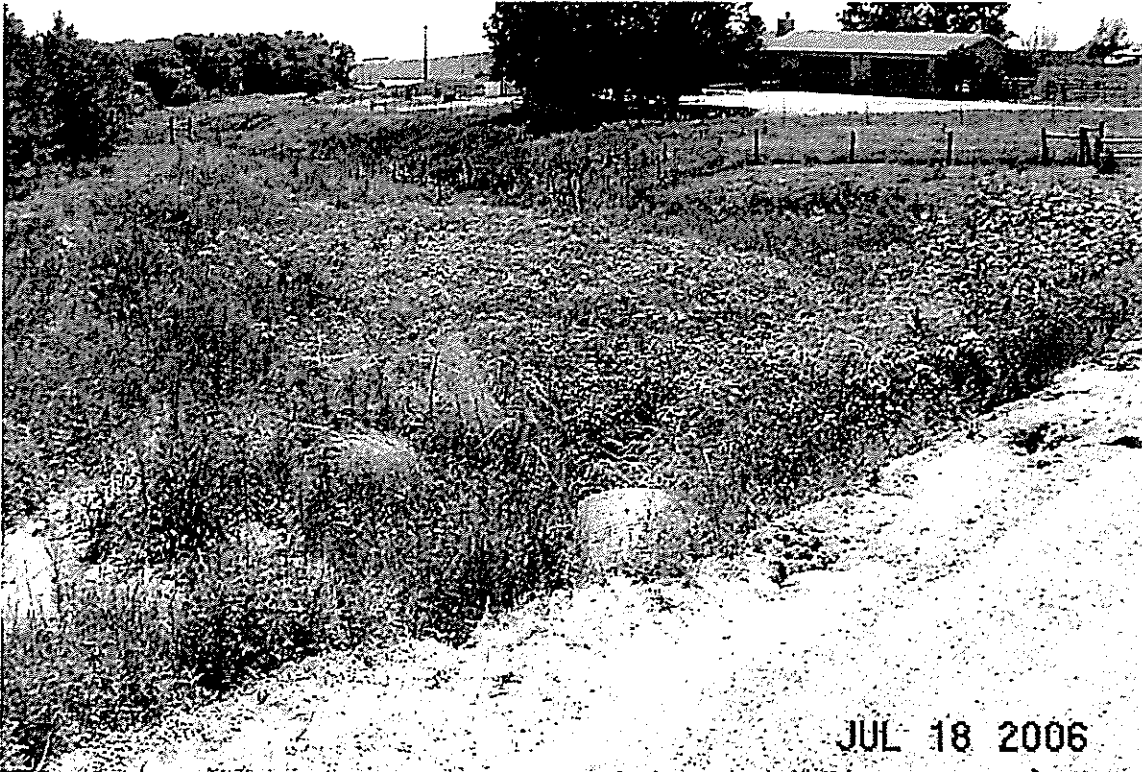
D6

Dodge Circle, 54" w x 38" h CMP Outlet Channel in Good Condition. Appears to be a drainage channel.

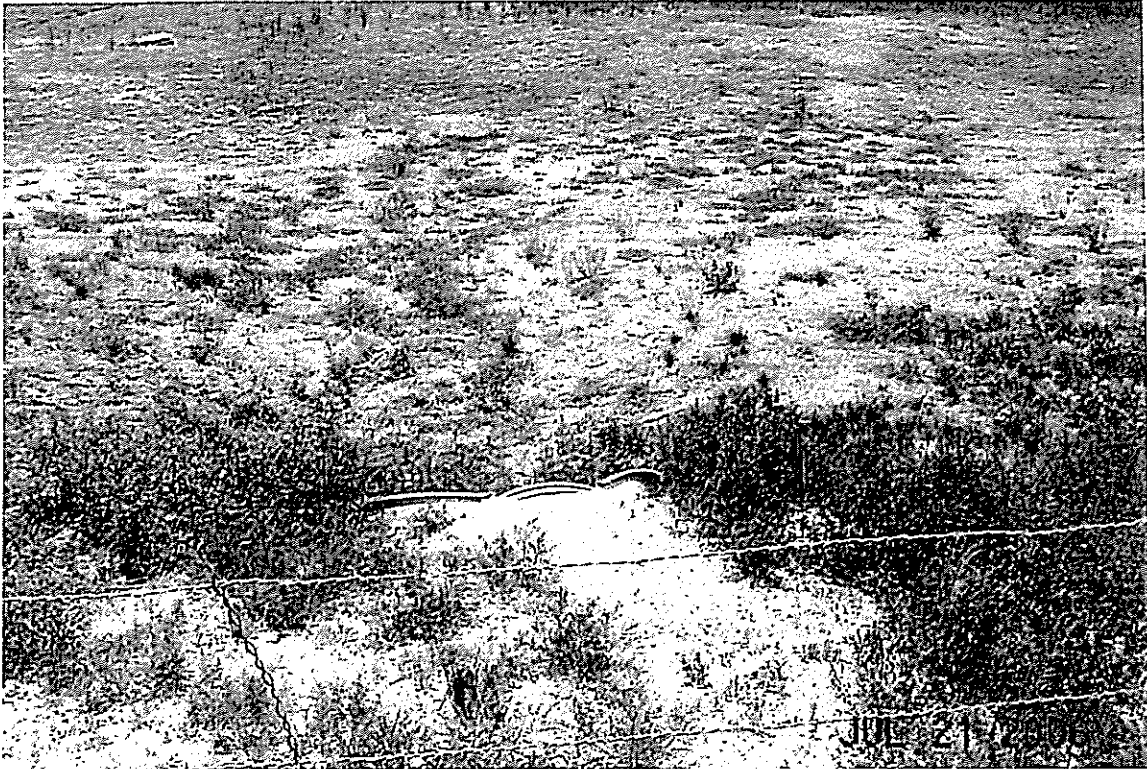
NF3

State Hwy 94, 24" CMP Outlet Channel in Fair Condition.

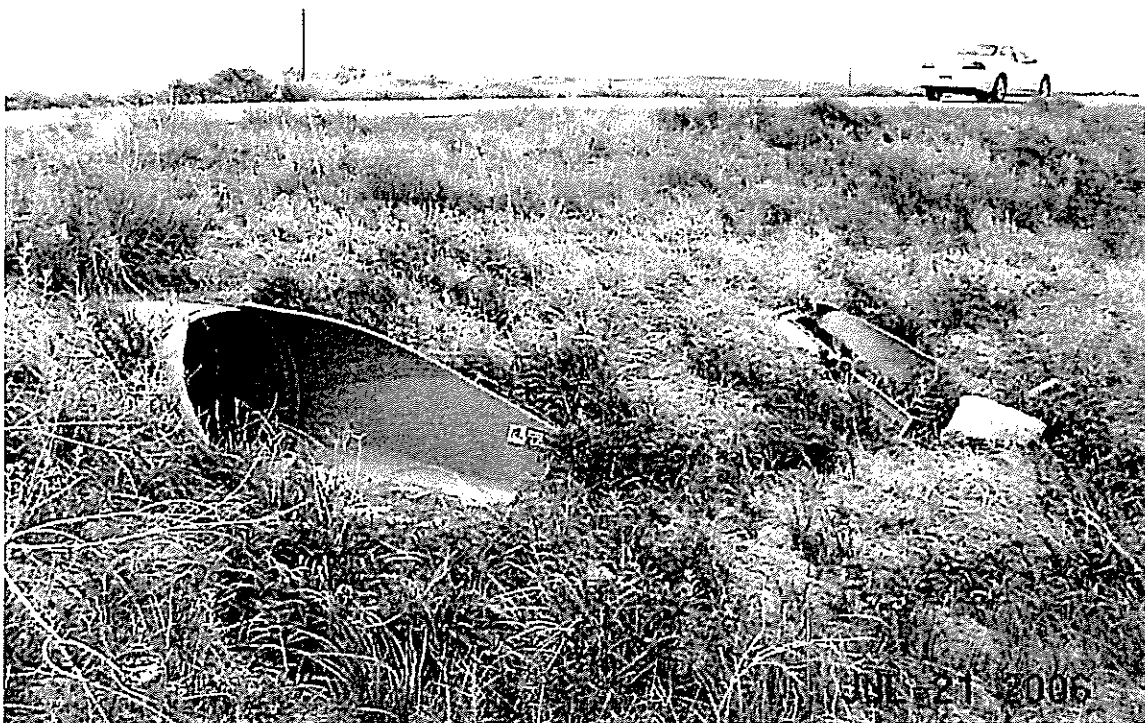
NF 4

State Hwy 94, One 24" CMP & One 30" CMP Inlet in OK Condition.

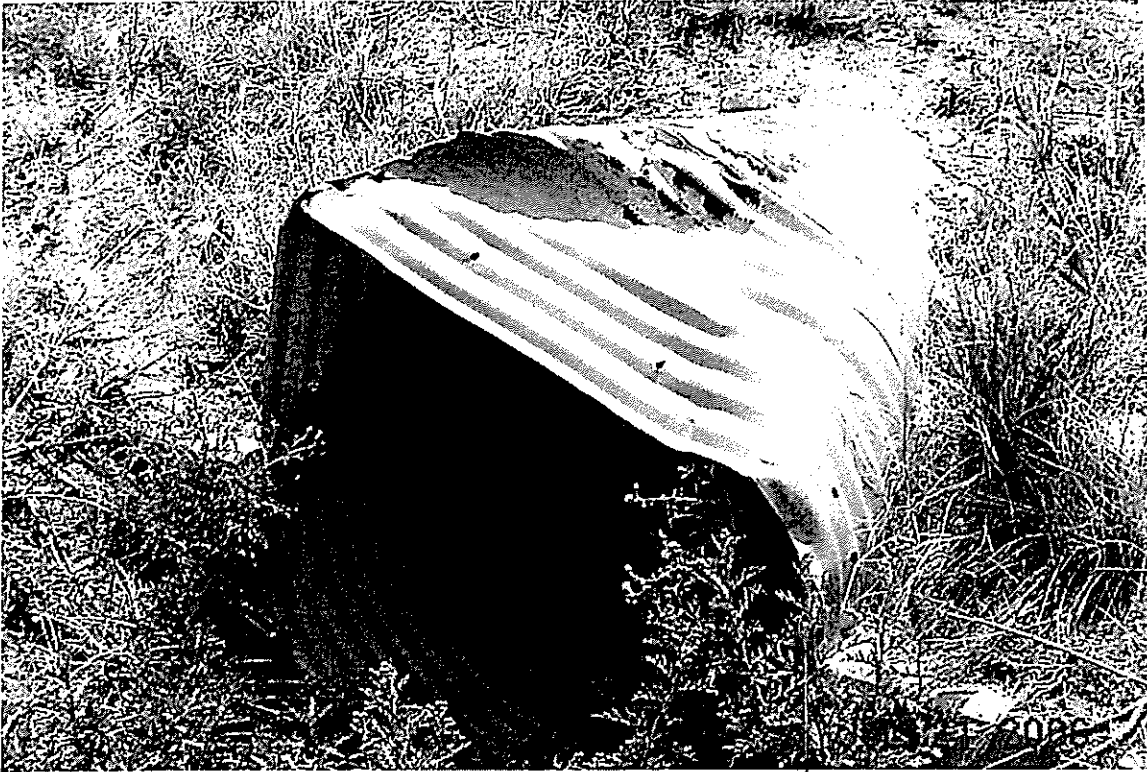
NFS

State Hwy 94, 54" CMP Inlet, bent.

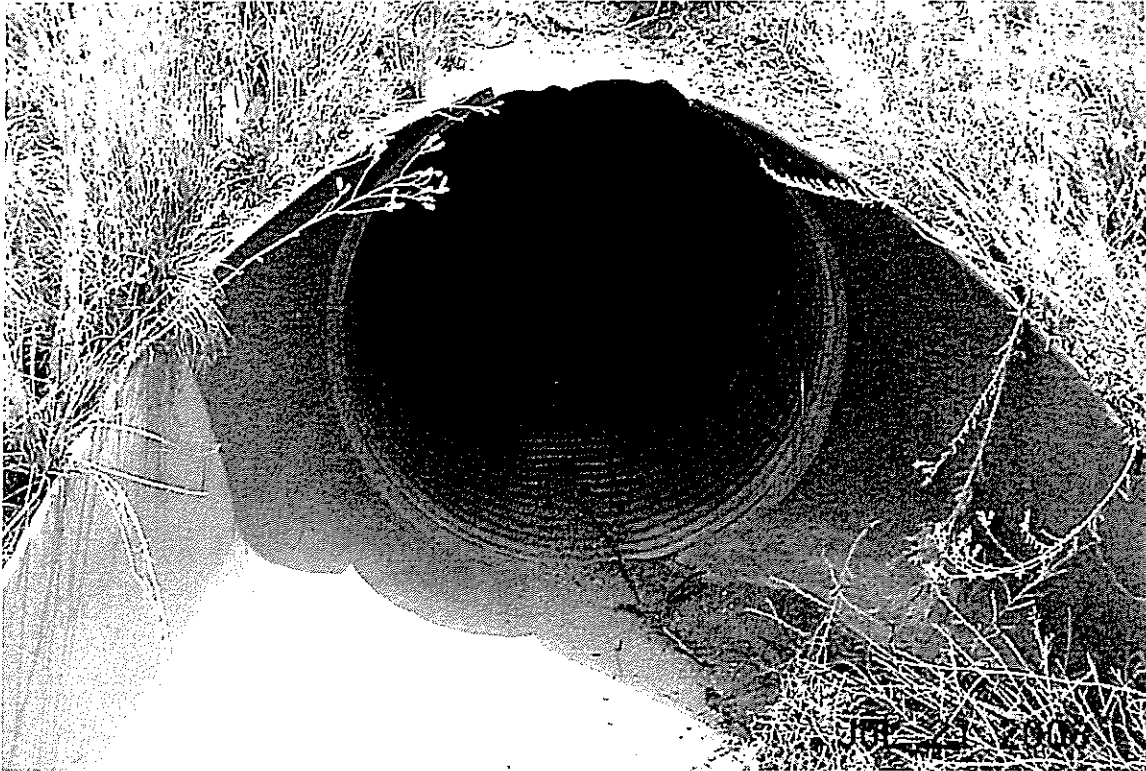
NF7

State Hwy 94, 48" CMP Inlet Channel in Good Condition.

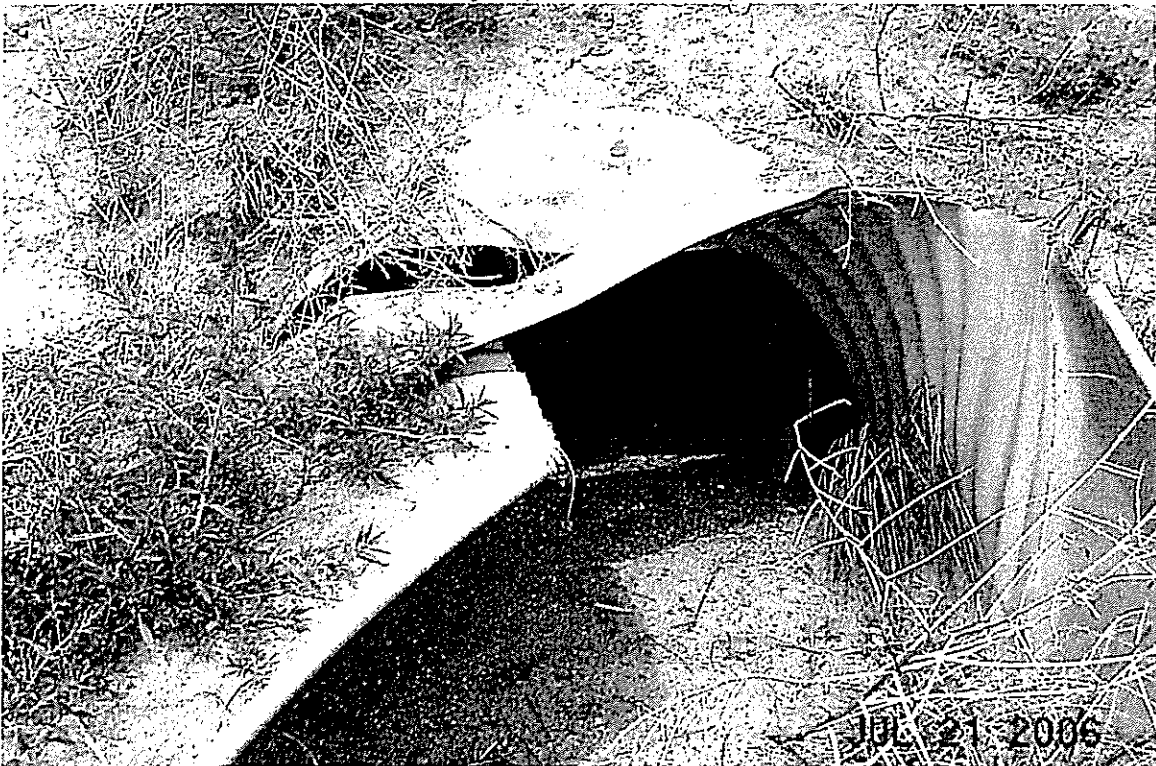
NF 7

State Hwy 94, 48" CMP Inlet, bent.

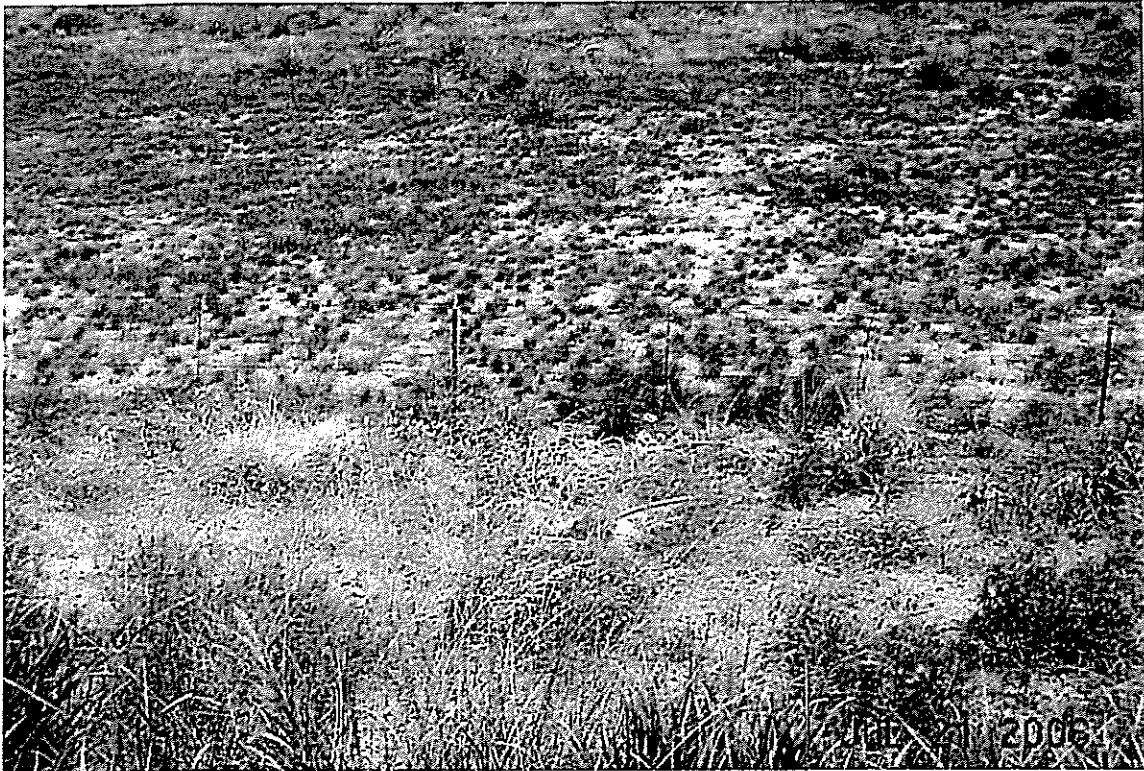
NF 7

State Hwy 94, 48" CMP Outlet, bent.

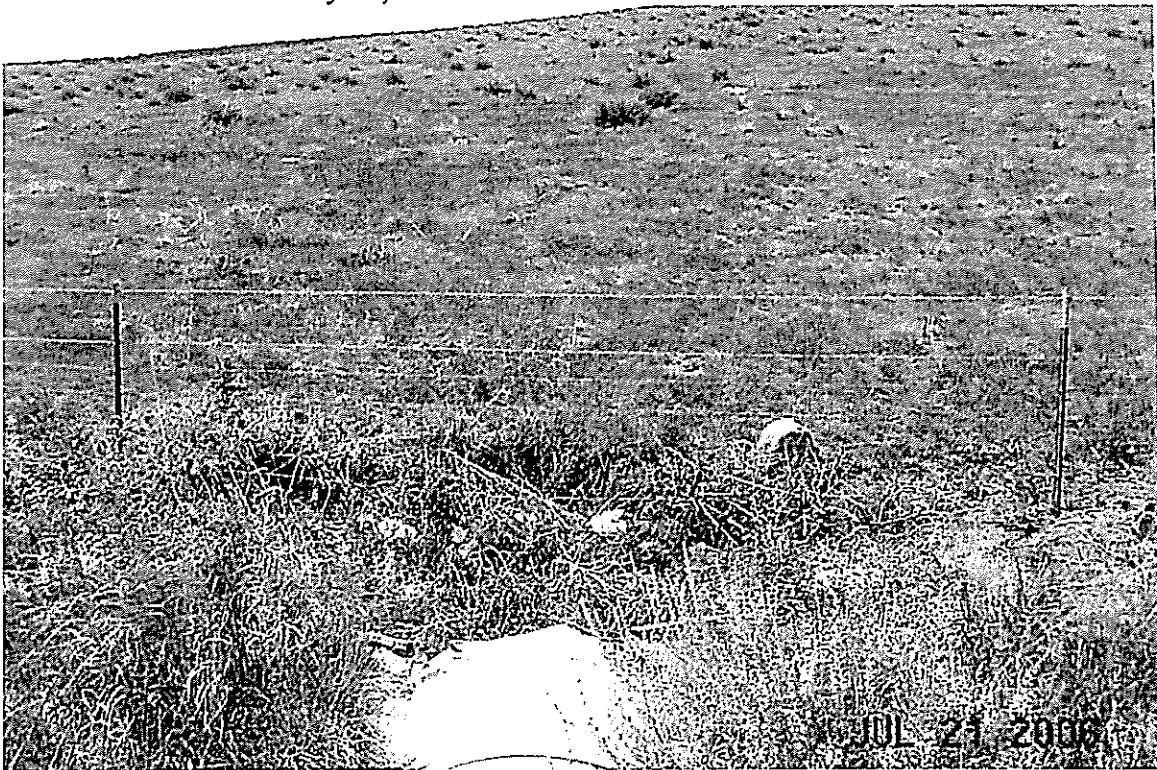
NF7

State Hwy 94, 48" CMP Outlet Channel in Fair Condition.

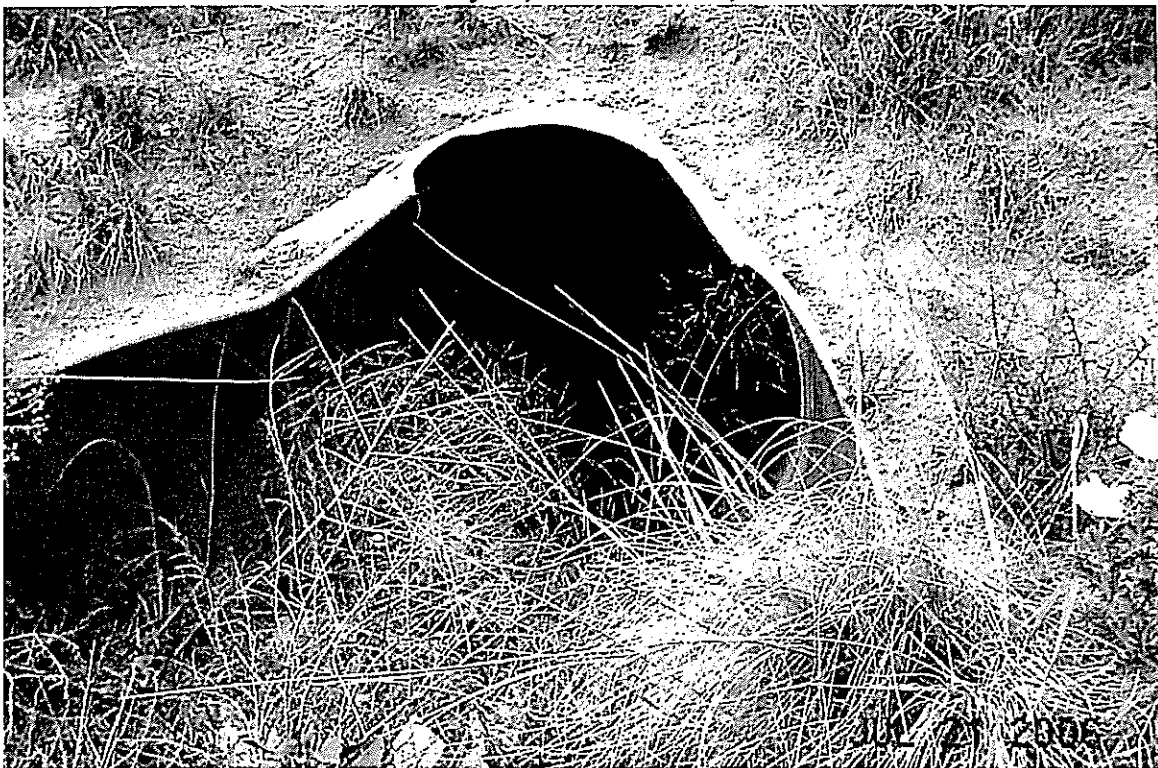
NF8

State Hwy 94, 48" CMP Inlet, bent.

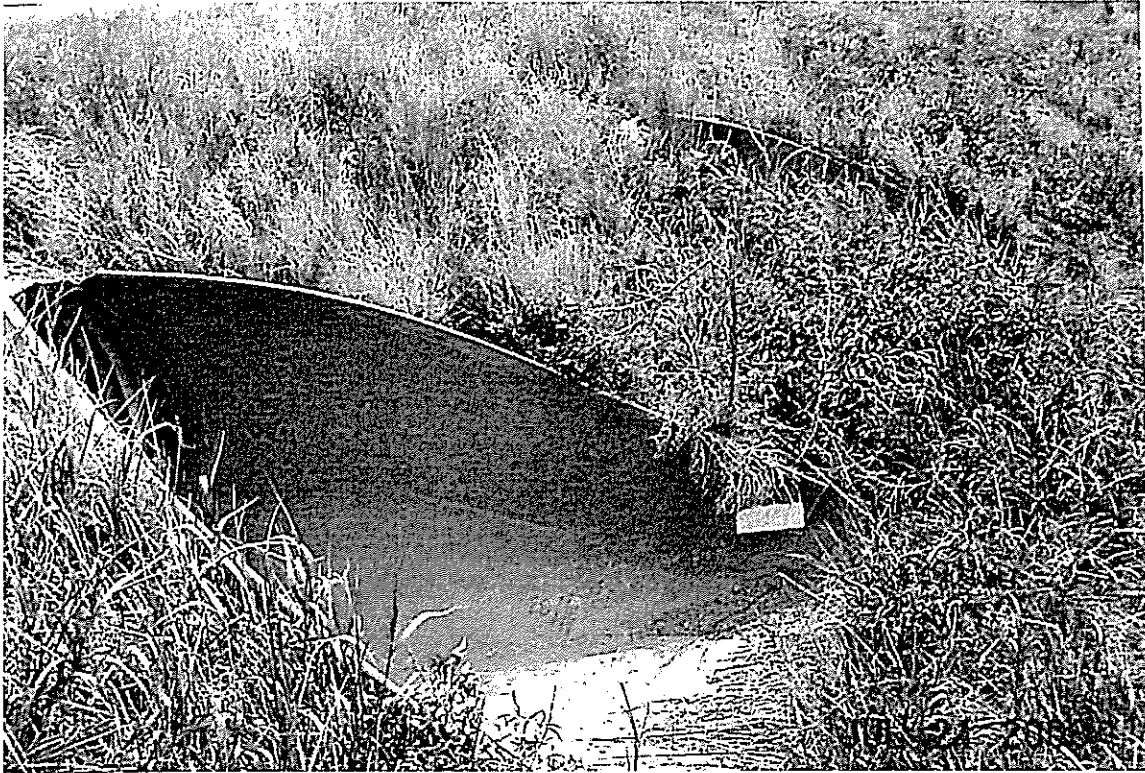
NF9

State Hwy 94, Two 42" CMPs Inlet Channel in Good Condition.

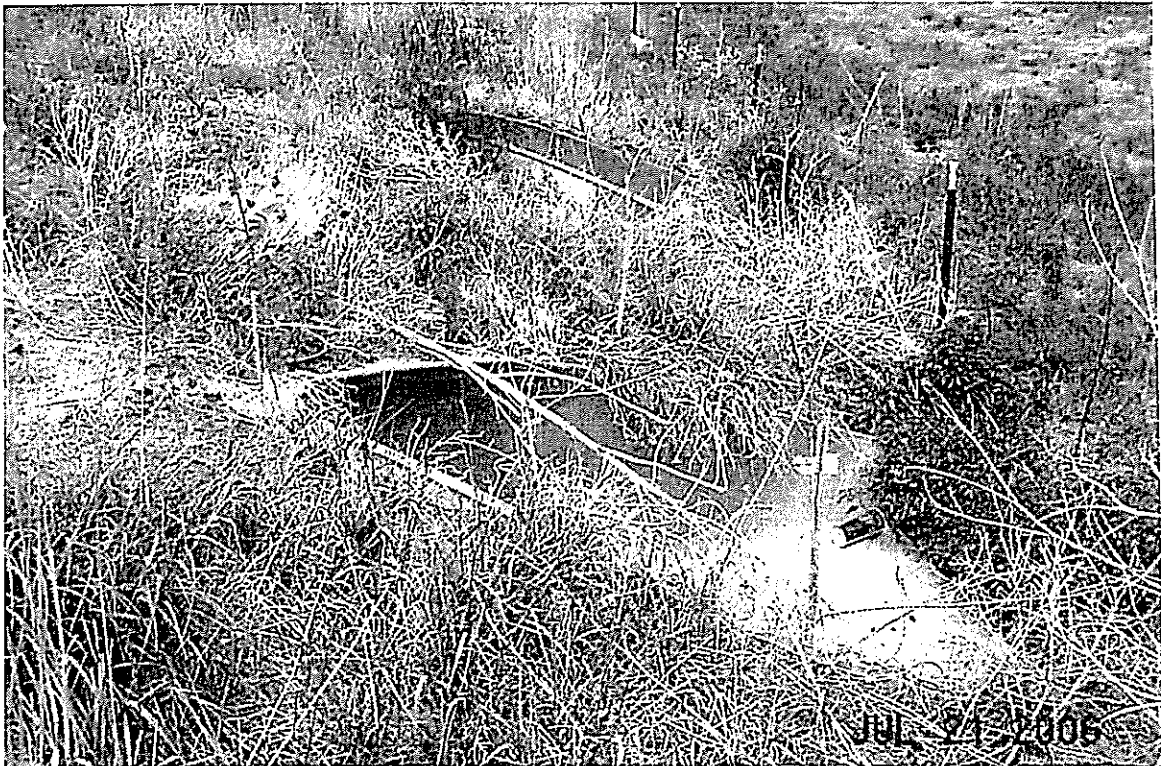
NF 9

State Hwy 94, Two 42" CMPs Inlets.

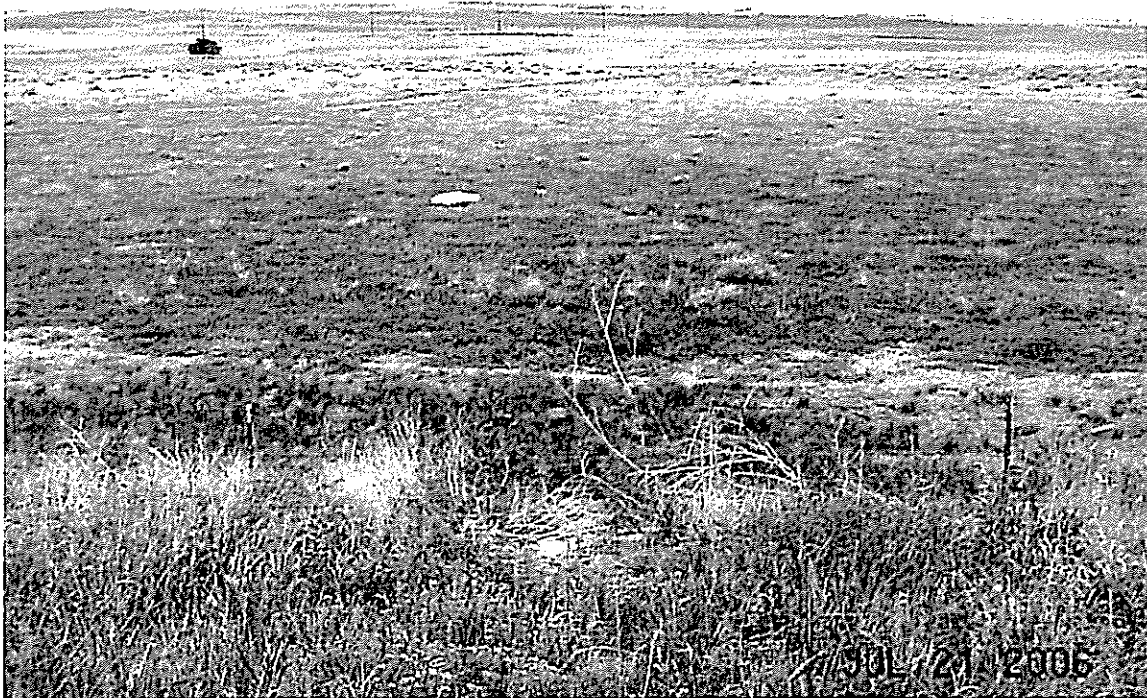
NF 9

State Hwy 94, Two 42" CMPs Outlets.
