**APPENDIX D**  
**EXISTING FACILITIES**  
**Facility Summary**  
**Photographs**

Table 1 Existing Major Drainageway Structure Inventory

JIMMY CAMP CREEK DBPS  
OLD PUEBLO ROAD BRIDGE  
JIMMY CAMP CREEK  
EL PASO COUNTY, COLORADO  
BRIDGE PROFILE

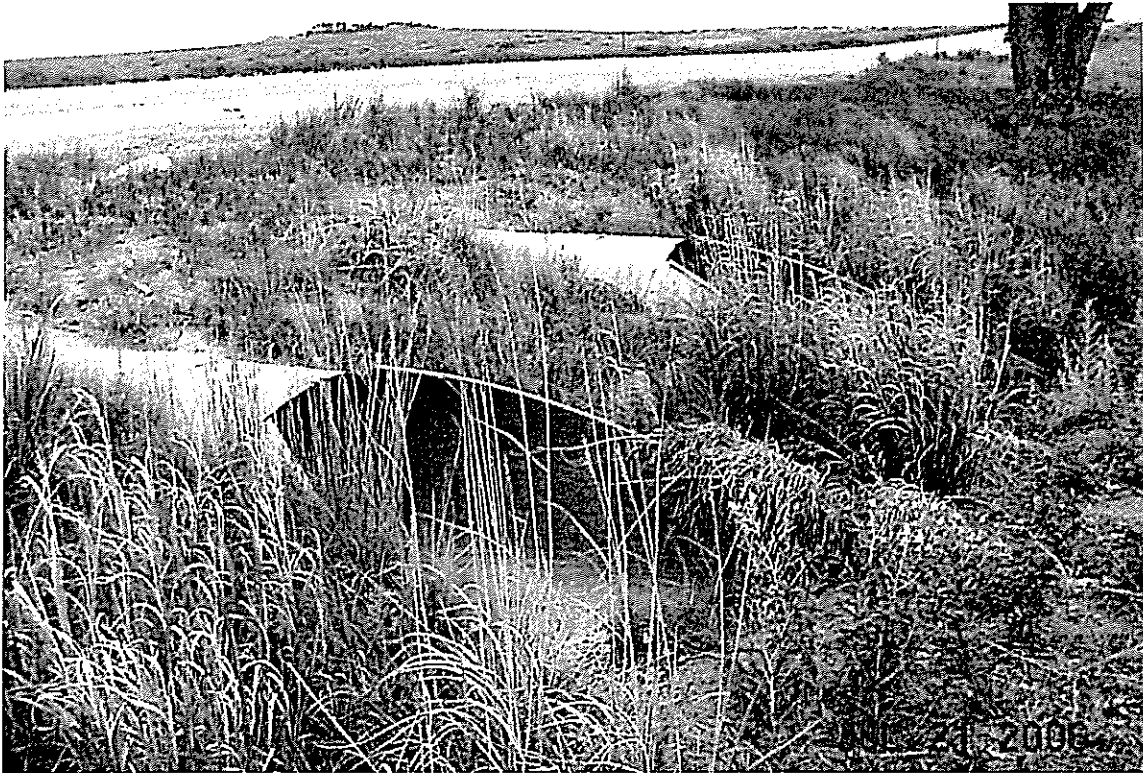
NF10

State Hwy 94, Two 48" CMPs Inlet Channel in Fair Condition.

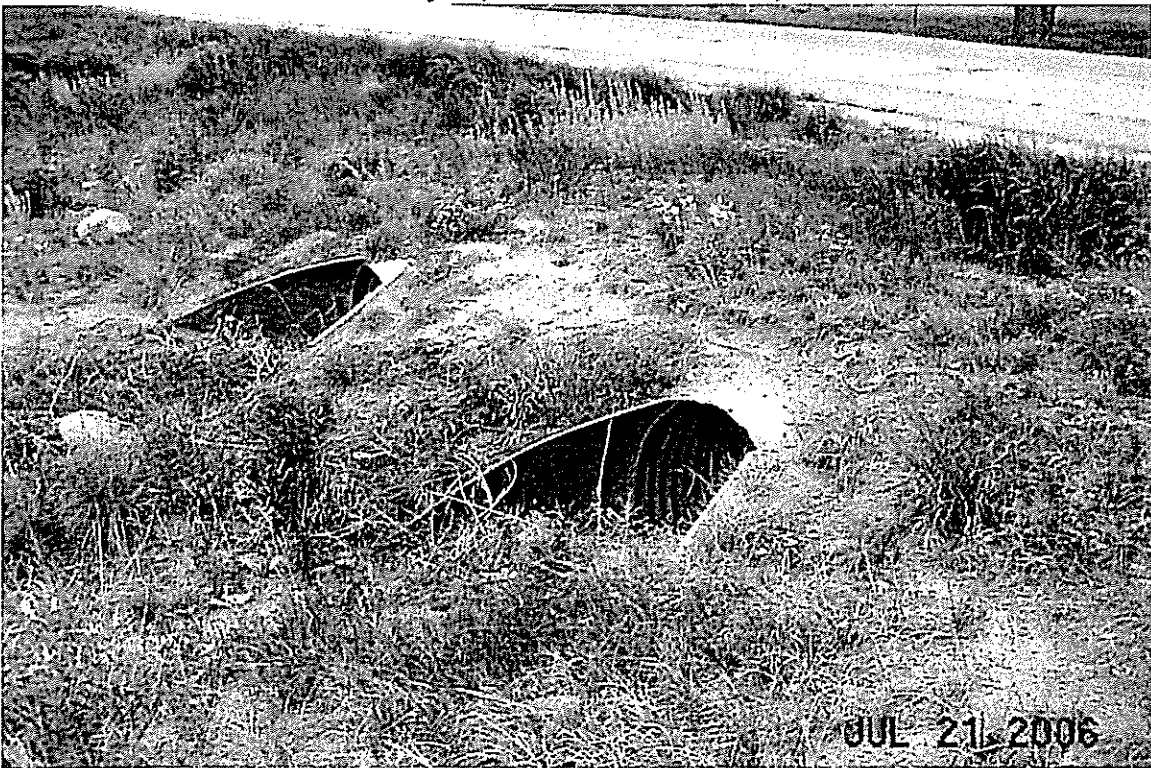
NF 10

State Hwy 94, Two 48" CMPs Inlets, OK.

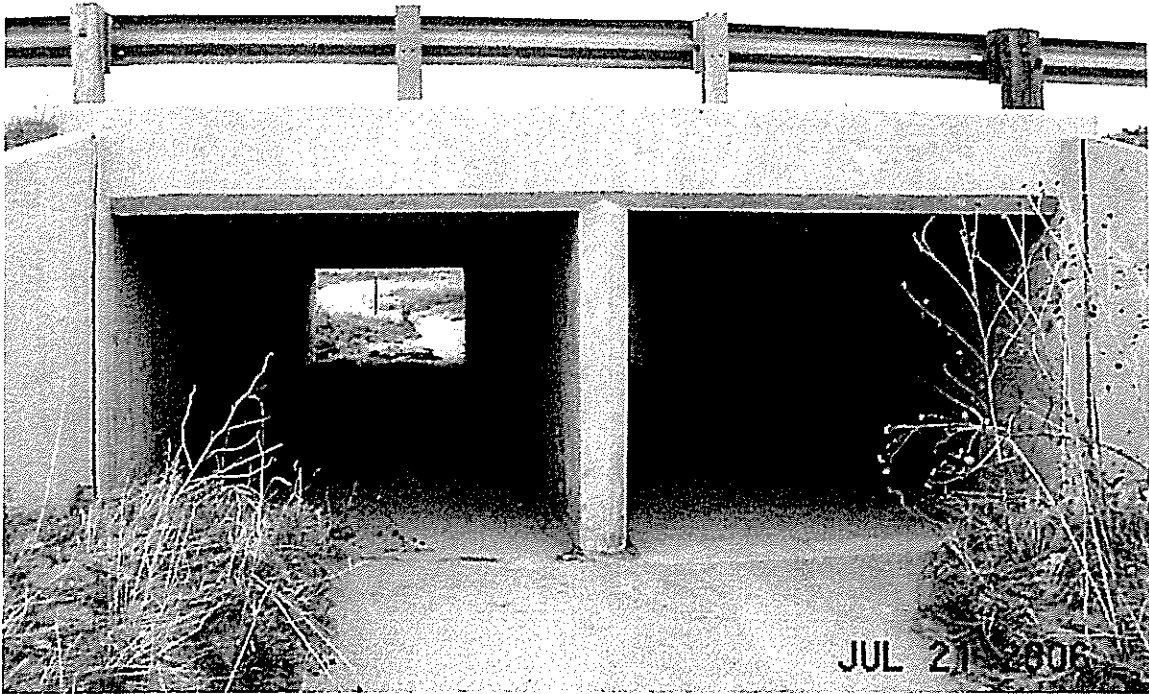
NF 11

State Hwy 94, Two 8'w x 6'h Concrete Boxes Inlet Channel in Fair Condition.

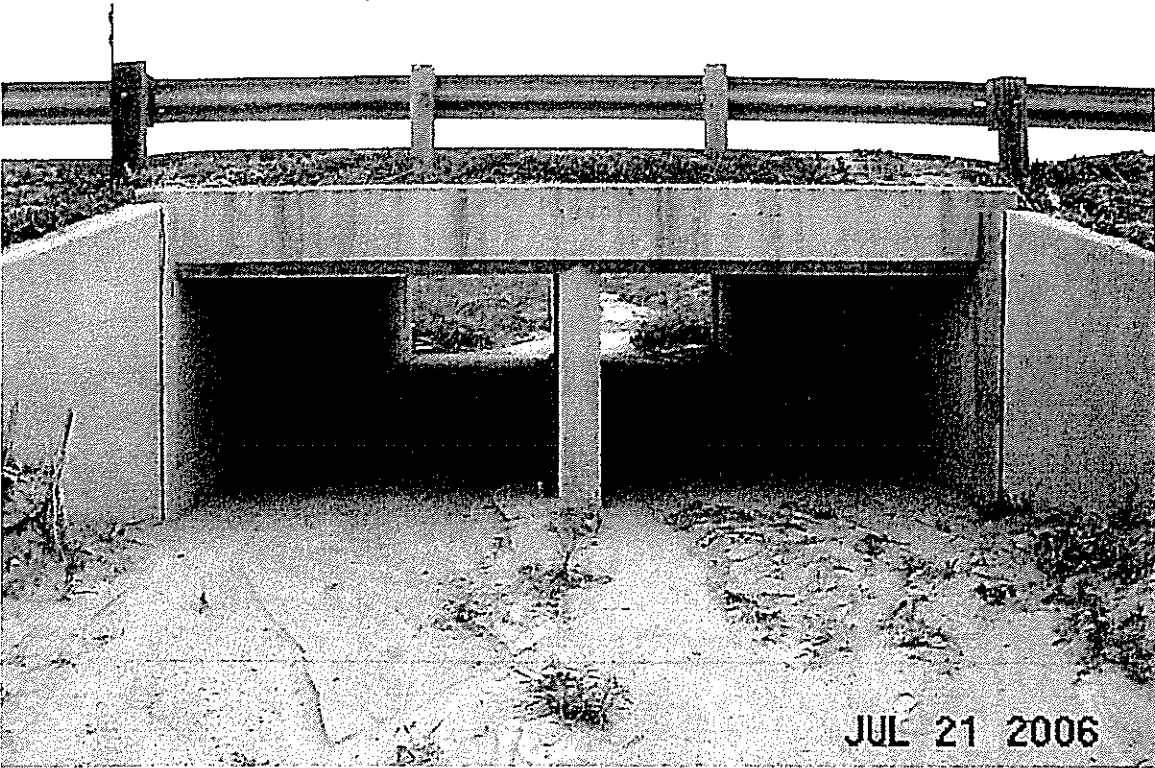
NF 11

State Hwy 94, Two 8'w x 6'h Concrete Boxes Inlet.

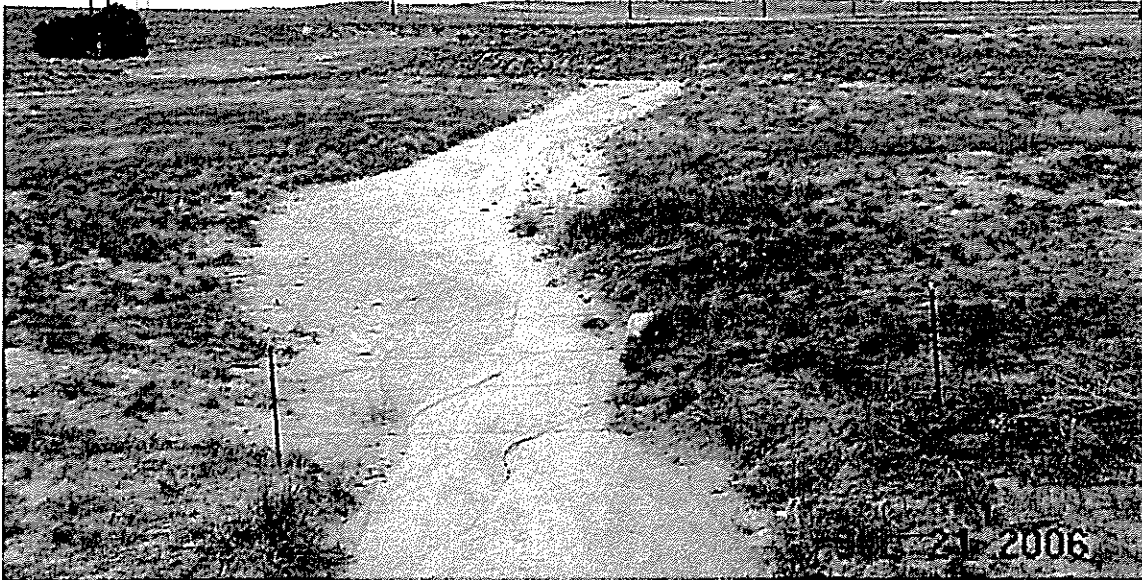
NF 11

State Hwy 94, Two 8'w x 6'h Concrete Boxes Outlet.

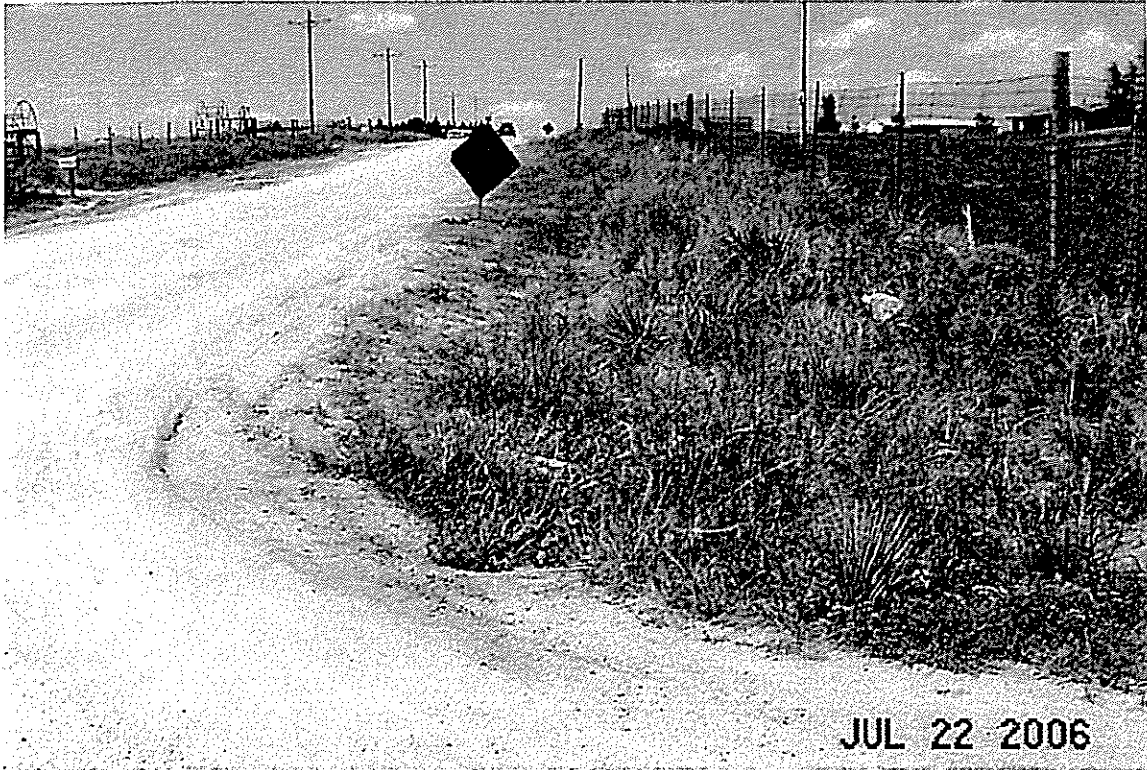
NF11

State Hwy 94, Two 8'w x 6'h Concrete Boxes Outlet Channel in Fair Condition.

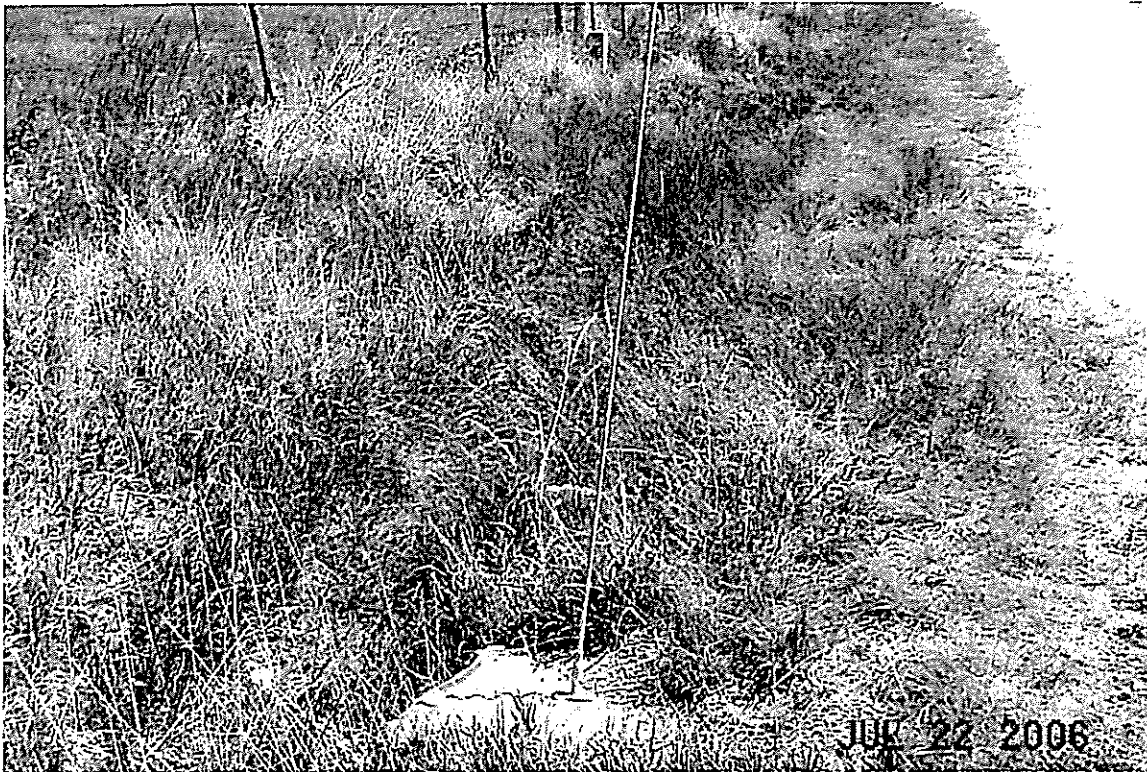
SD1

Smith Road, 21" CMP Outlet Channel in Fair Condition.

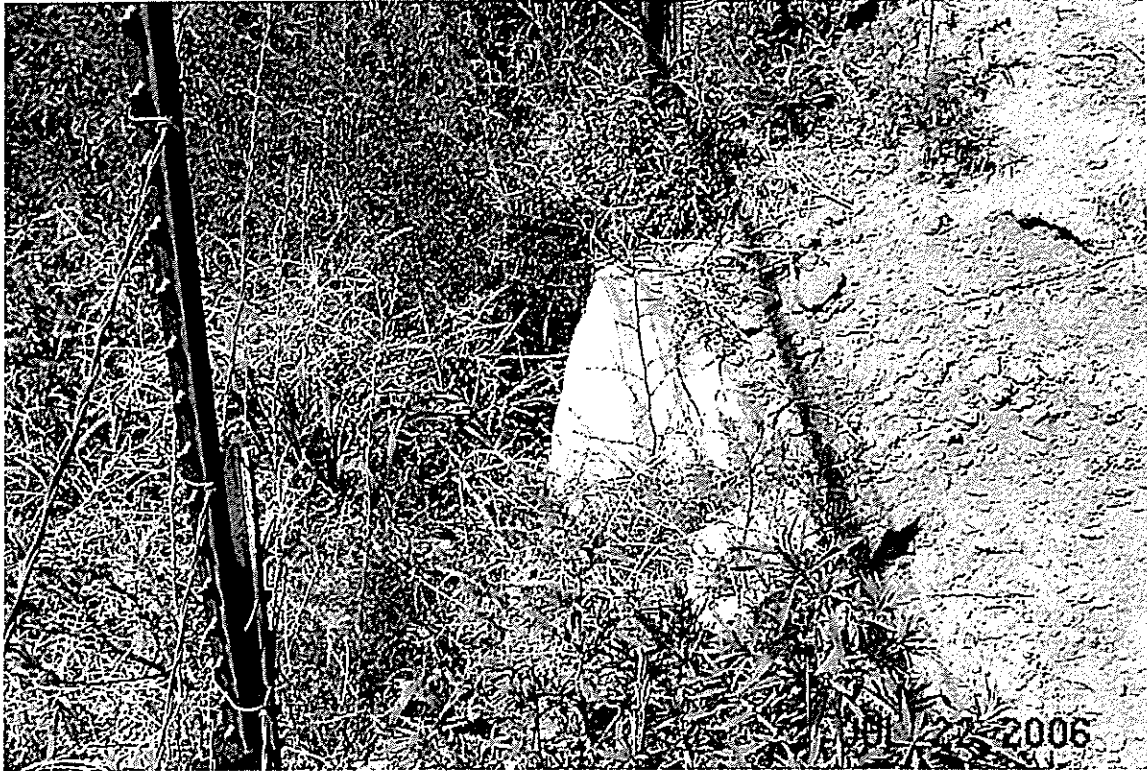
M1

Meridian Road, 21" CMP Inlet, bent.

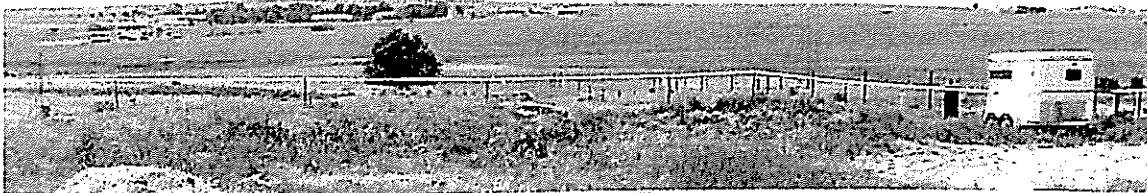
M1

Meridian Road, 21" CMP Outlet.

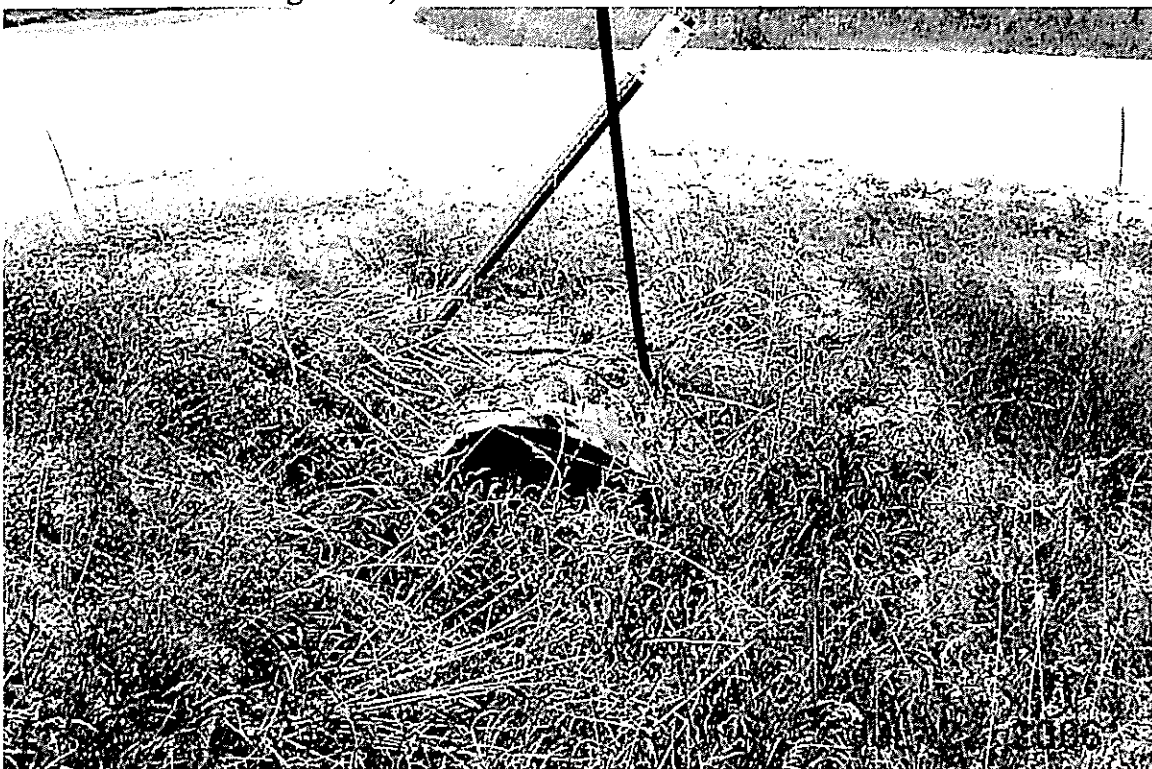
P1

Partridge Lane, 30" CMP Inlet Channel in Good Condition.

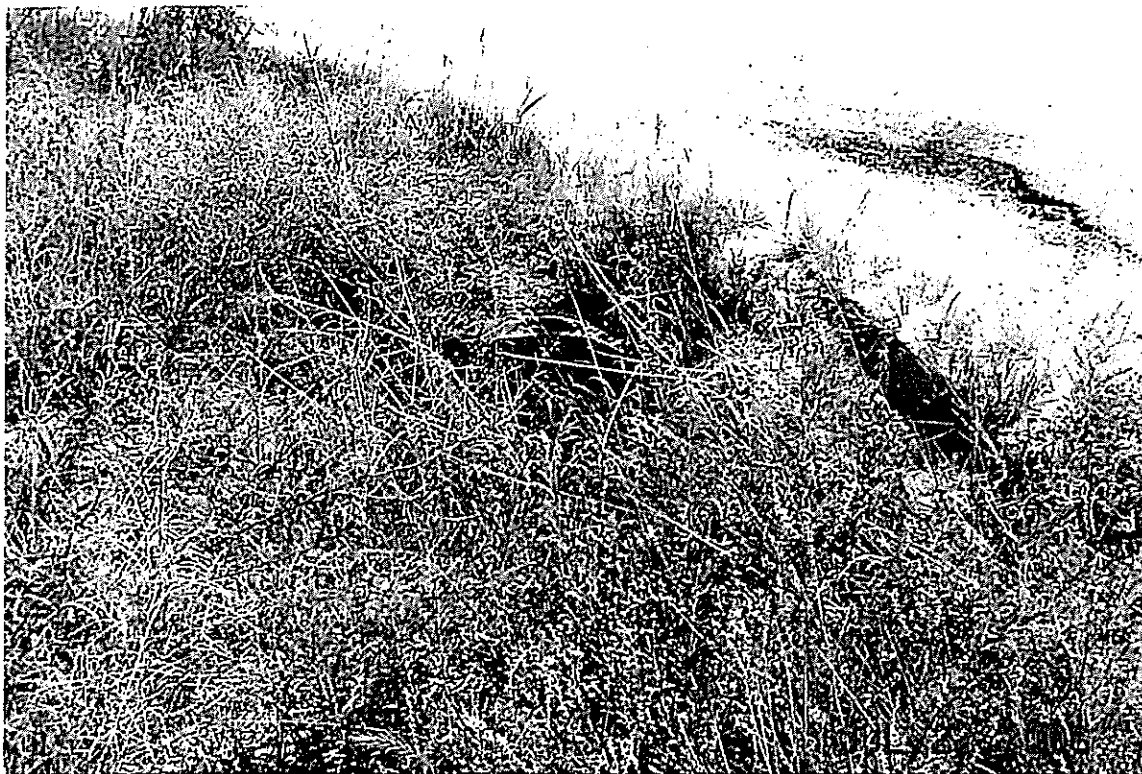
P1

Partridge Lane, 30" CMP Inlet, bent.

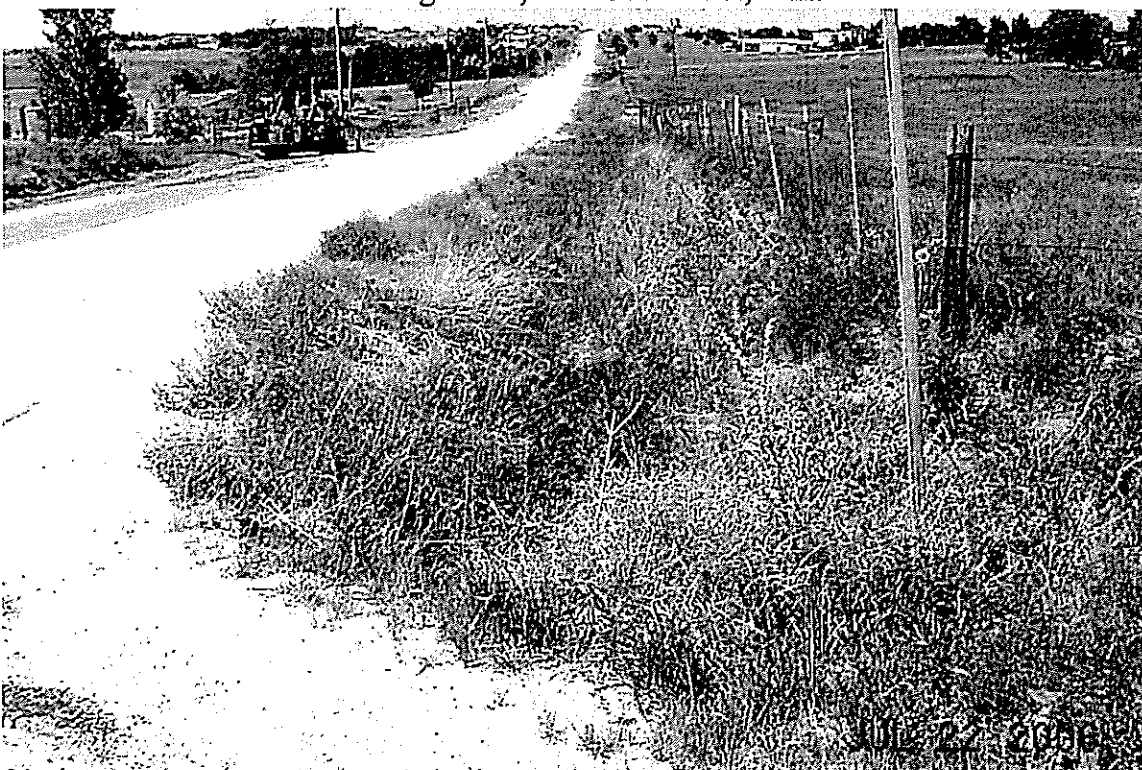
P1  
SP1

Partridge Lane, 30" CMP Outlet, bent.

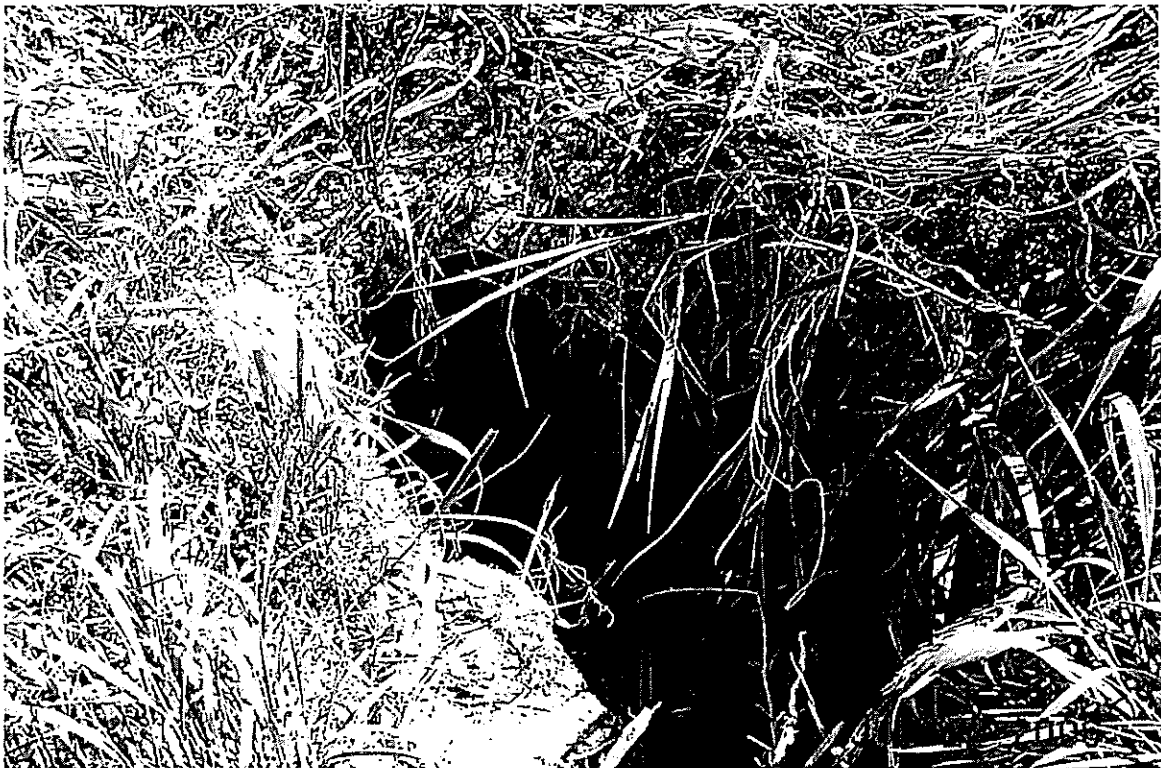
SP1

Sand Place, 21" CMP Inlet Channel in Good Condition.

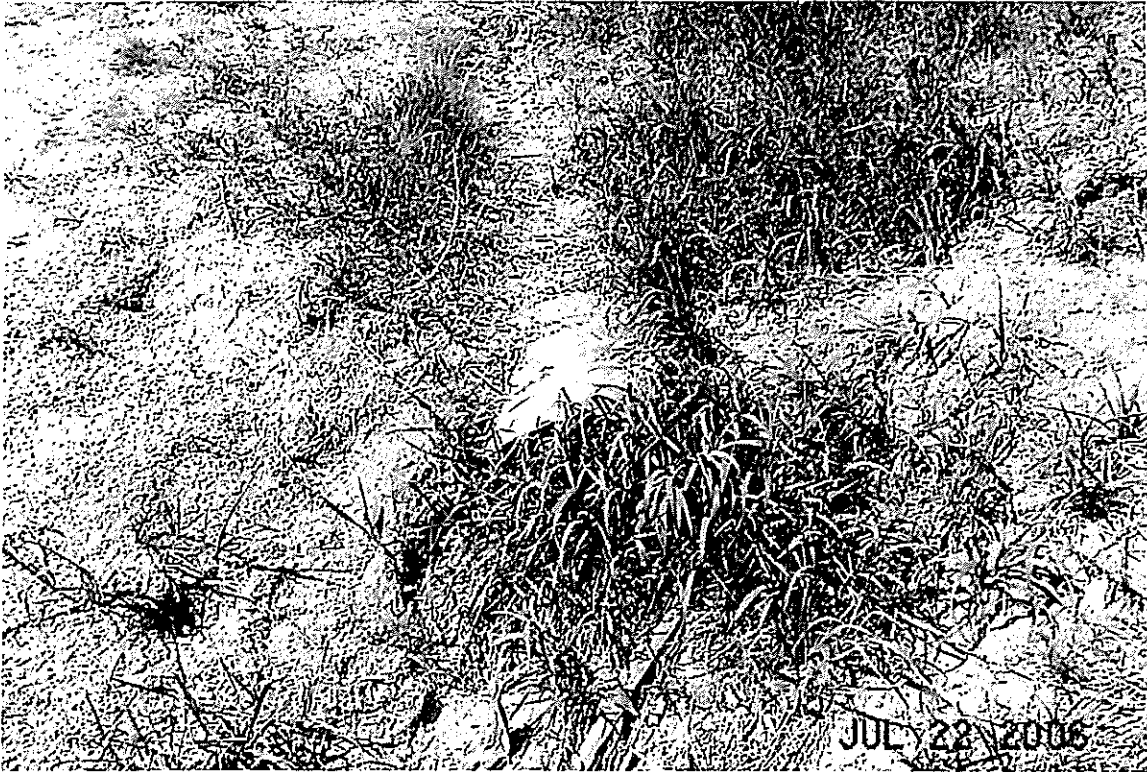
SP1

Sand Place, 21" CMP Inlet, bent.

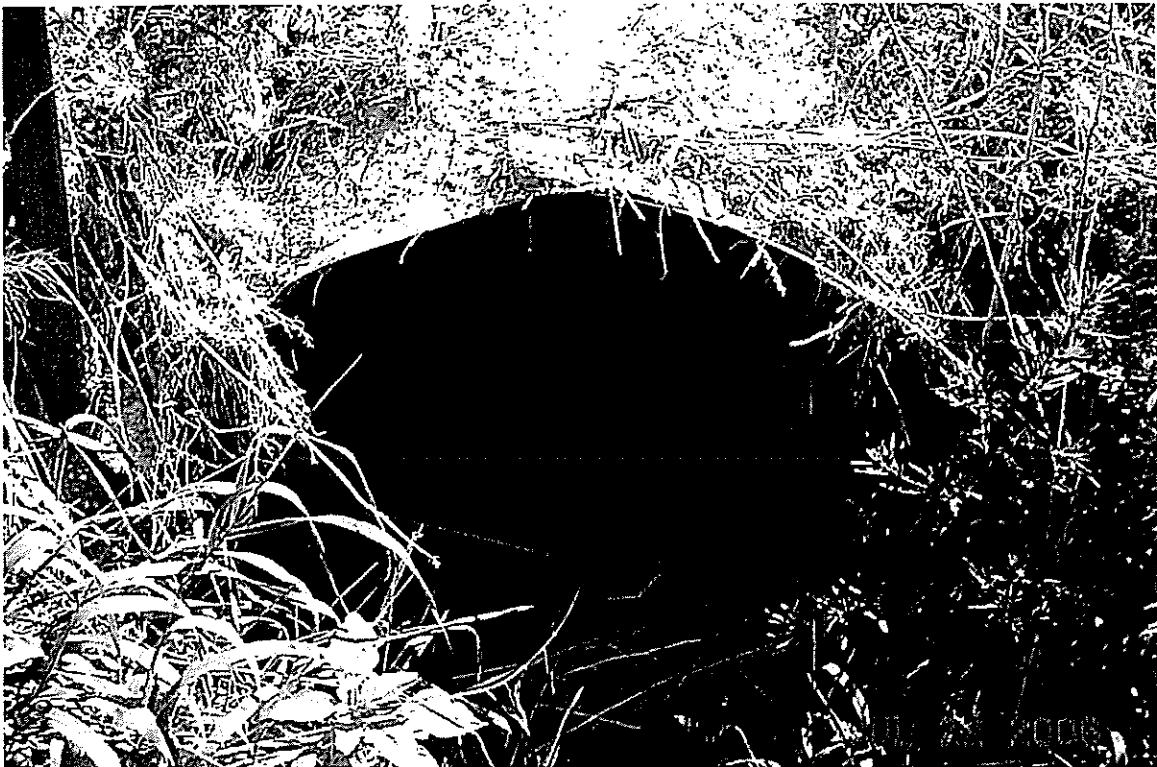
SP2

Sand Place, 30" CMP Inlet Channel.

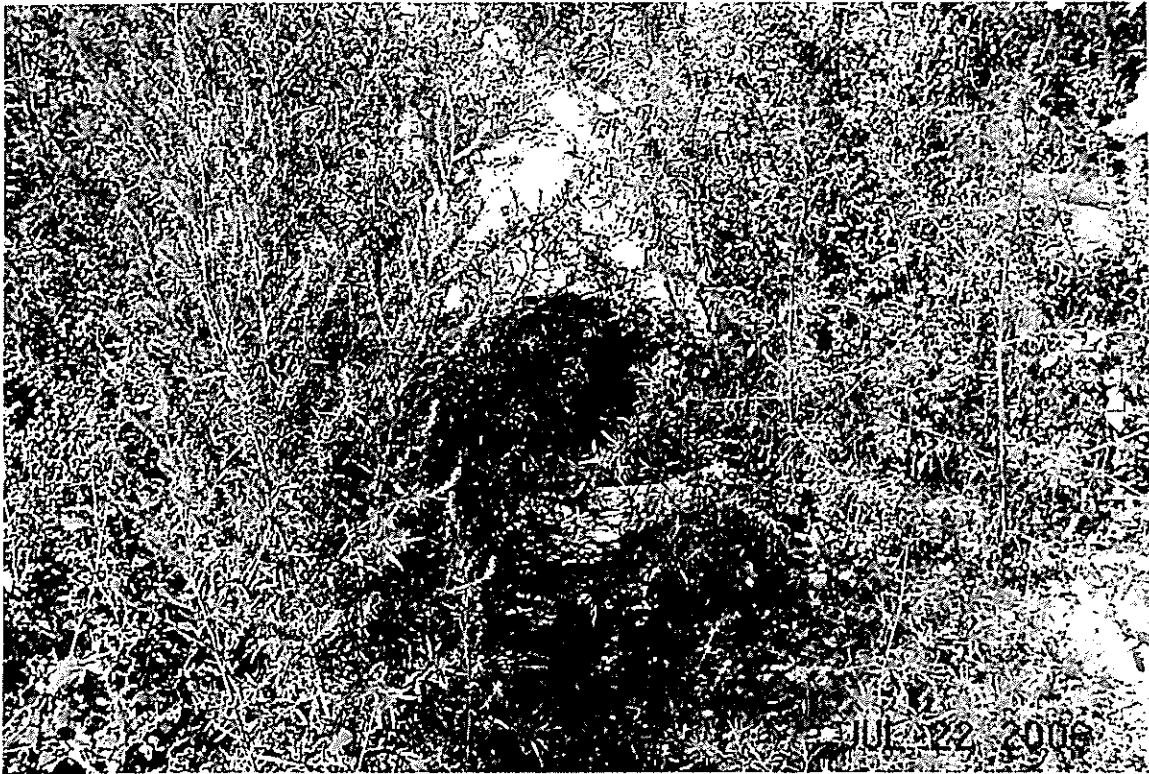
SP2

Sand Place, 30" CMP Inlet, bent.

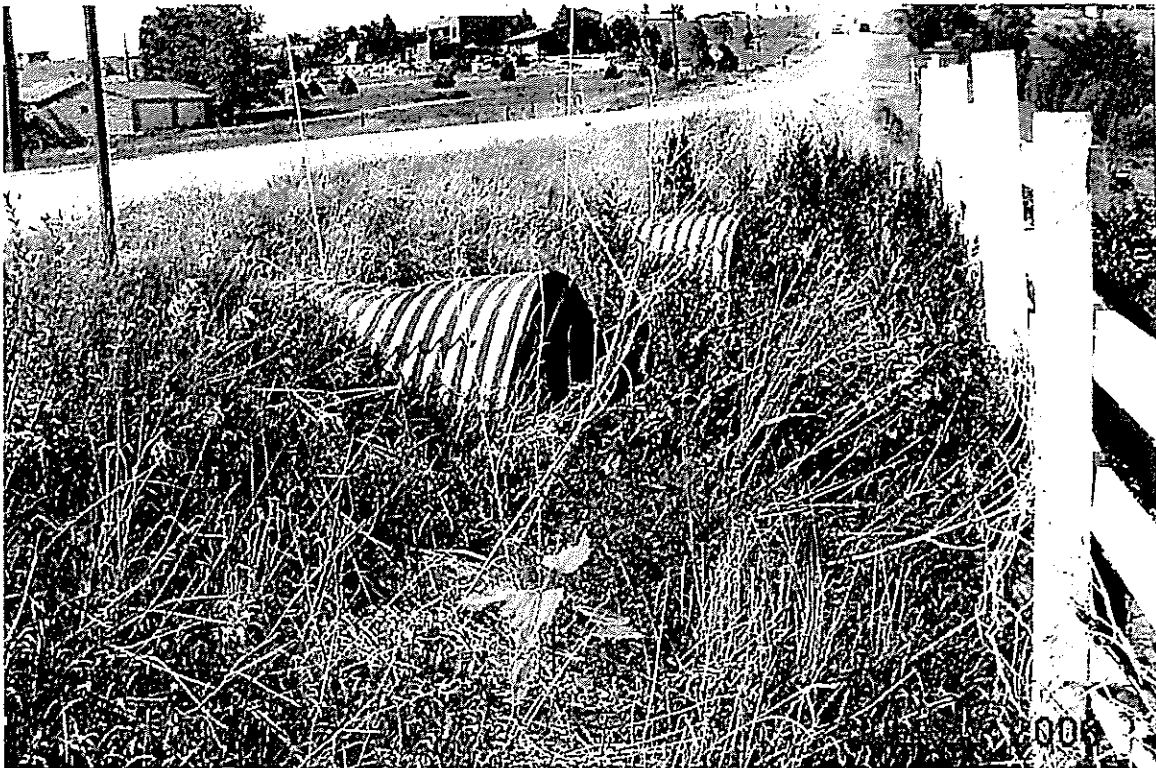
M2

Meridian Road, Two 58" w x 36" h CMPs Inlet channel in Fair Condition.

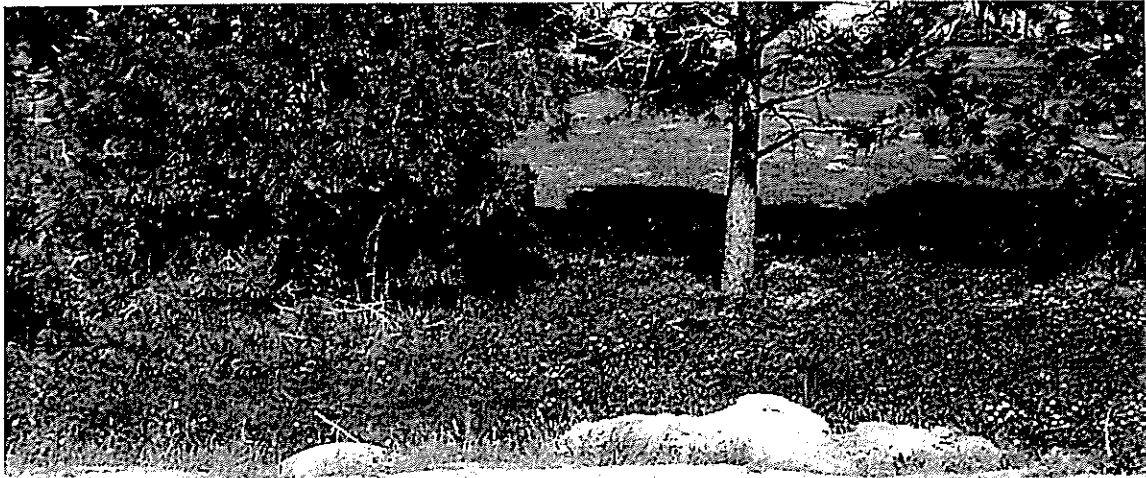
M2

Meridian Road, Two 58" w x 36" h CMPs Outlet channel in Fair Condition.

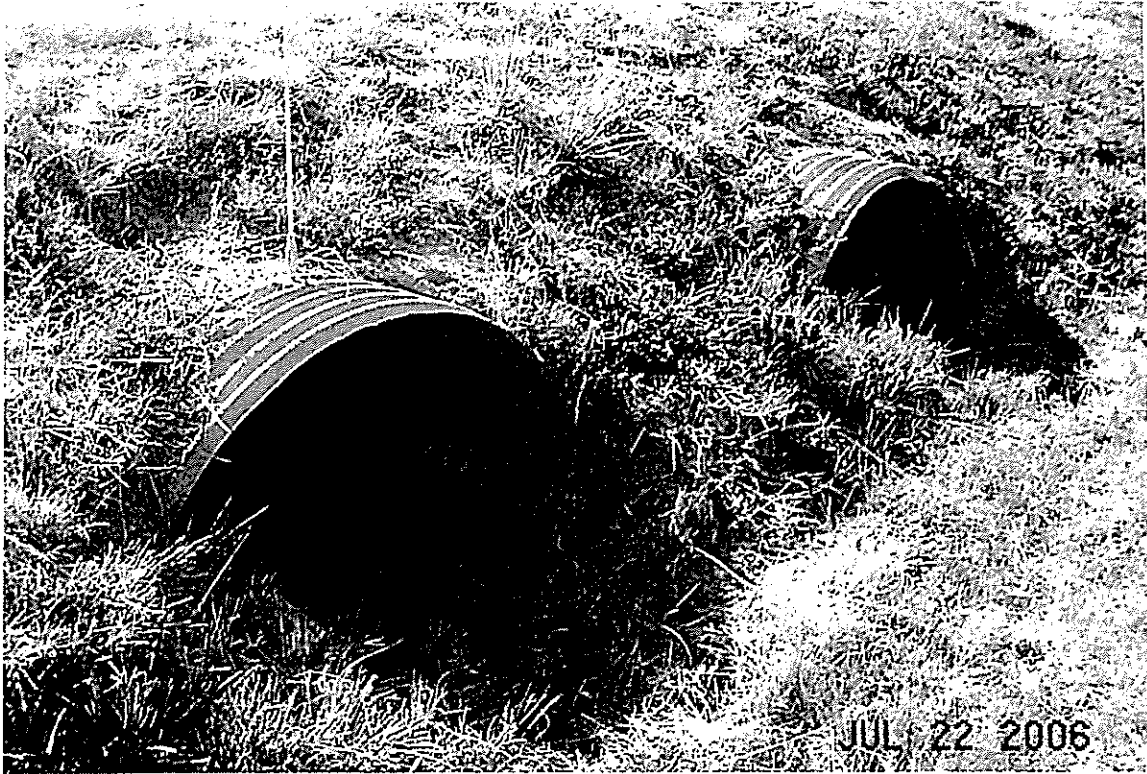
M5

Meridian Road, Two 52" w x 34" h CMPs Inlet channel in Good Condition.

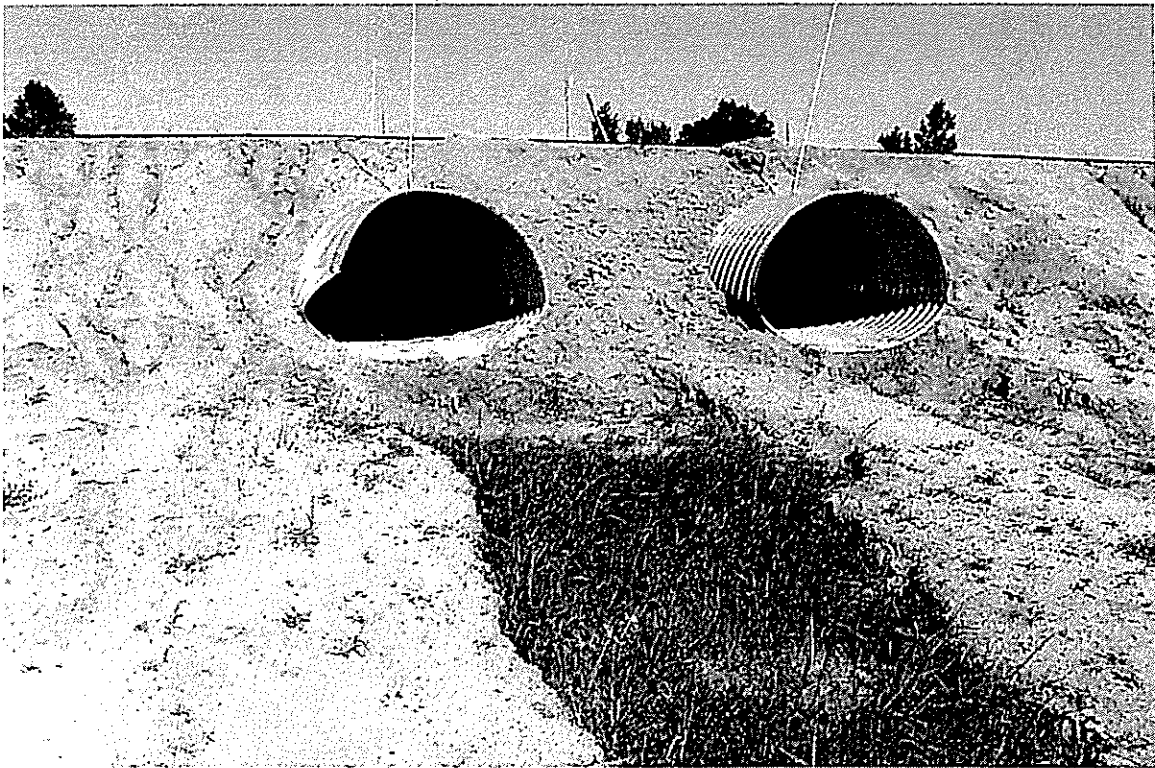
M5

Meridian Road, Two 52" w x 34" h CMPs Inlet, bent.

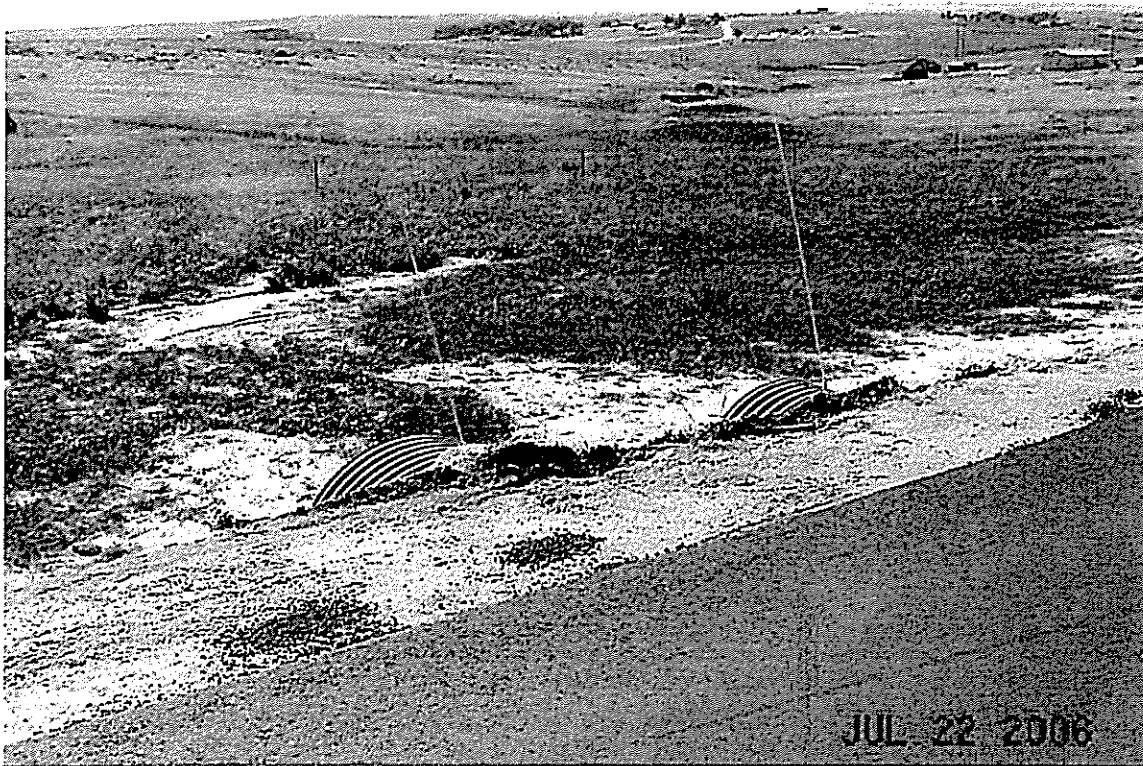
M5

Meridian Road, Two 52" w x 34" h CMPs Outlet, bent.

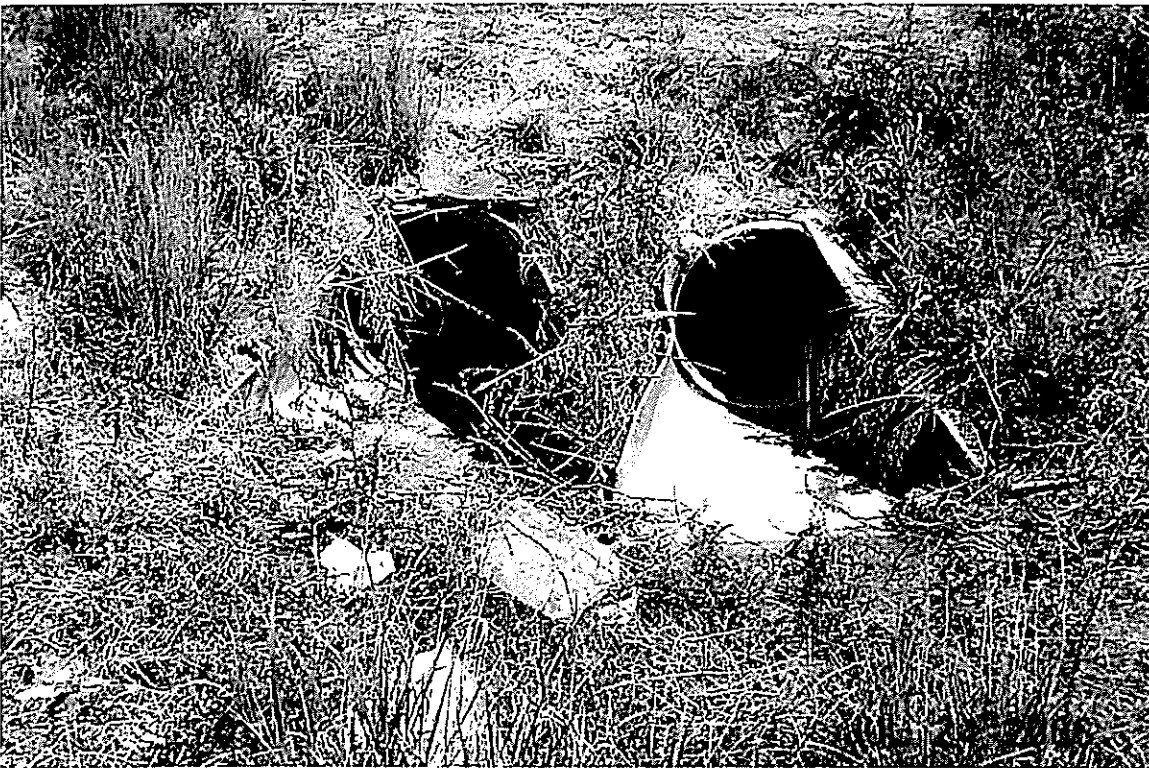
NF-13

State Hwy 94, Two 24" CMPs Inlet Channel in Fair Condtion.

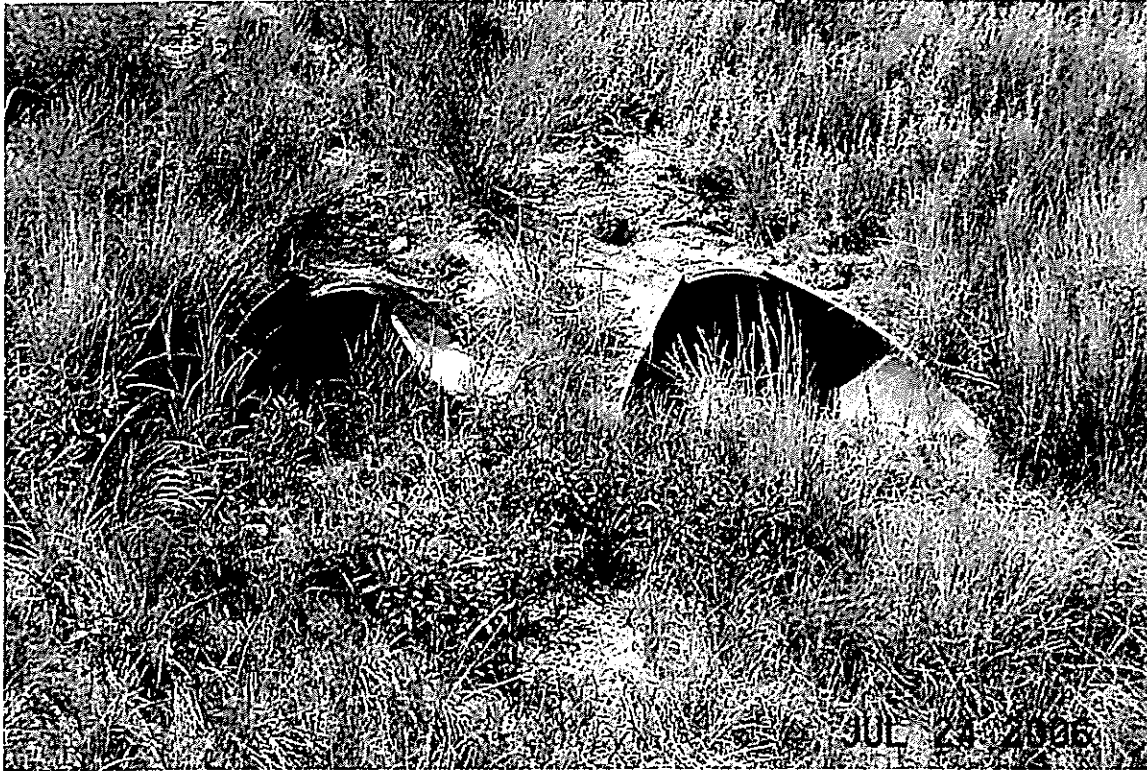
NF-13

State Hwy 94, Two 24" CMPs Inlet, bent.

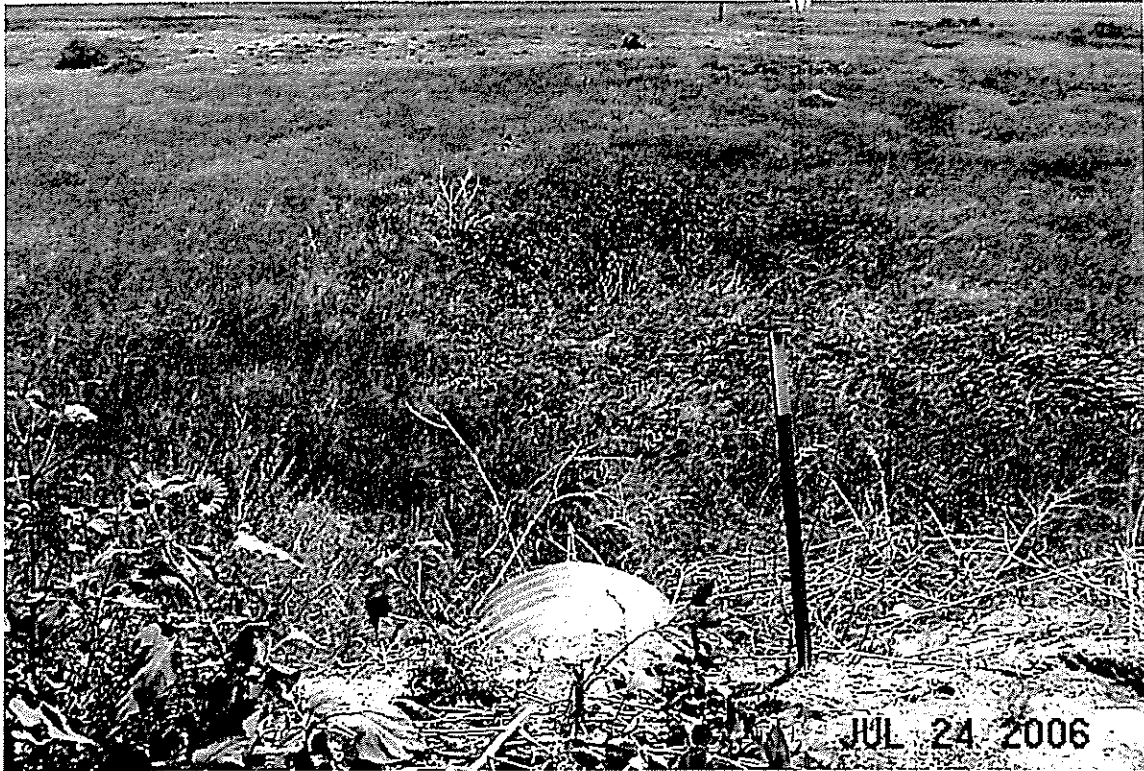
NF-13

State Hwy 94, Two 24" CMPs Outlet Channel in Fair Condition.

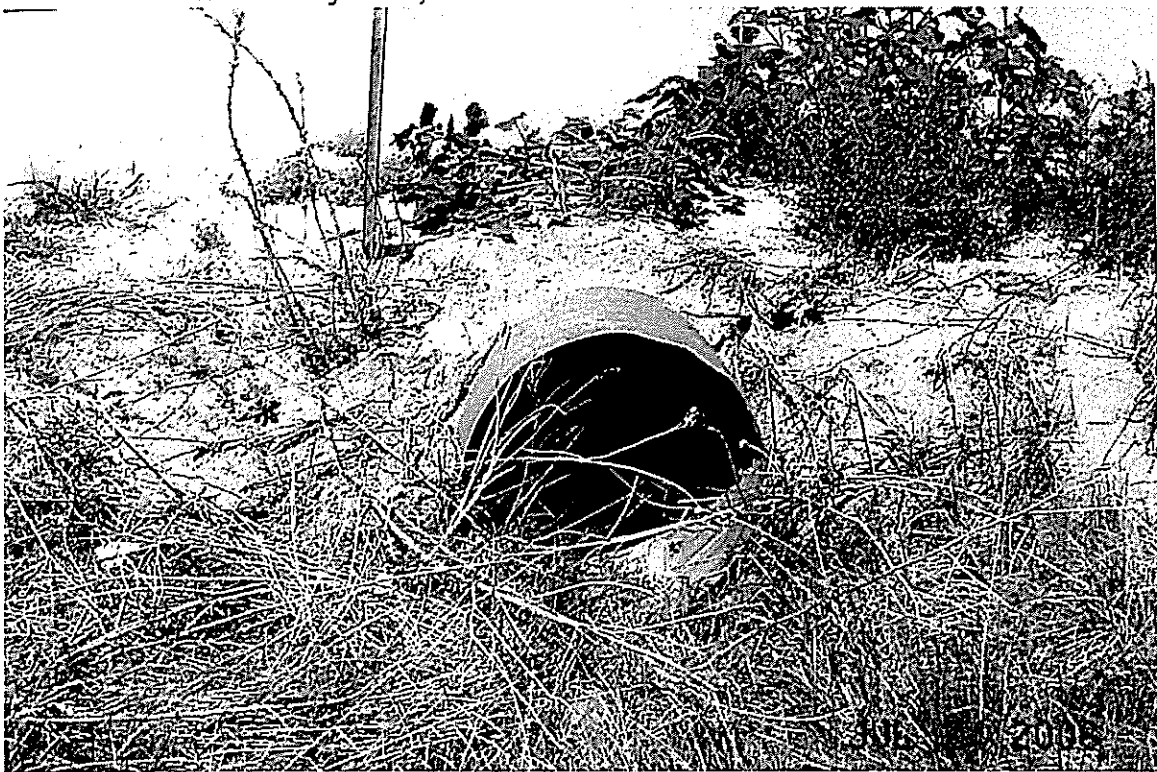
C1

Corral Valley Road, 30" CMP Inlet Channel in Good Condition.

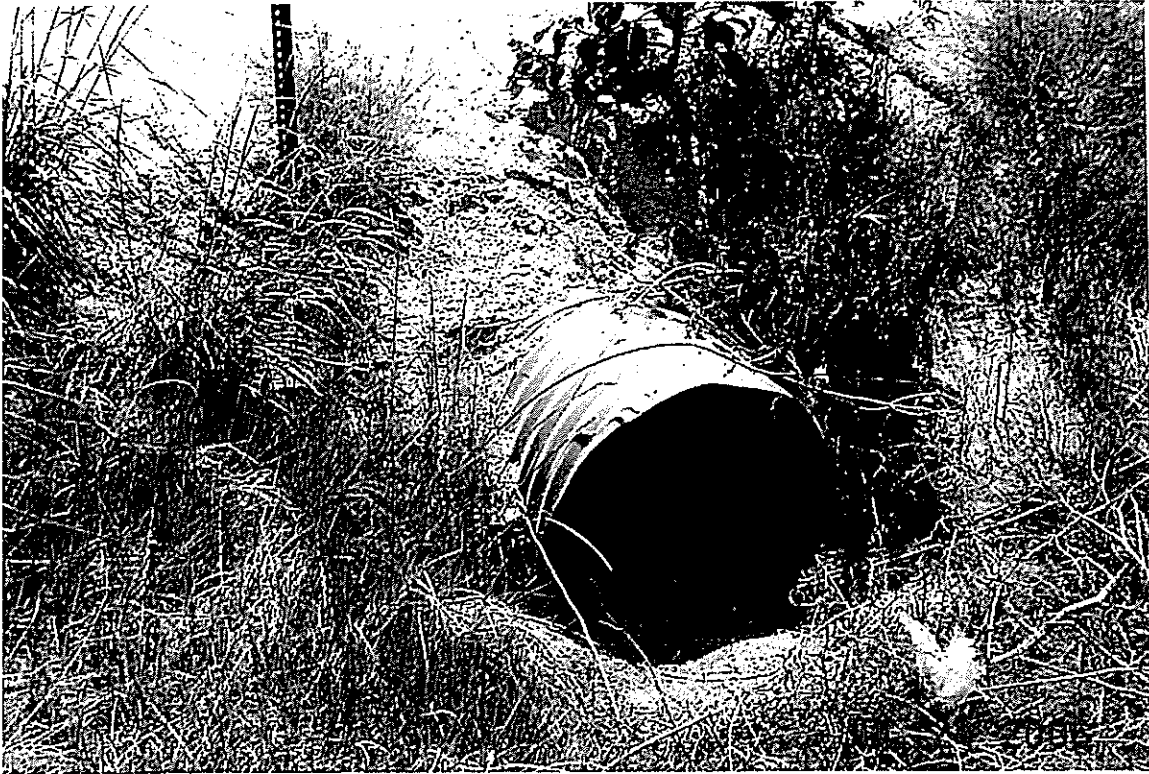
C1

Corral Valley Road, 30" CMP Inlet.

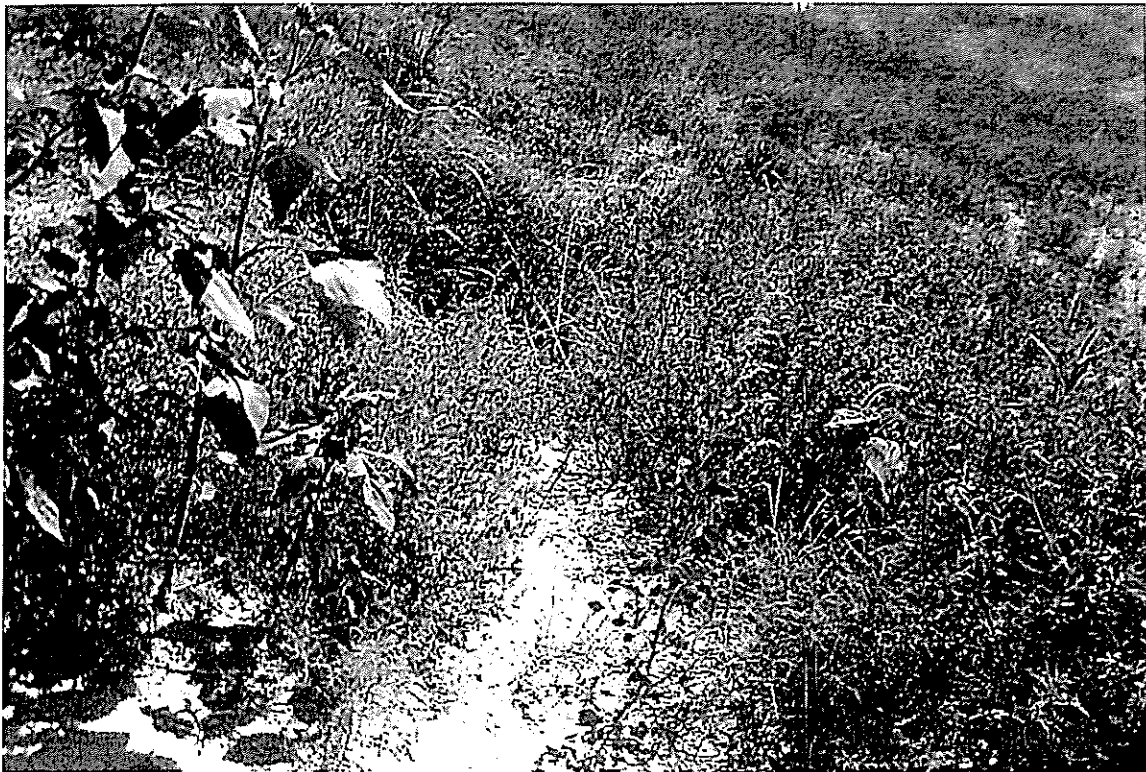
C1

Corral Valley Road, 30" CMP Outlet Channel in Fair to Good Condition.
