**APPENDIX D**  
**EXISTING FACILITIES**  
**Facility Summary**  
**Photographs**

Table 1 Existing Major Drainageway Structure Inventory

JIMMY CAMP CREEK DBPS  
OLD PUEBLO ROAD BRIDGE  
JIMMY CAMP CREEK  
EL PASO COUNTY, COLORADO  
BRIDGE PROFILE

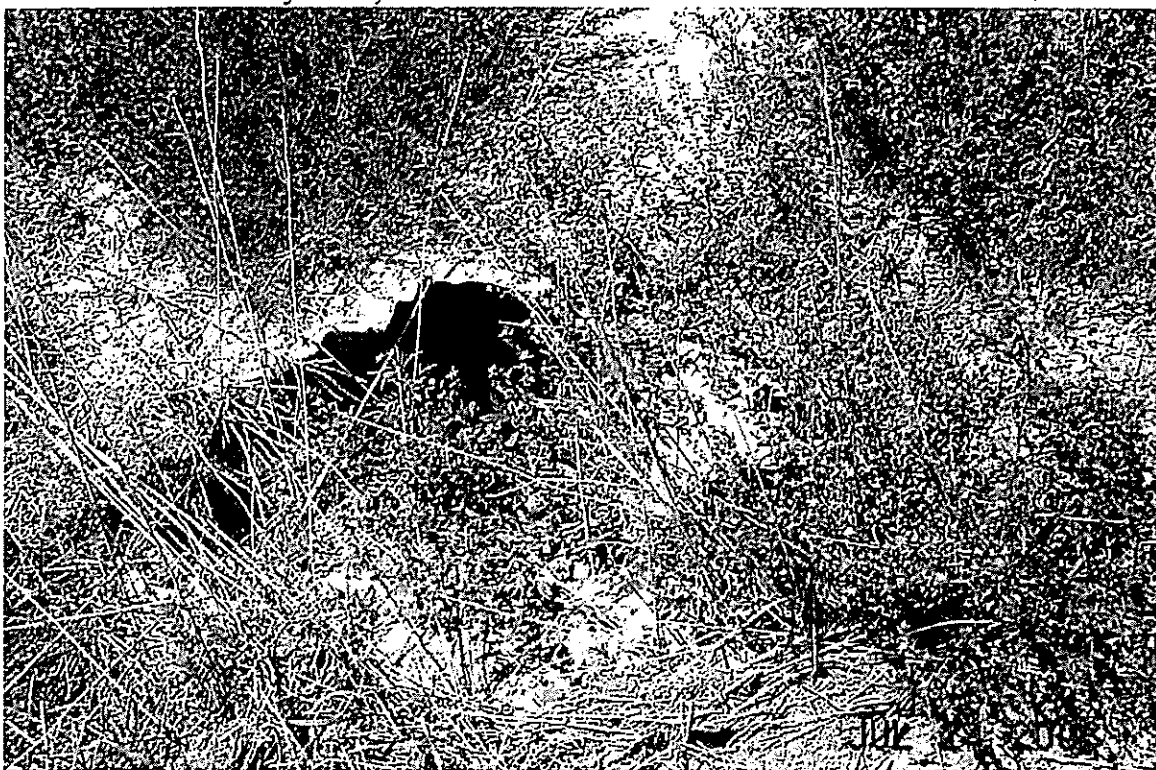
C2

Corral Valley Road, 24" CMP Inlet Channel in Fair to Good Condition.

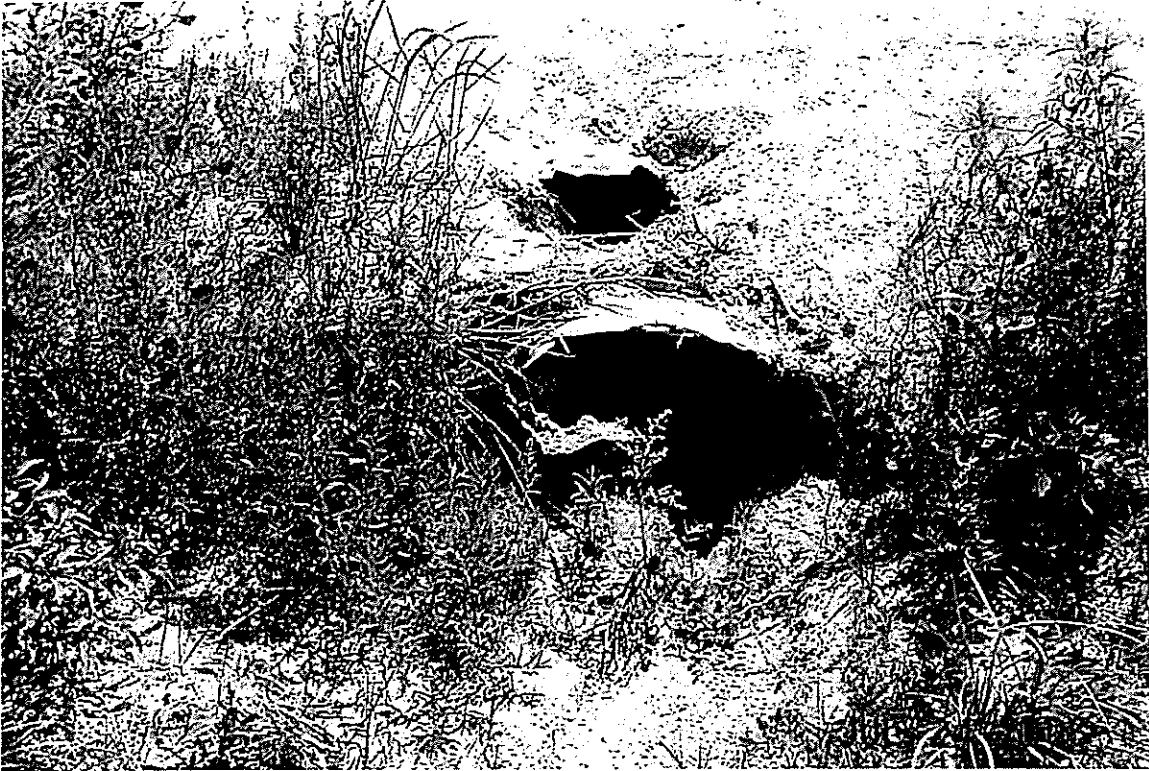
C2

Corral Valley Road, 24" CMP Inlet, bent.

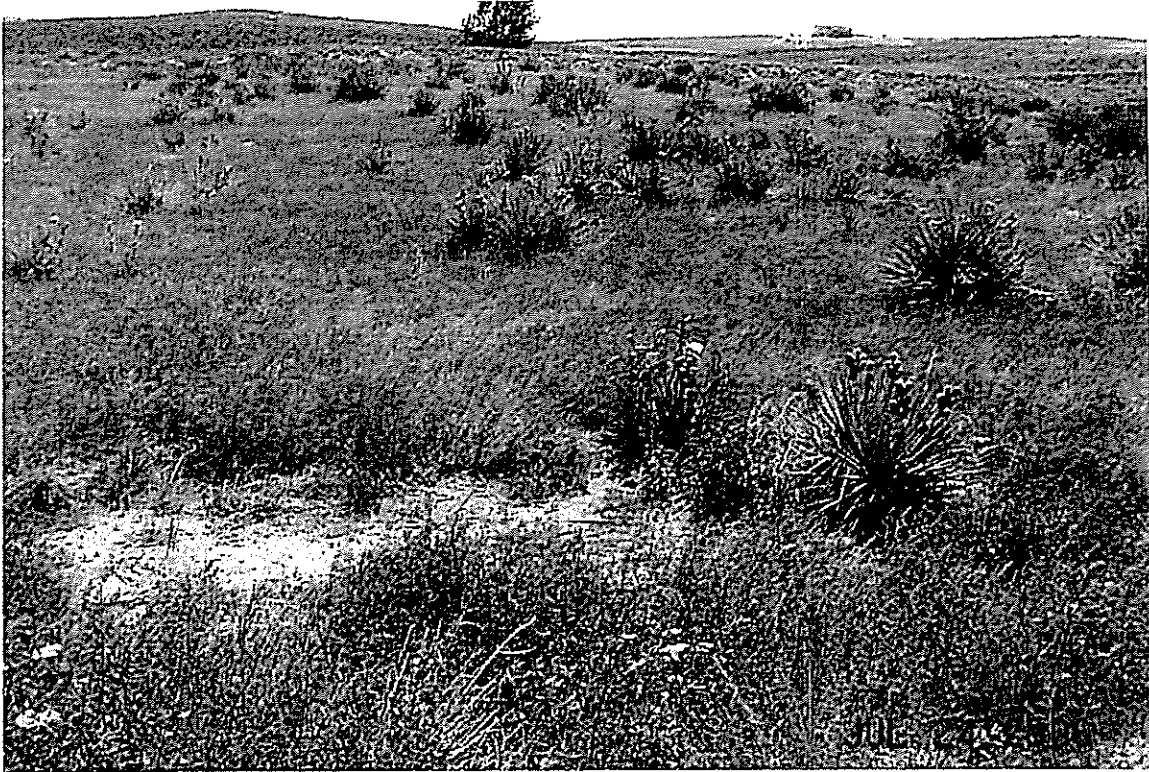
C2

Corral Valley Road, 24" CMP Outlet Channel in Good Condition.

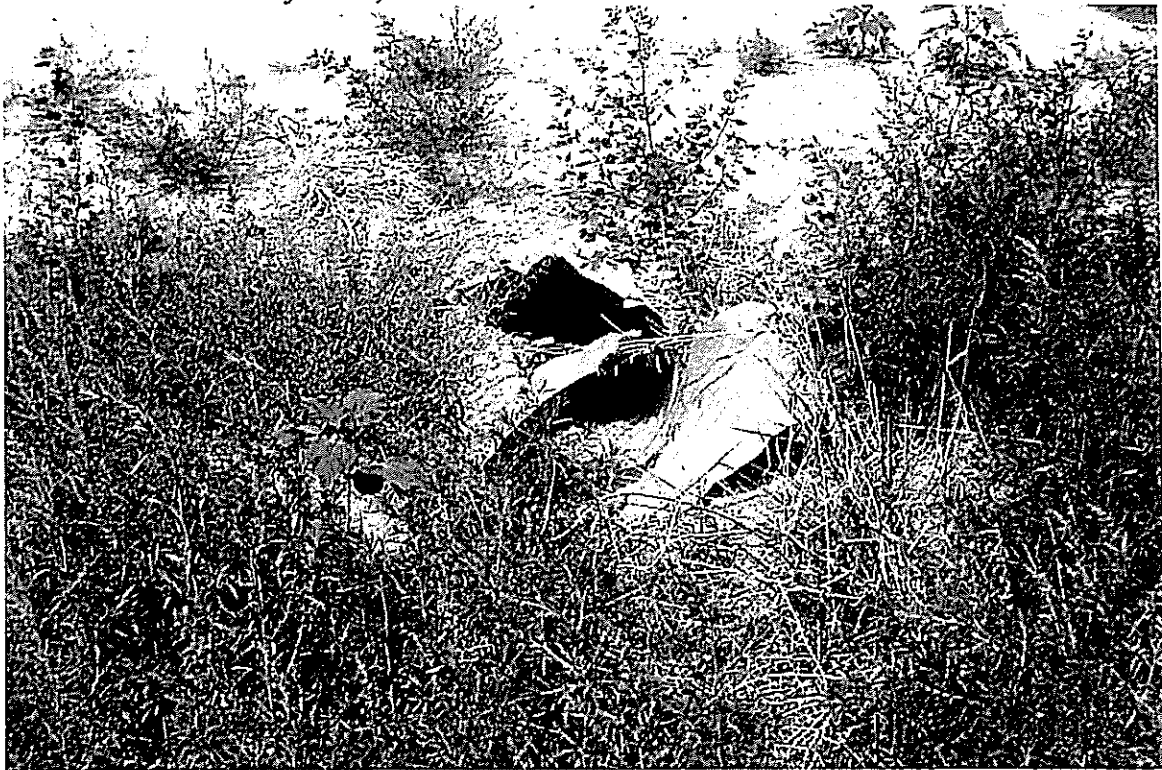
C3

Corral Valley Road, 24" CMP Inlet Channel in Good to Fair Condition.

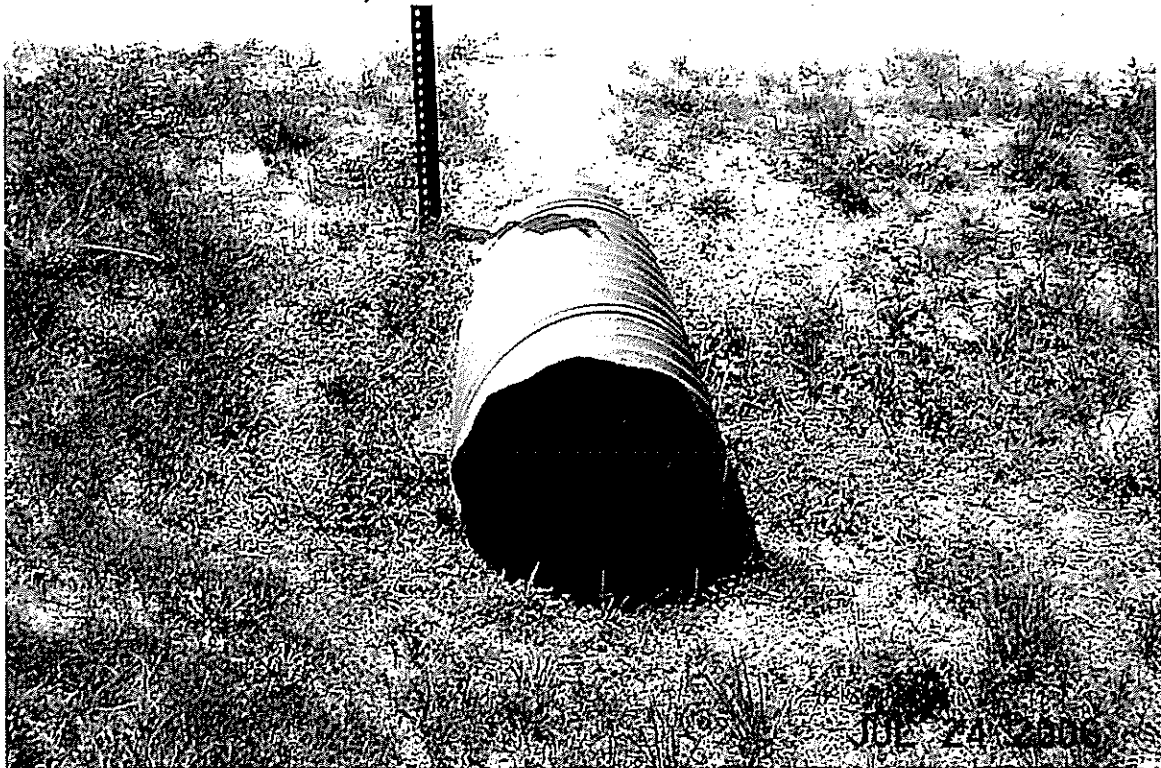
W1

West Lane, 18" CMP Inlet Channel in Good Condition.

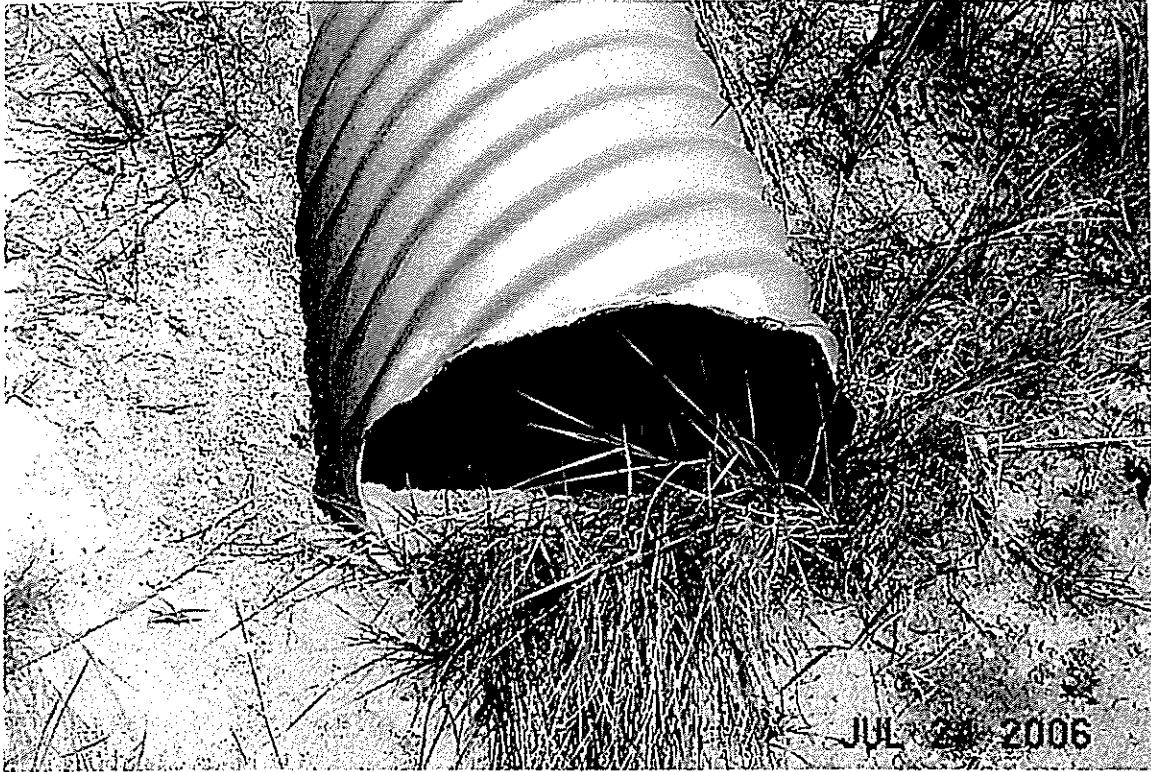
W1

West Lane, 18" CMP Inlet.

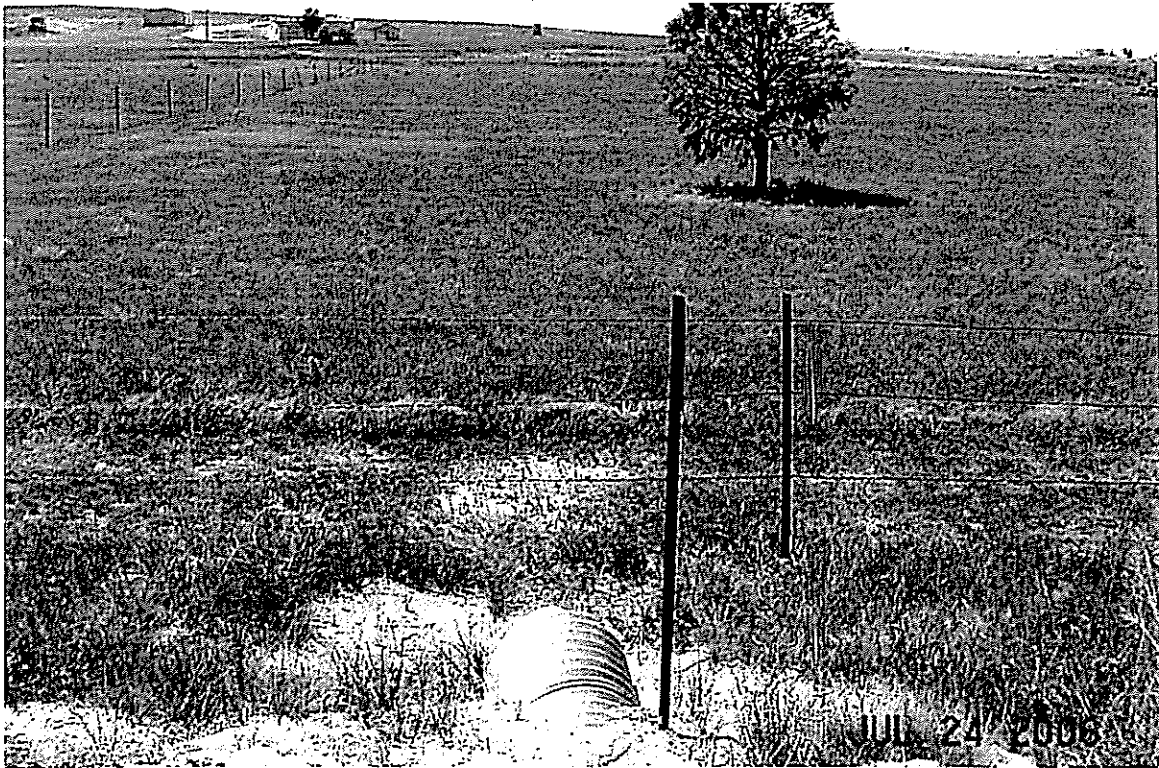
W1

West Lane, 18" CMP Outlet.

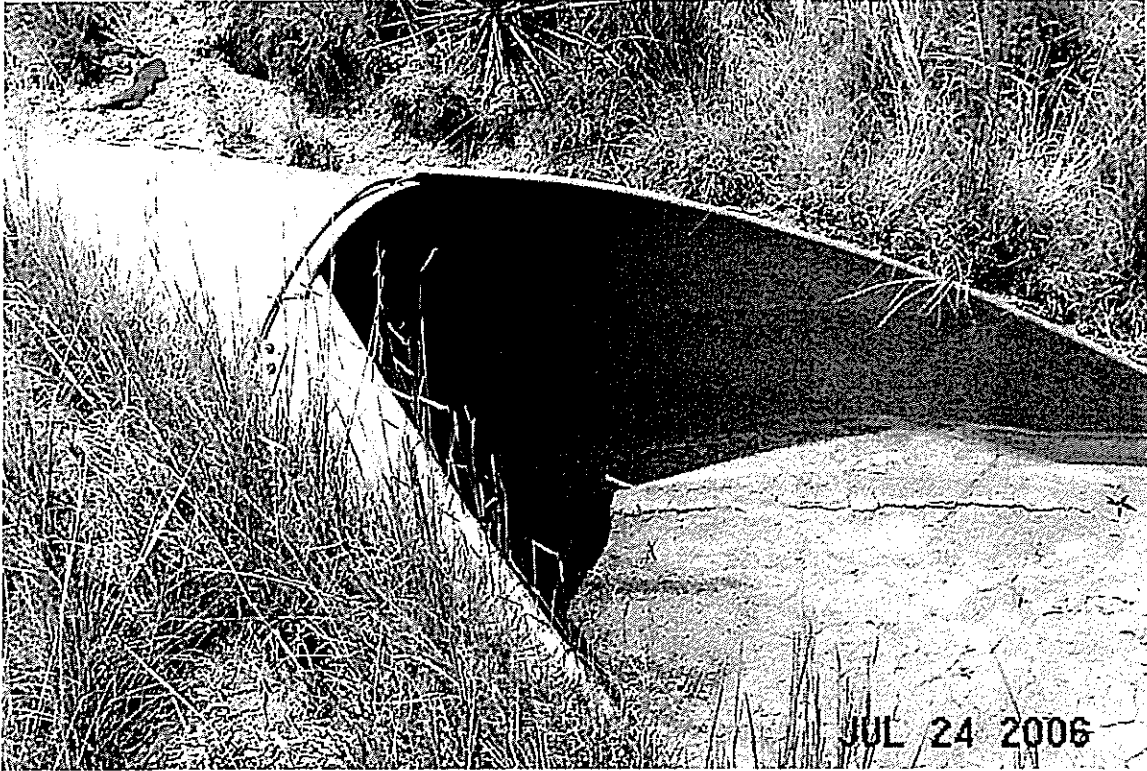
NF-14

State Hwy 94, 36" CMP Inlet.

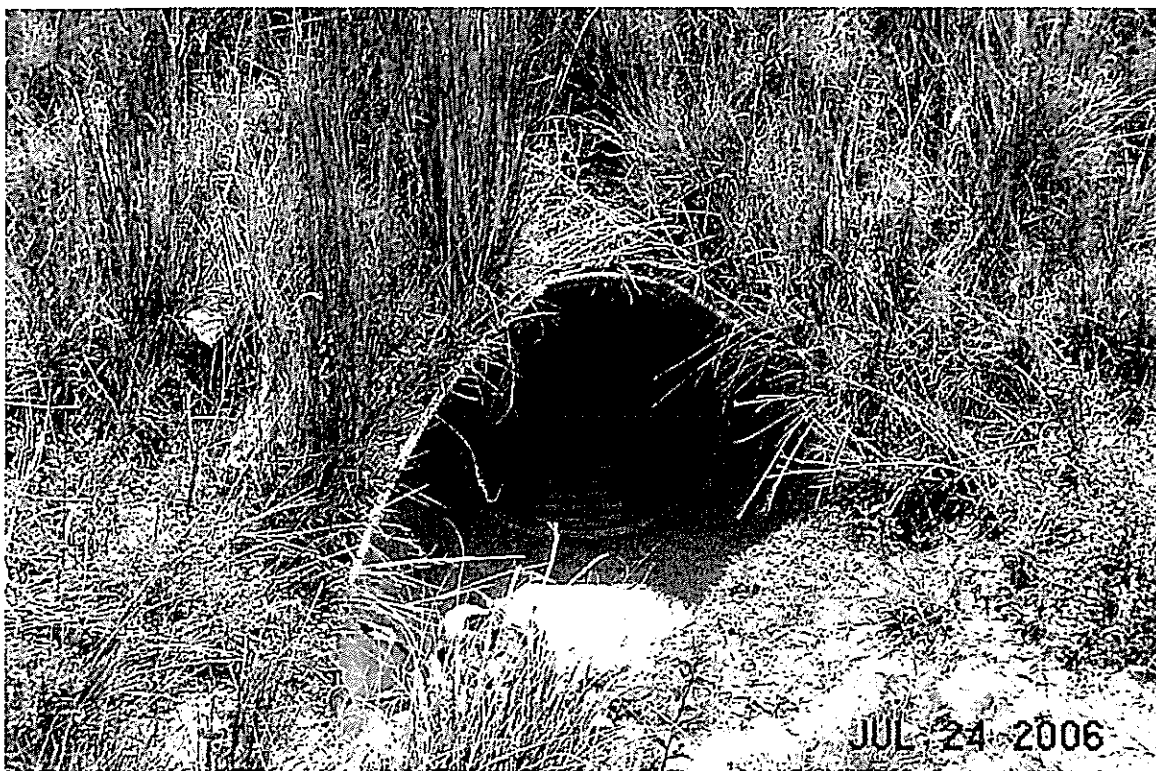
NF-15

State Hwy 94, 24" CMP Inlet Channel in Fair Condition.

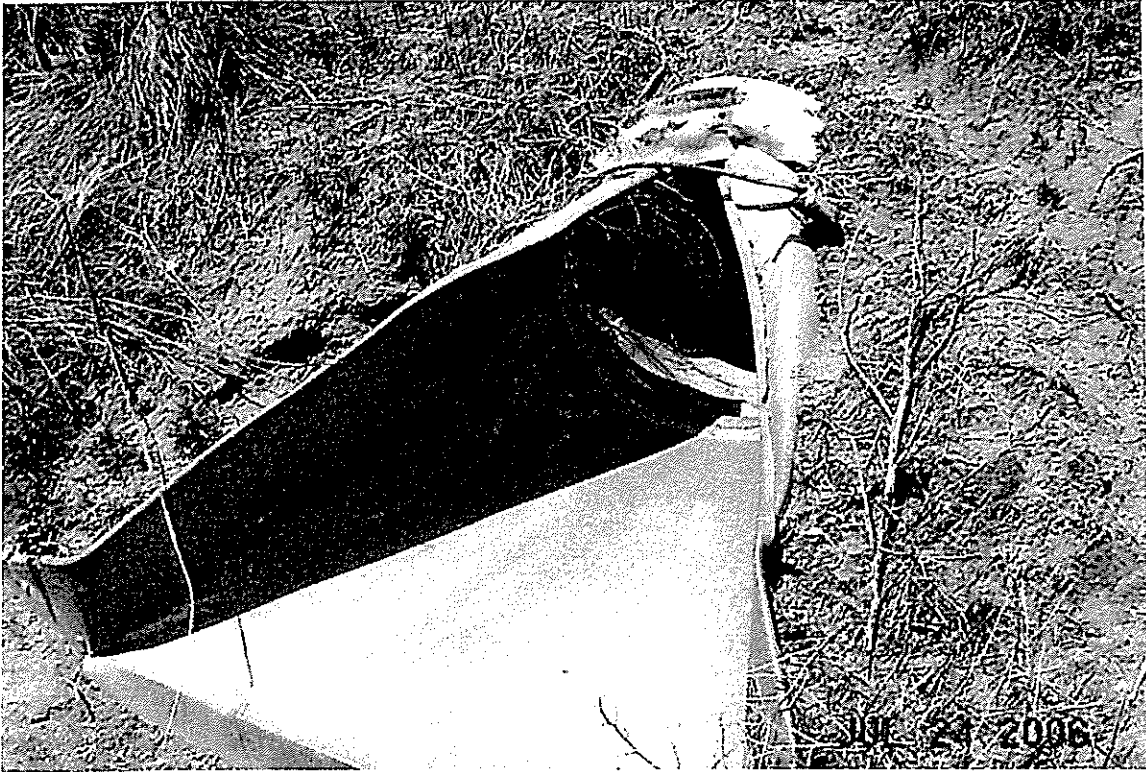
NF-15

State Hwy 94, 24" CMP Inlet.

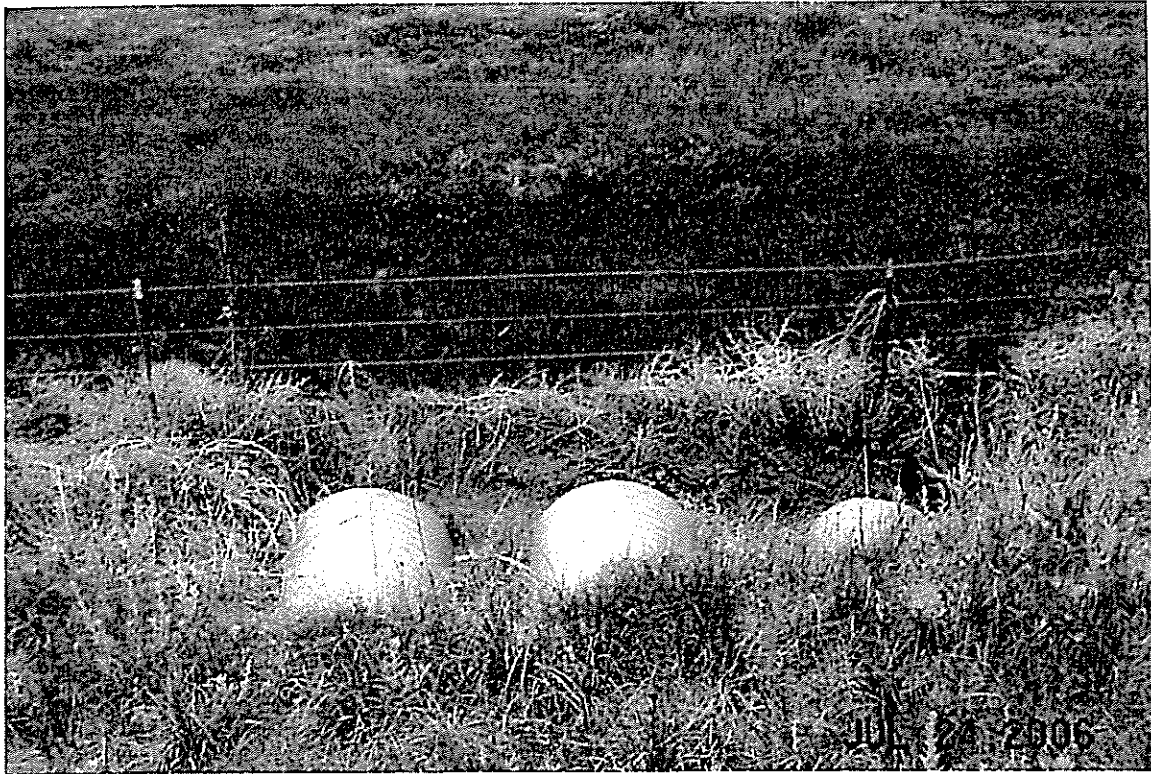
NF-15

State Hwy 94, 24" CMP Outlet Channel in Fair Condition.

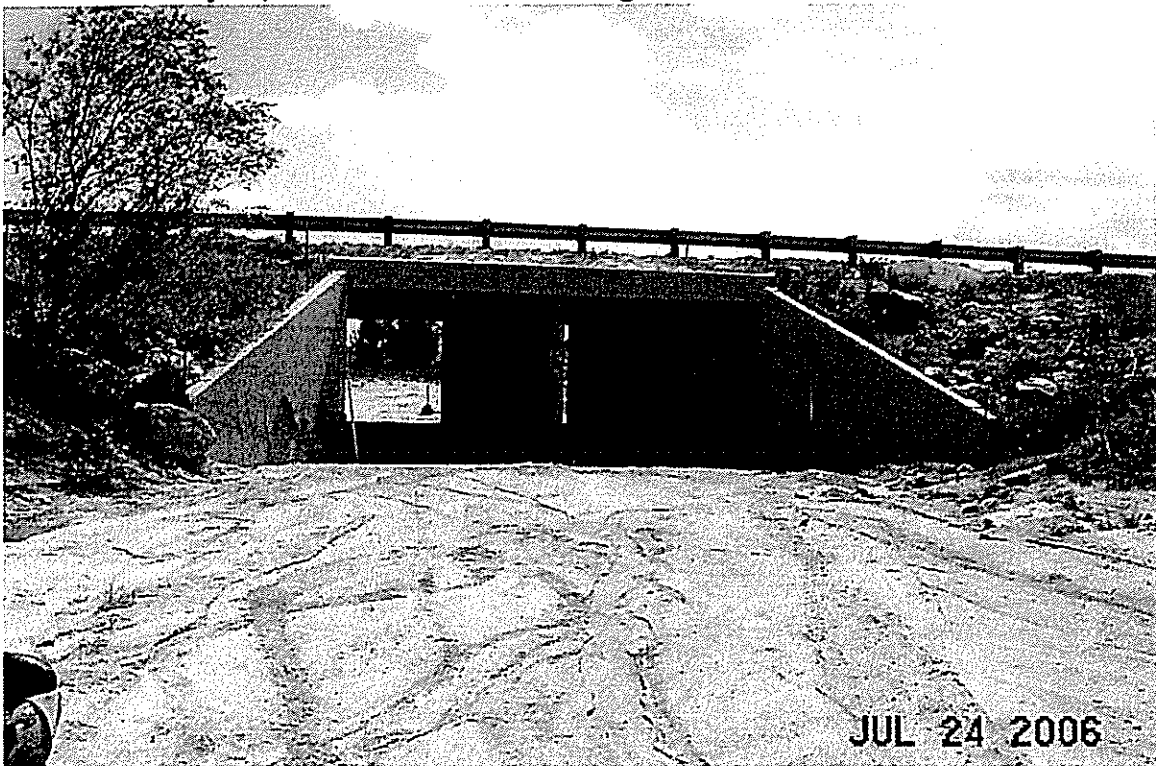
NF-17

State Hwy 94, 25'w x 10'h Concrete Bridge Inlet Channel in Fair Condition.

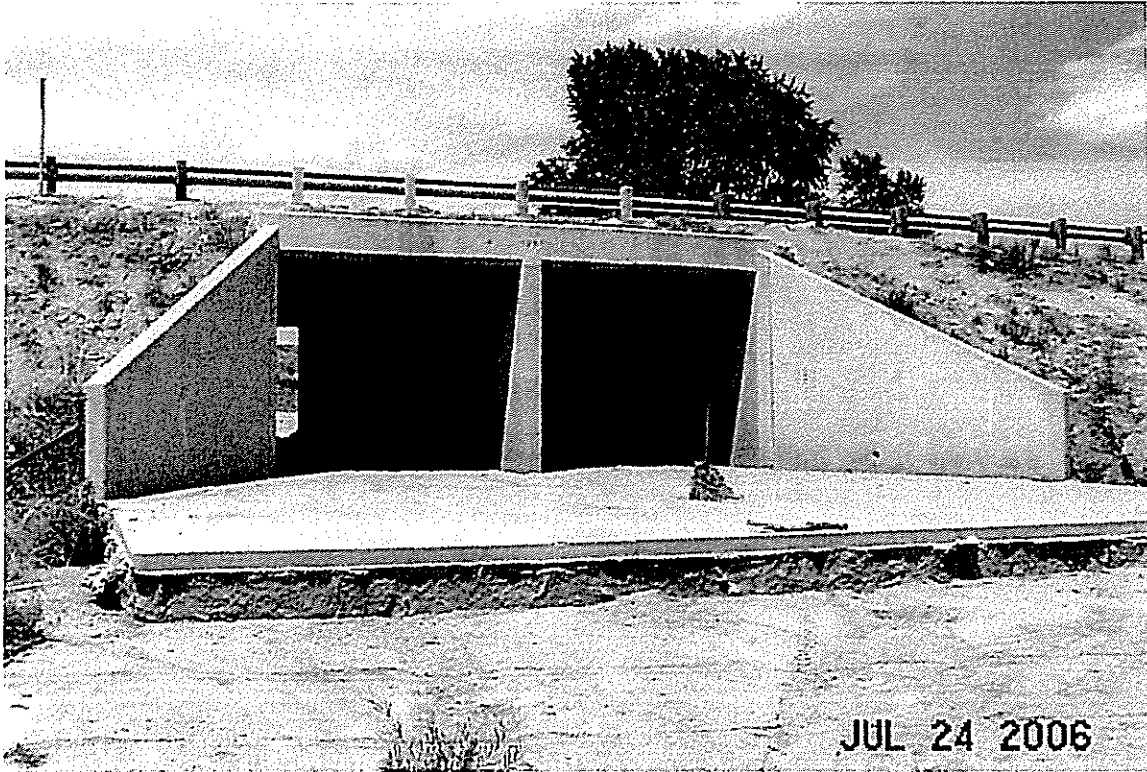
NF-17

State Hwy 94, 25'w x 10'h Concrete Bridge Inlet.

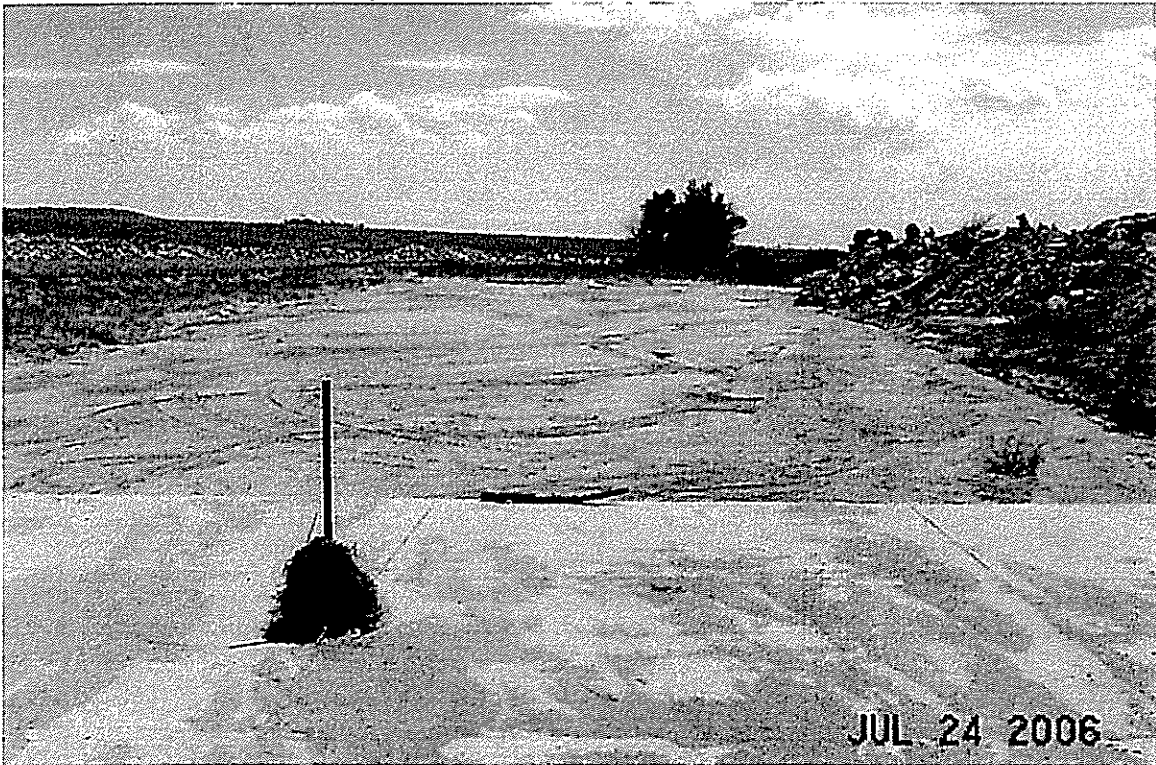
NF-17

State Hwy 94, 25'w x 10'h Concrete Bridge Outlet.

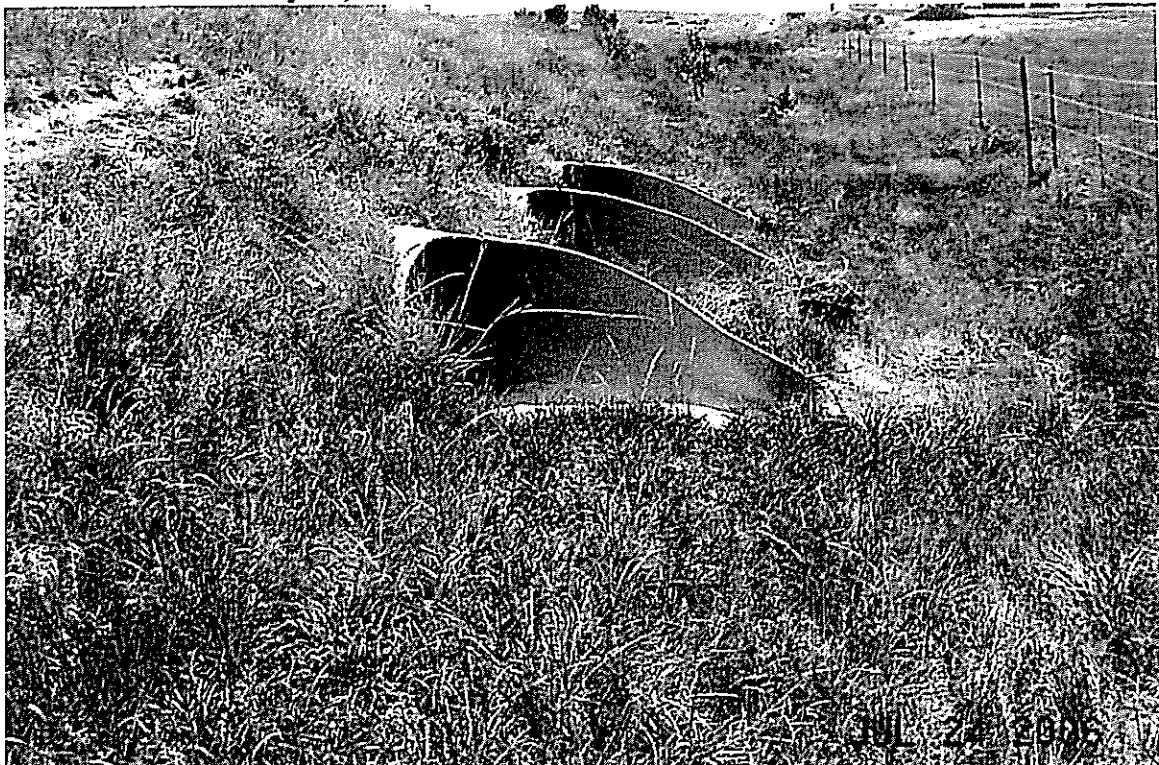
NF-18

State Hwy 94, Three 36" CMPs Inlet Channel in Fair Condition.

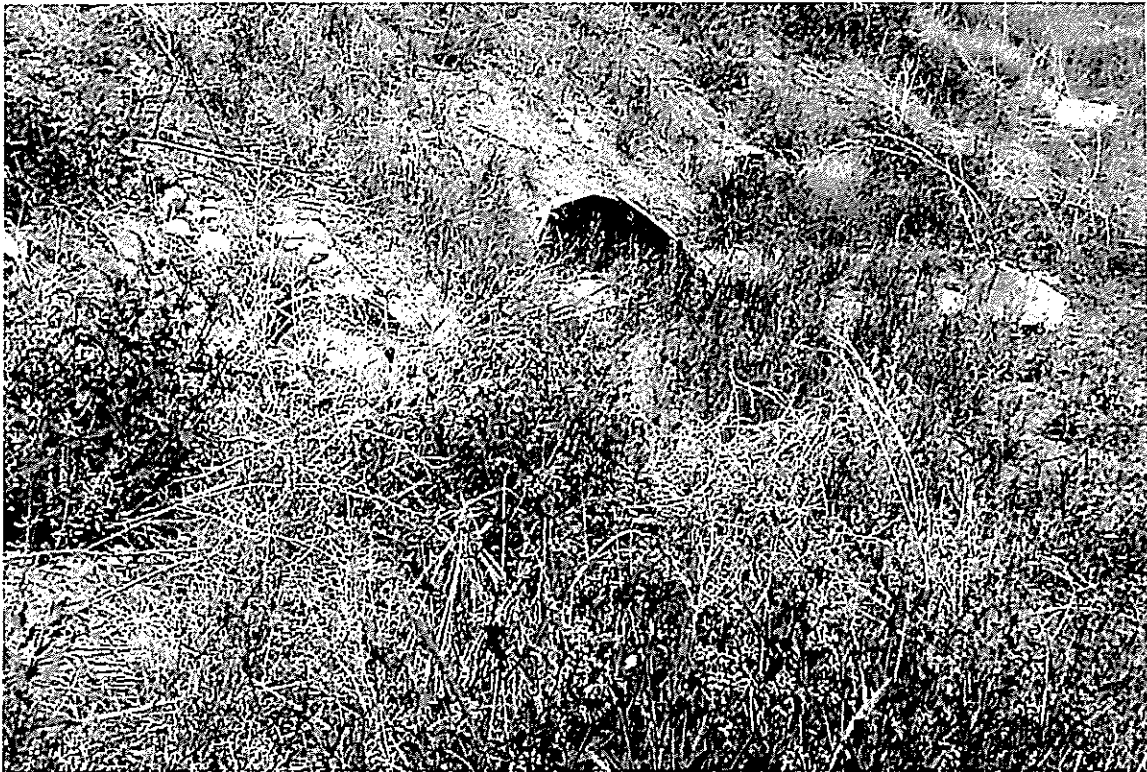
NF-18

State Hwy 94, Three 36" CMPs Inlet.

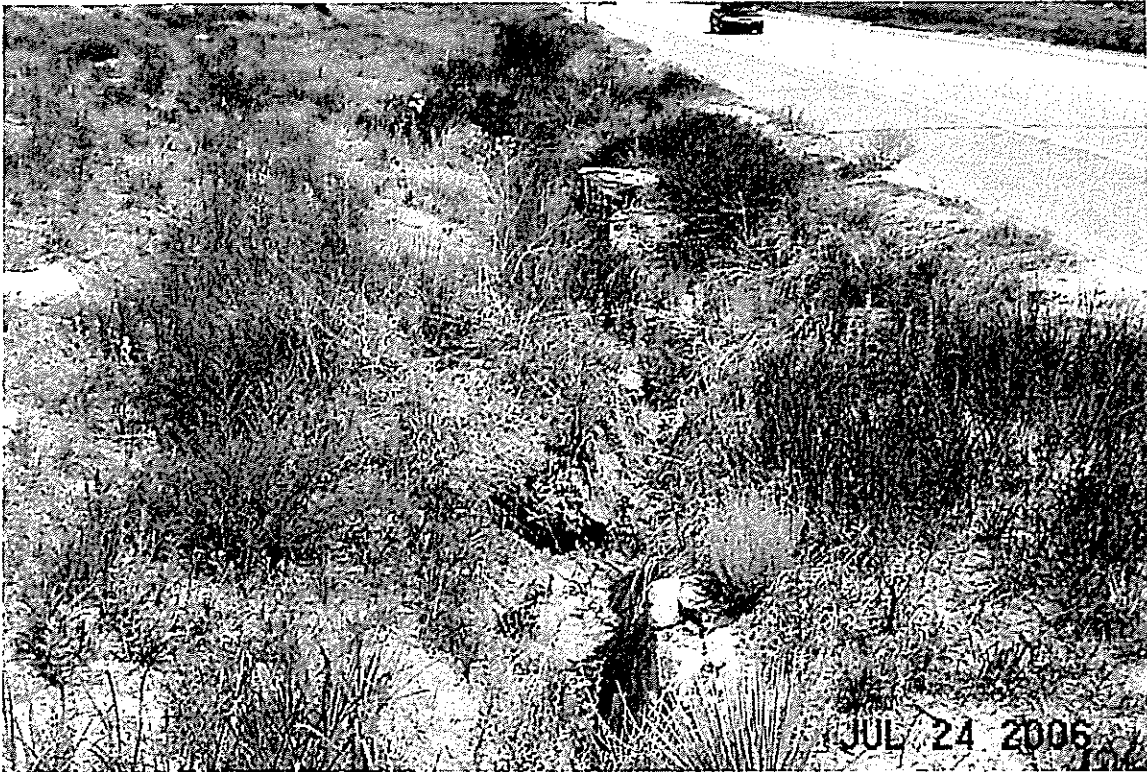
NF-18

State Hwy 94, Three 36" CMPs Outlet Channel in Fair Condition.

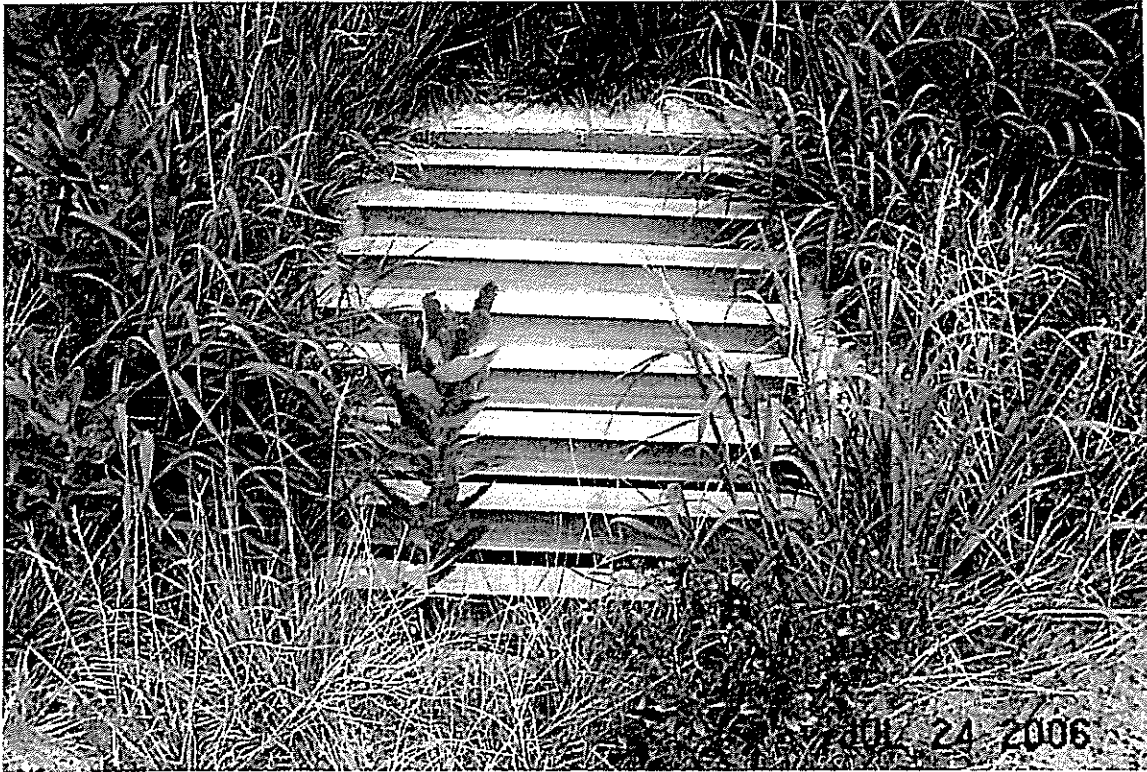
NF-19

State Hwy 94, 18" CMP Inlet.

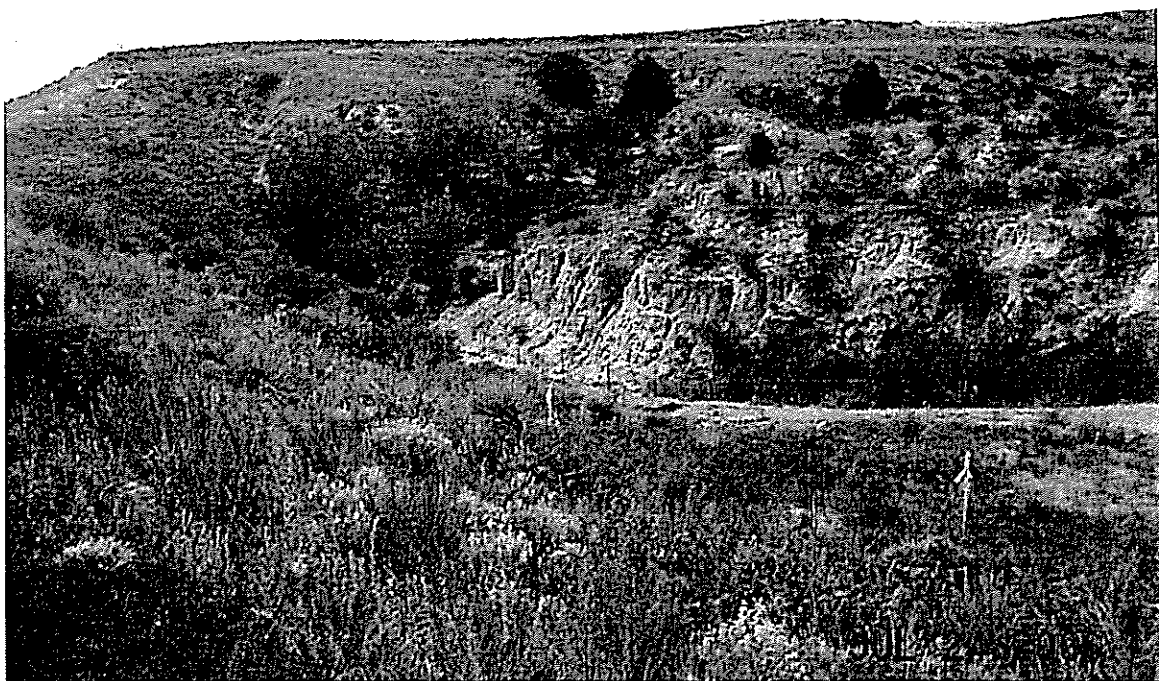
NF-19

State Hwy 94, 18" CMP Outlet Channel in Fair Condition. 18" CMP Outlet not visible from Right of Way.

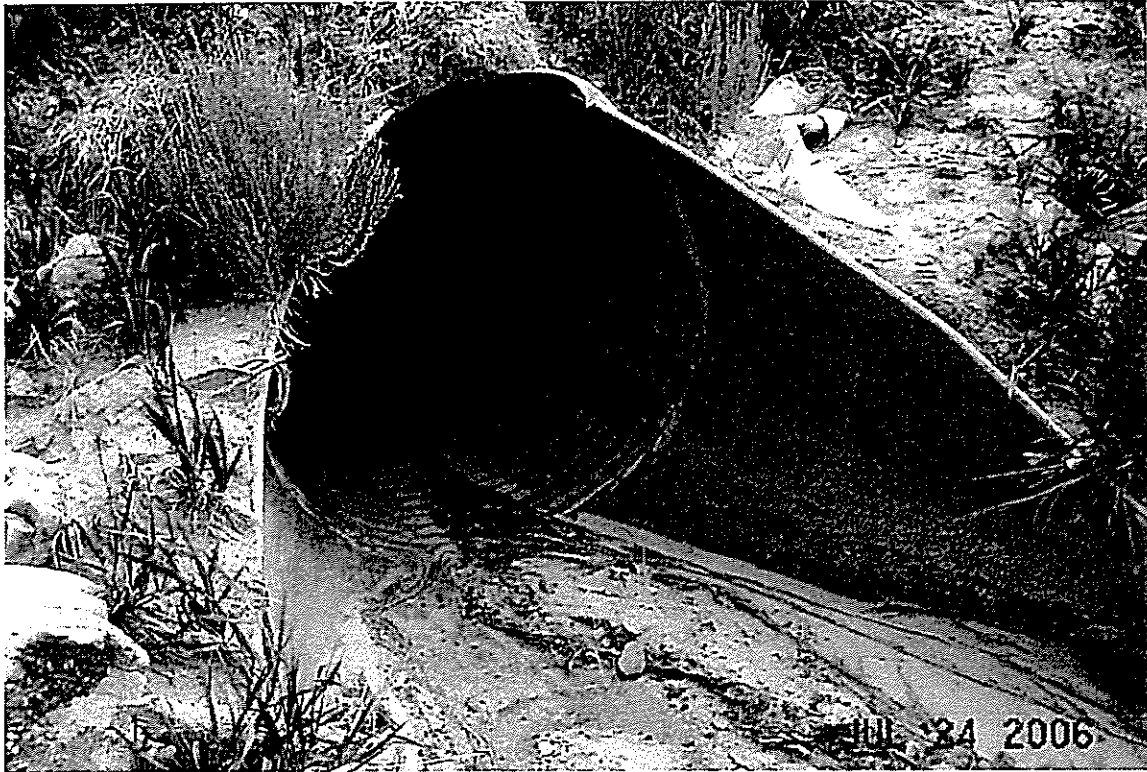
NF-20

State Hwy 94, 48" CMP Inlet Channel with some fill.

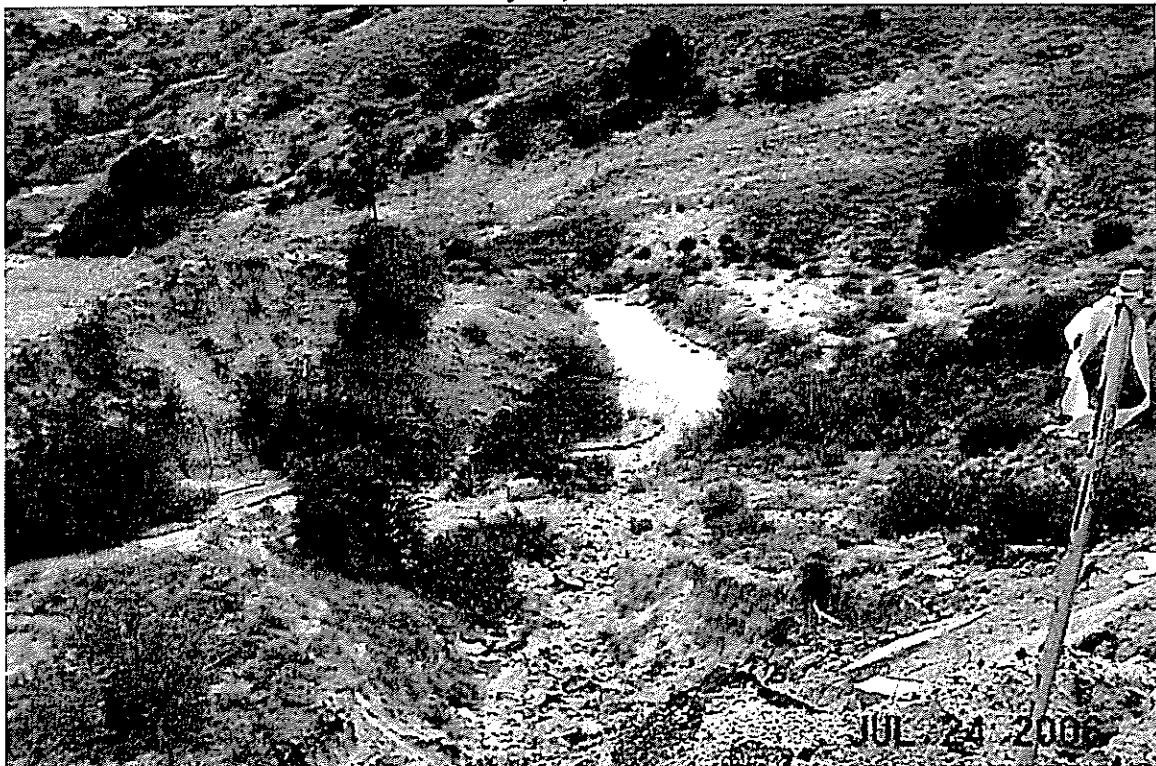
NF-20

State Hwy 94, 48" CMP Inlet.

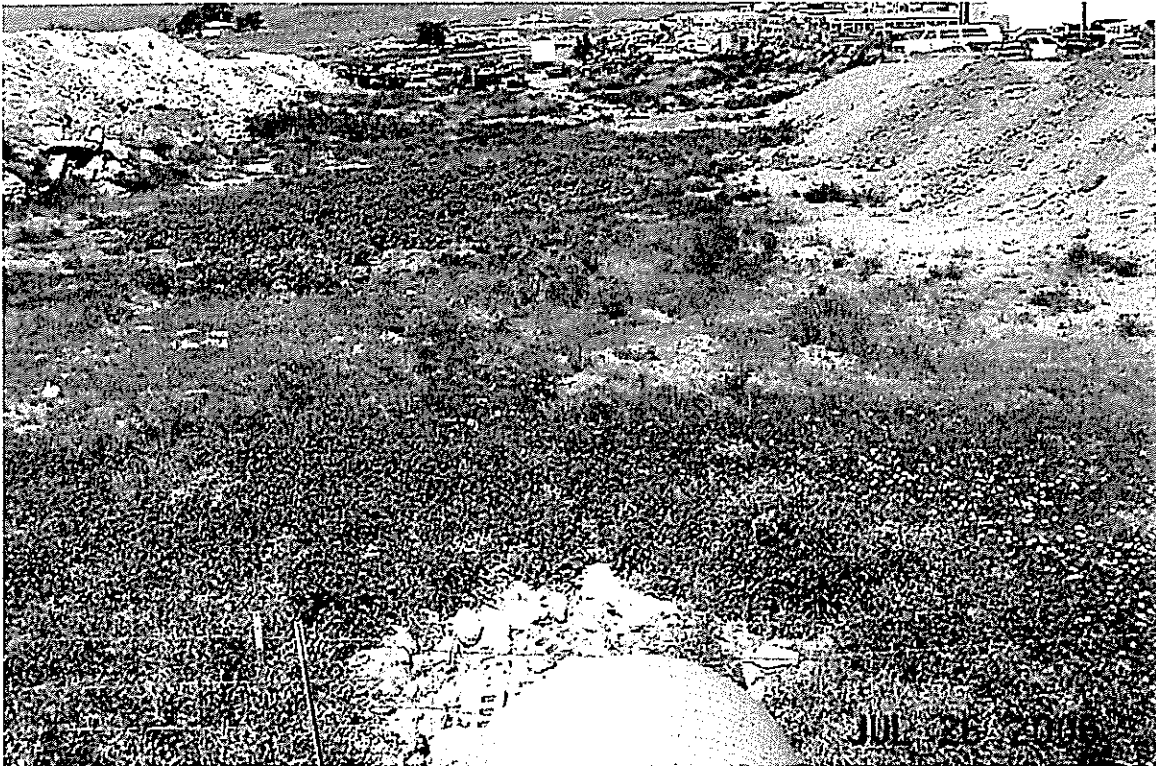
F1

Franceville Coal Mine Road, 54" CMP Outlet, rusted with holes.

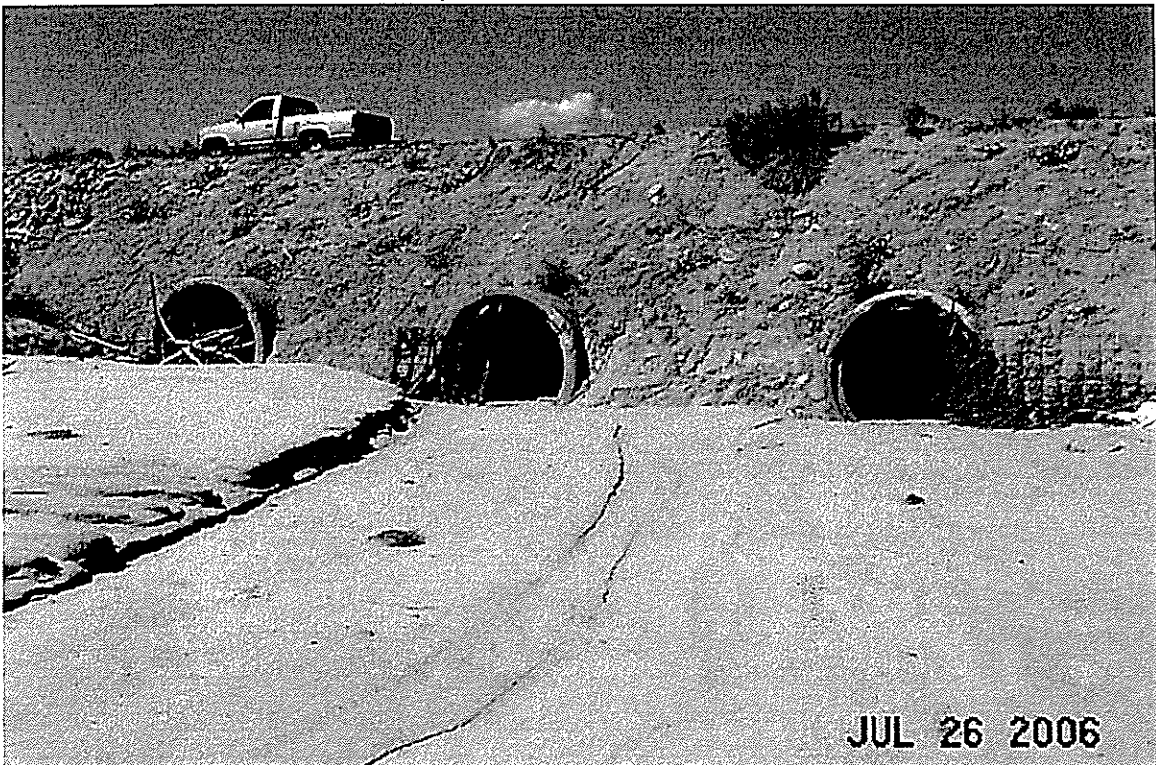
F2

Franceville Coal Mine Road, Three 60" RCPs Inlet Channel in Fair Condition.

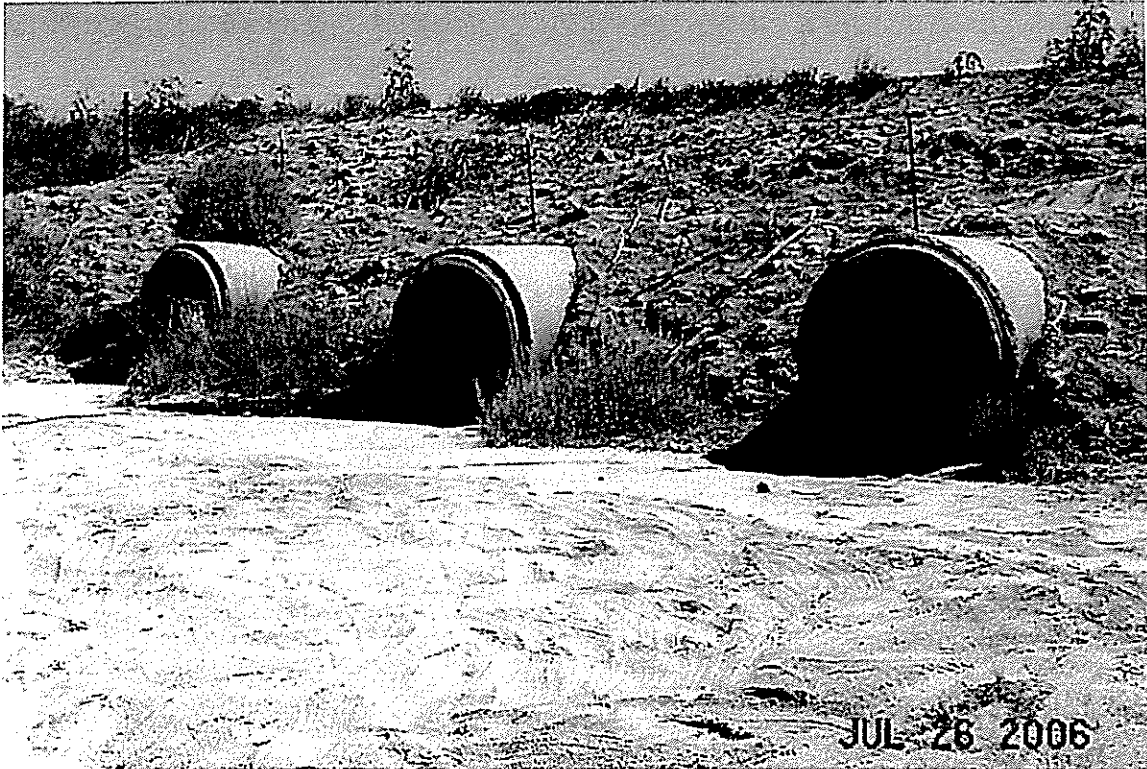
F2

Franceville Coal Mine Road, Three 60" RCPs Inlet.

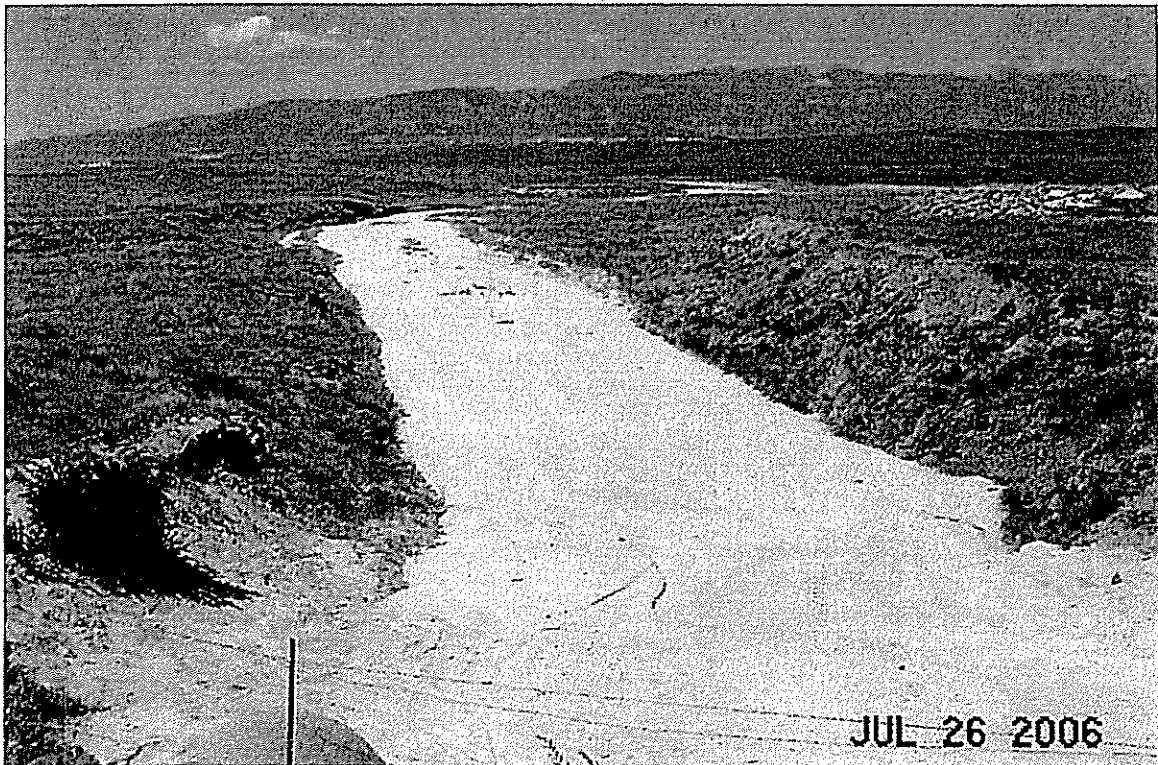
F2

Franceville Coal Mine Road, Three 60" RCPs Outlet.
