**APPENDIX D**  
**EXISTING FACILITIES**  
**Facility Summary**  
**Photographs**

Table 1 Existing Major Drainageway Structure Inventory

JIMMY CAMP CREEK DBPS  
OLD PUEBLO ROAD BRIDGE  
JIMMY CAMP CREEK  
EL PASO COUNTY, COLORADO  
BRIDGE PROFILE

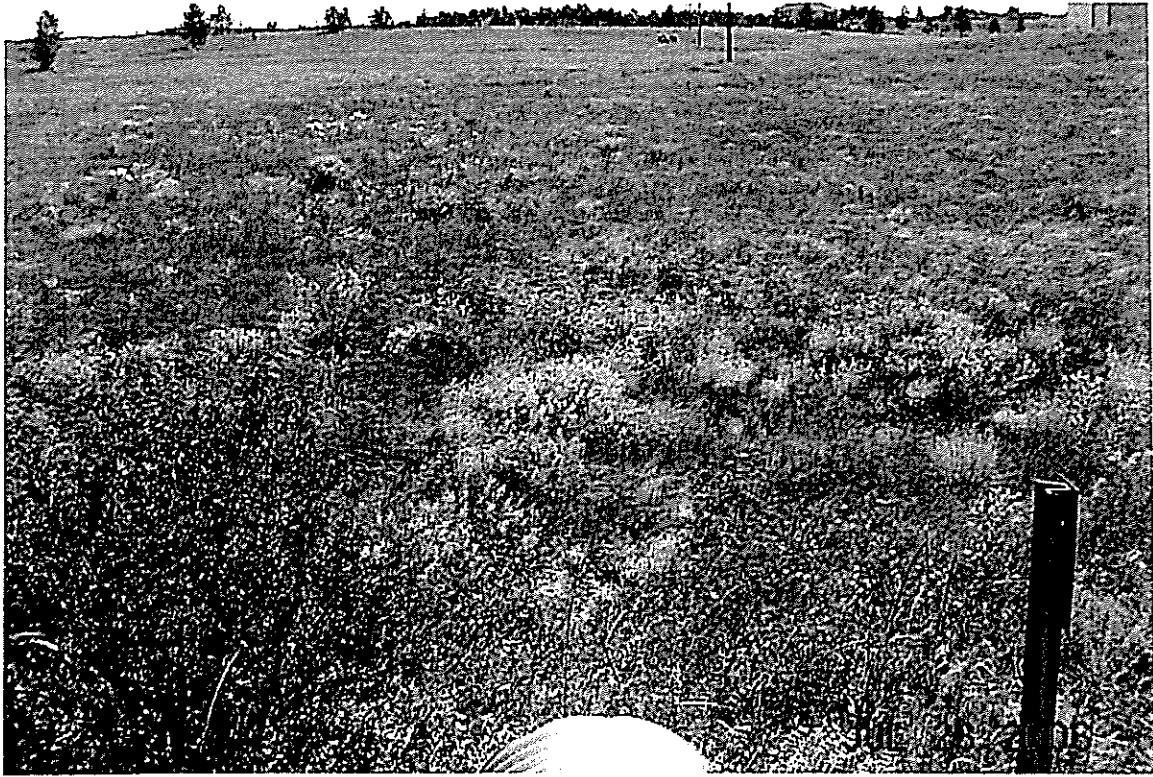
F2

Franceville Coal Mine Road, Three 60" RCPs Outlet Channel in Fair Condition.

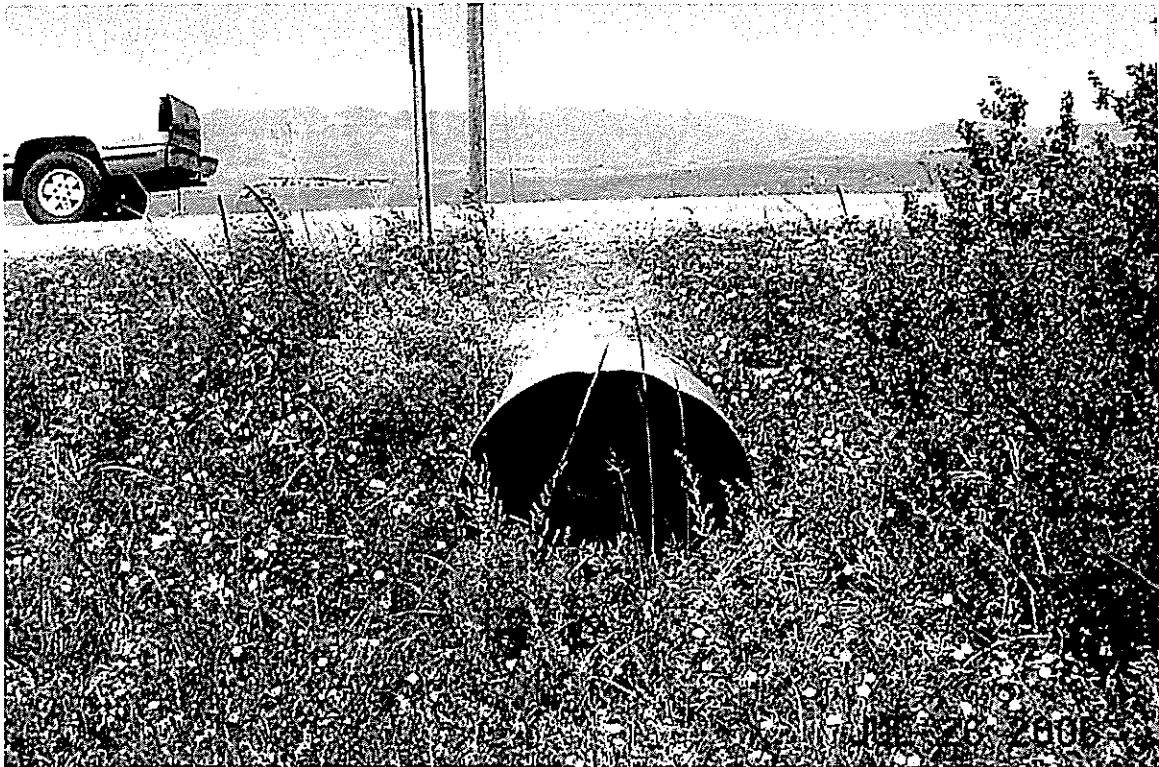
F3

Franceville Coal Mine Road, 30" CMP Inlet Channel in Good Condition.

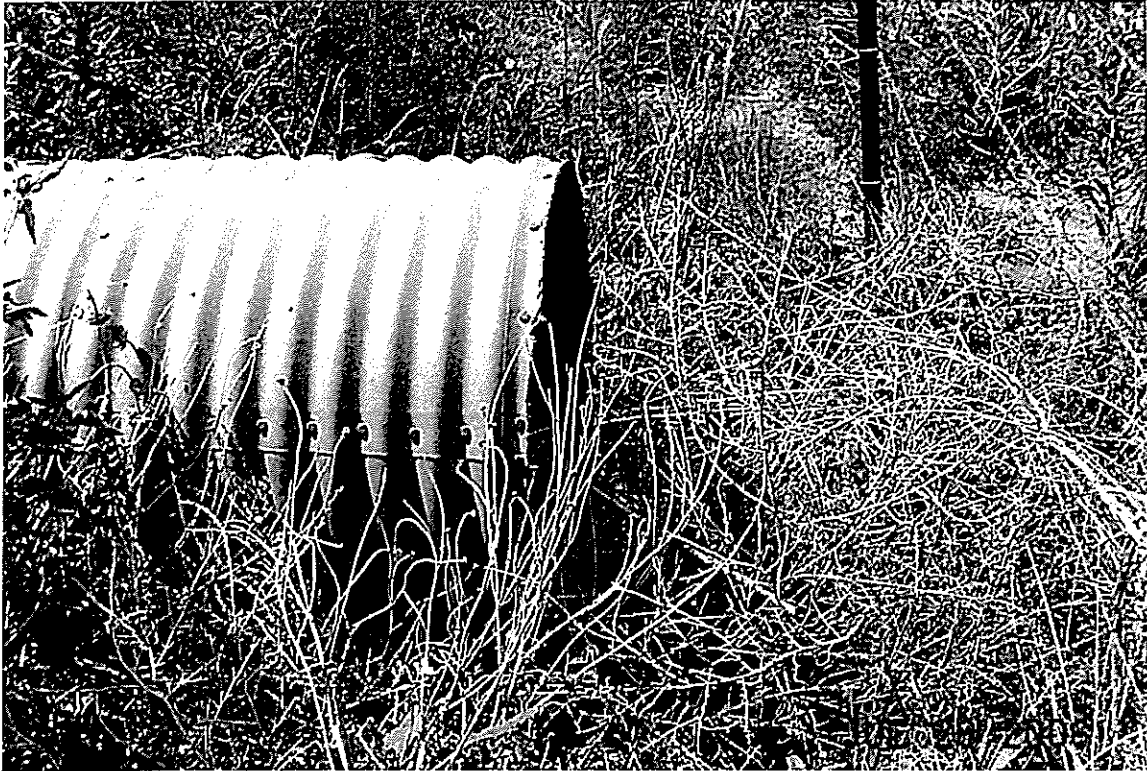
F3

Franceville Coal Mine Road, 30" CMP Inlet.

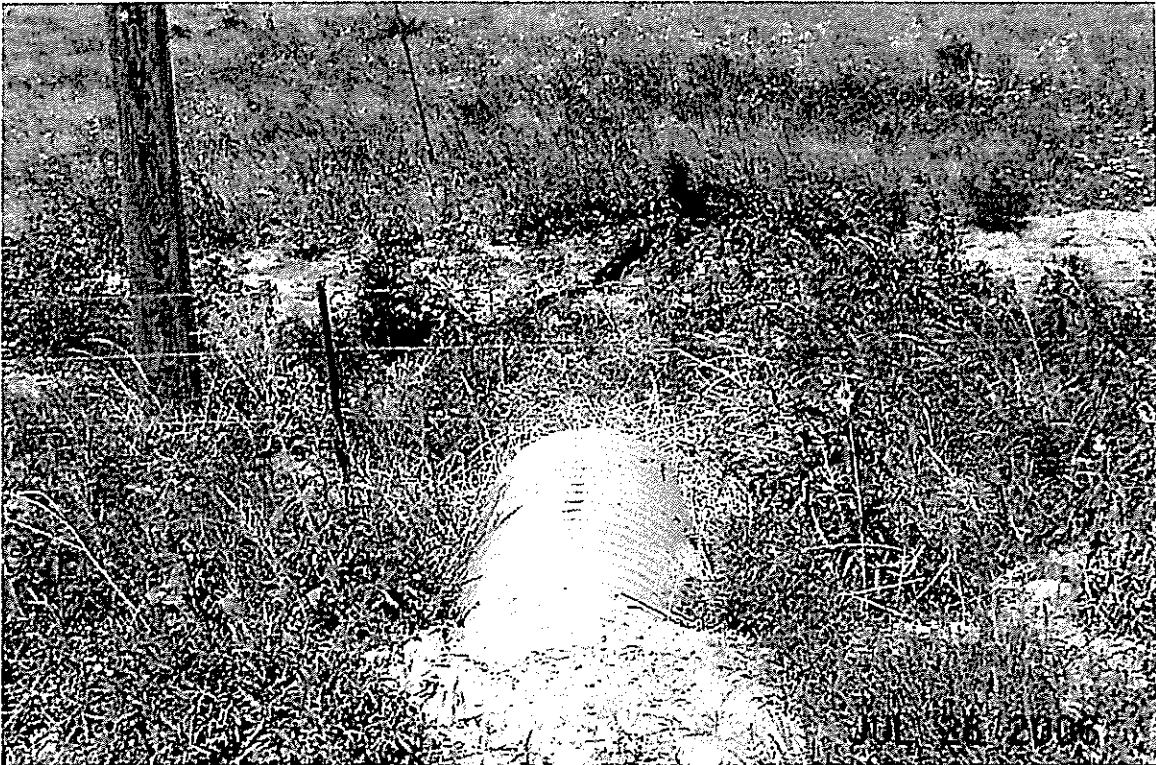
F3

Franceville Coal Mine Road, 30" CMP Outlet.

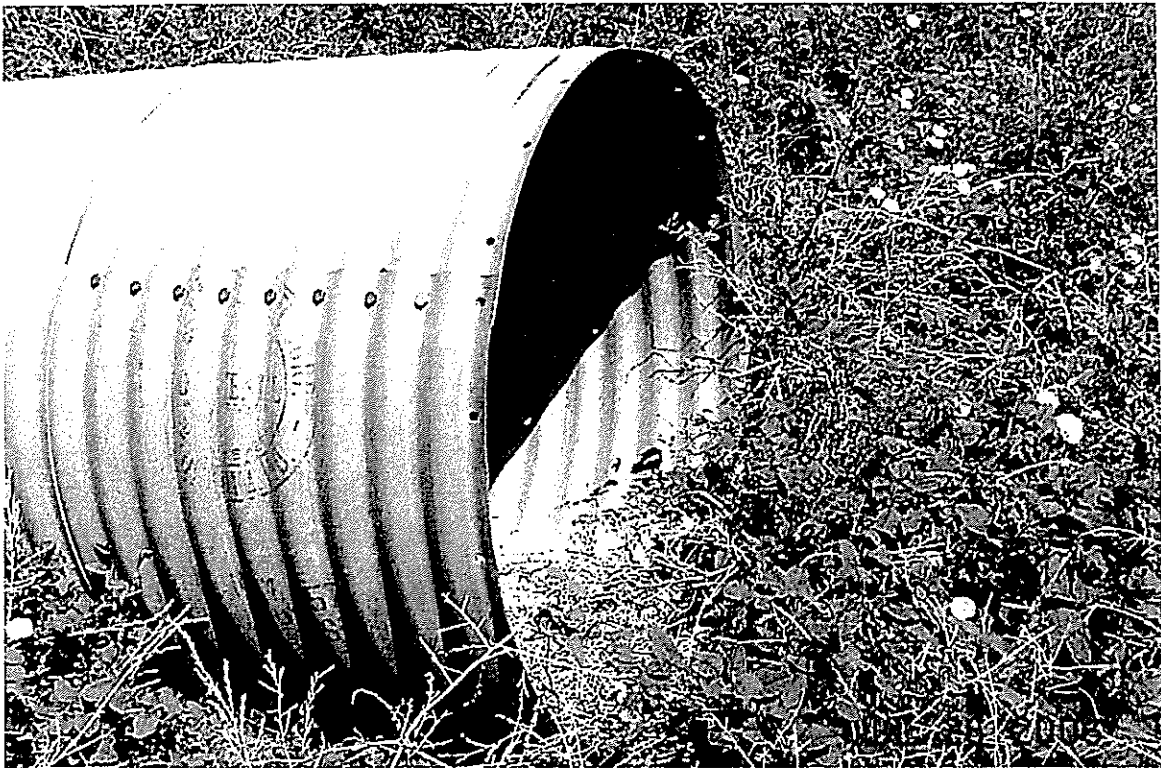
F4

Franceville Coal Mine Road, 36" CMP Inlet Channel in Good Condition.

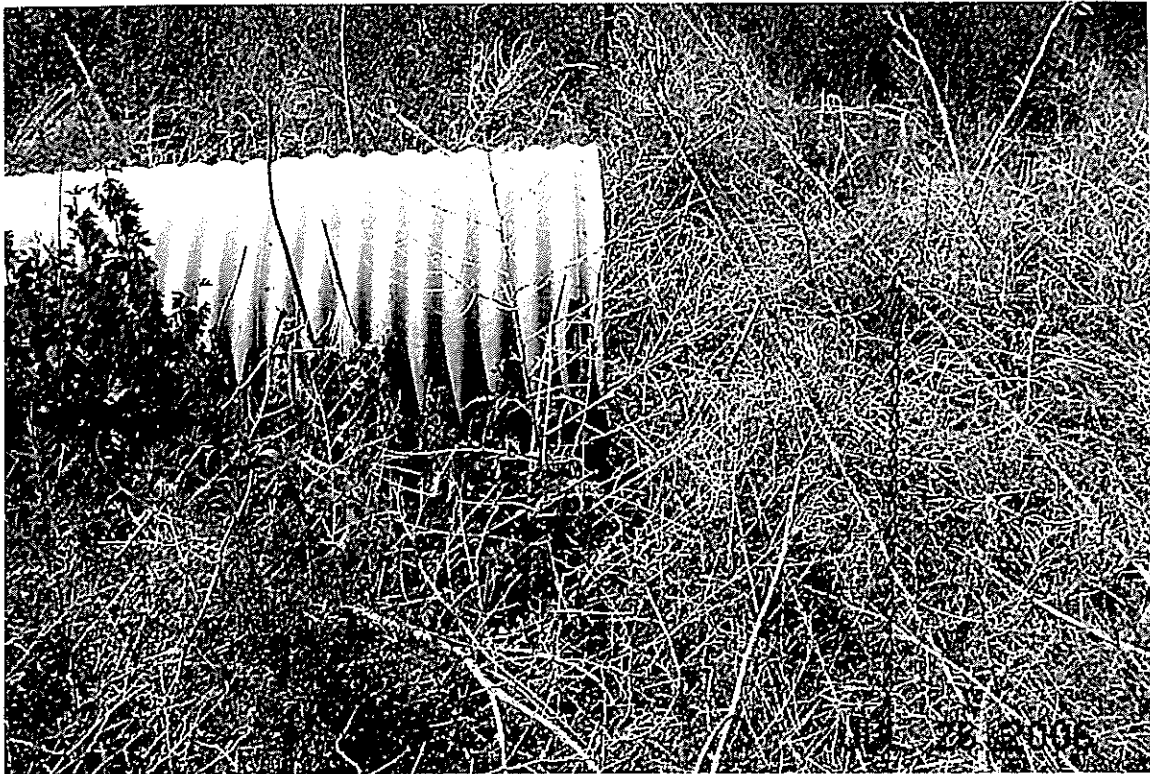
F4

Franceville Coal Mine Road, 36" CMP Inlet.

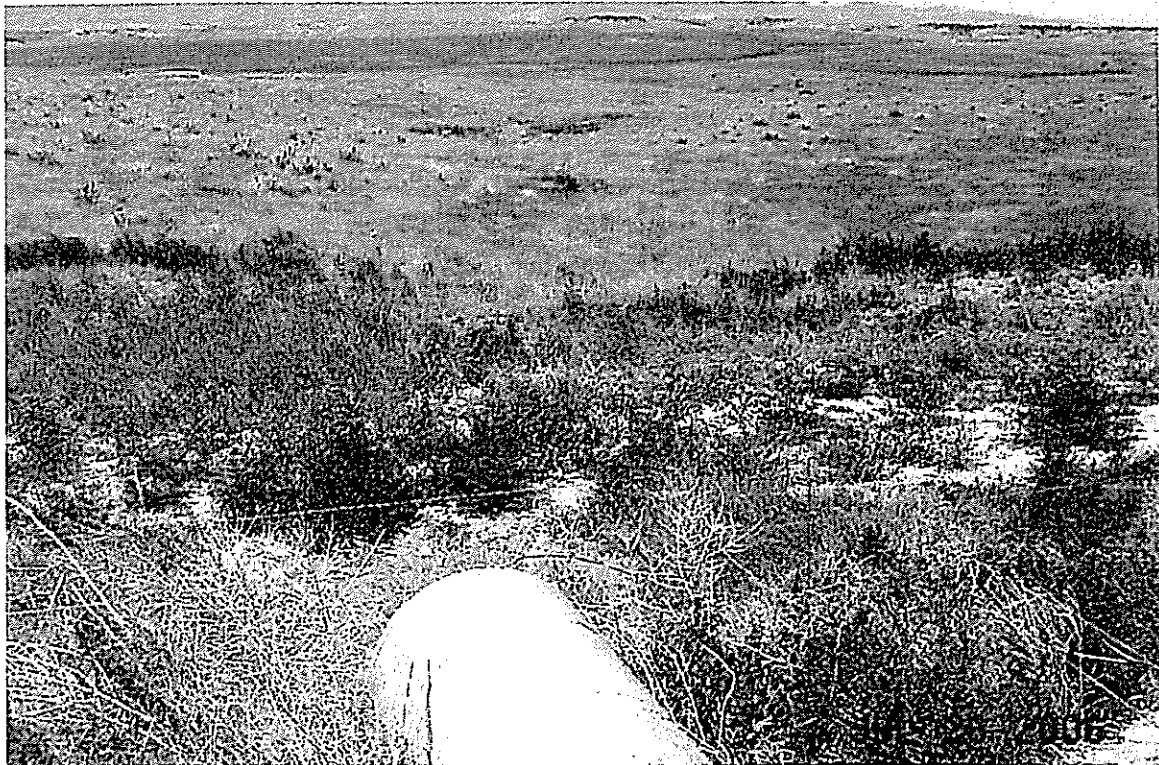
F4

Franceville Coal Mine Road, 36" CMP Outlet.

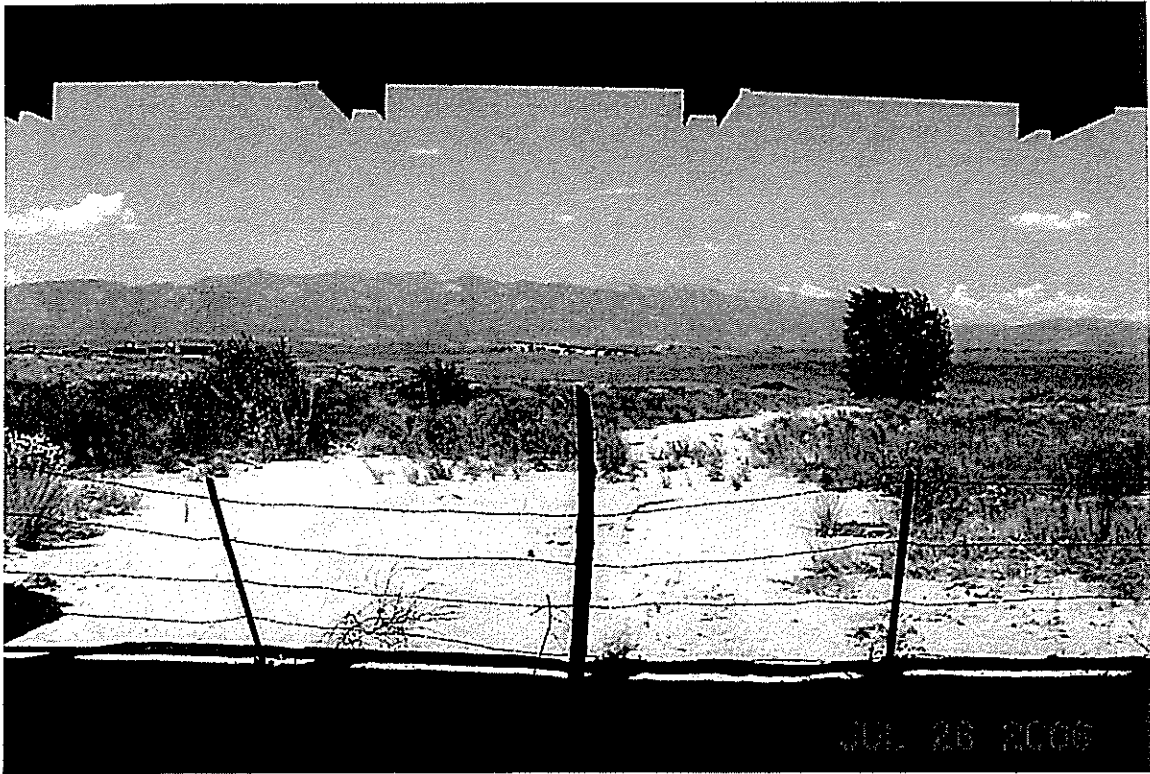
F5

Franceville Coal Mine Road, 37'w x 8'h Concrete and Steel Bridge Inlet.

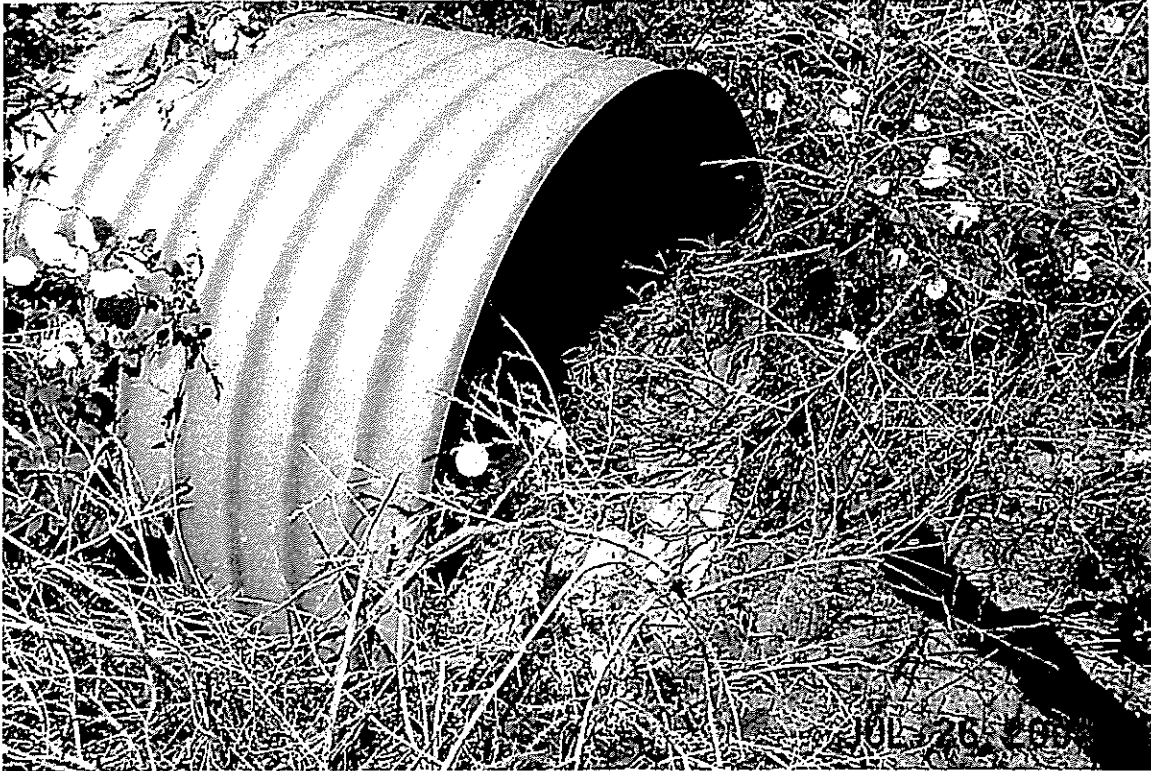
F6

Franceville Coal Mine Road, 30" CMP Inlet Channel in Good Condition.

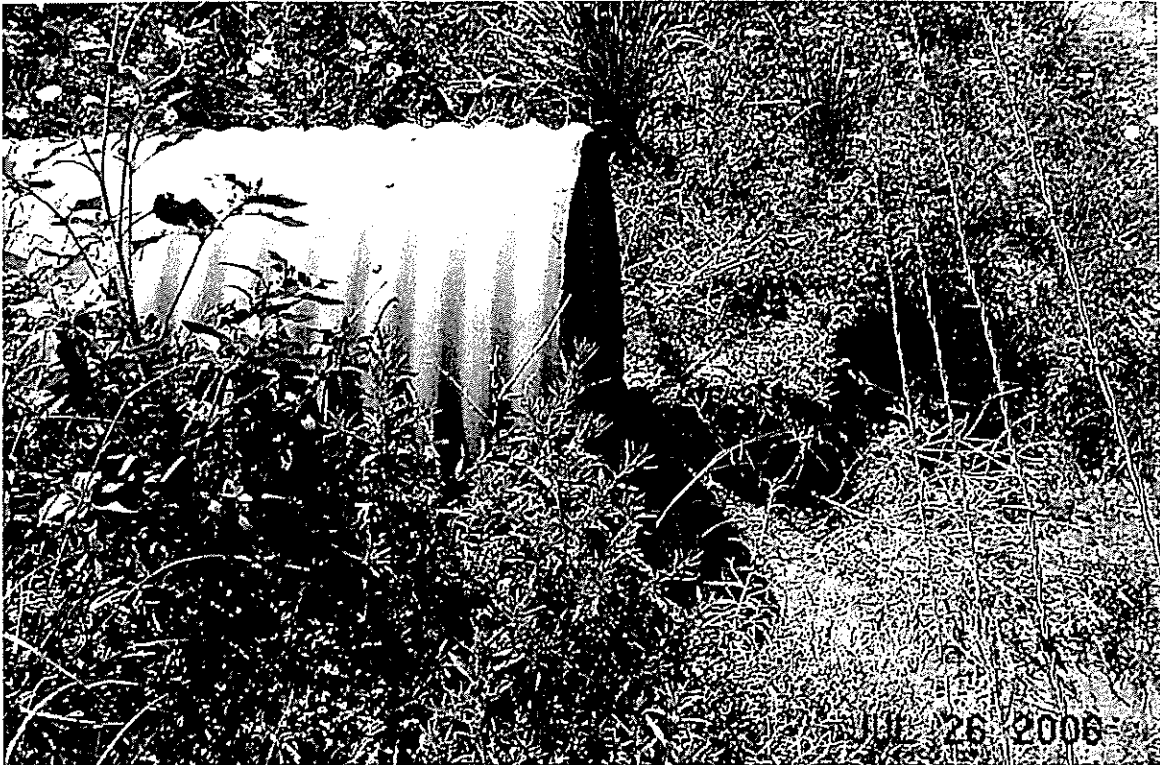
F6

Franceville Coal Mine Road, 30" CMP Inlet.

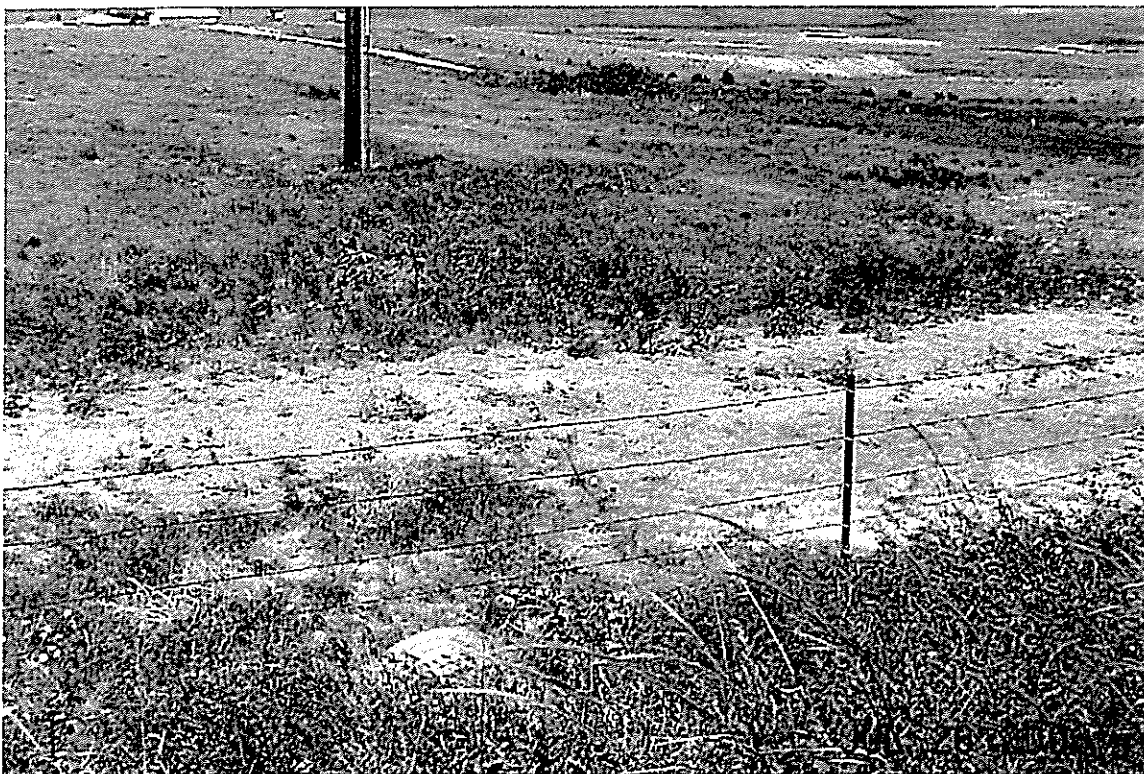
F6

Franceville Coal Mine Road, 30" CMP Outlet.

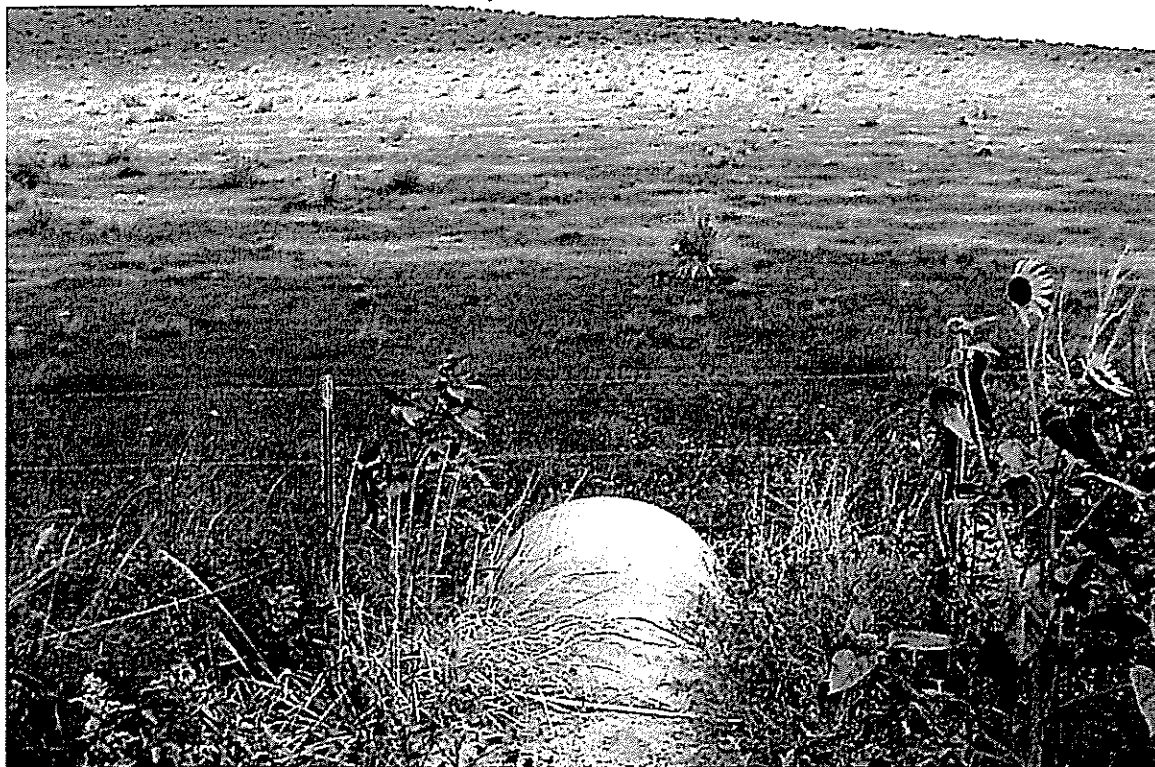
F6

Franceville Coal Mine Road, 30" CMP Inlet Channel in Fair Condition.

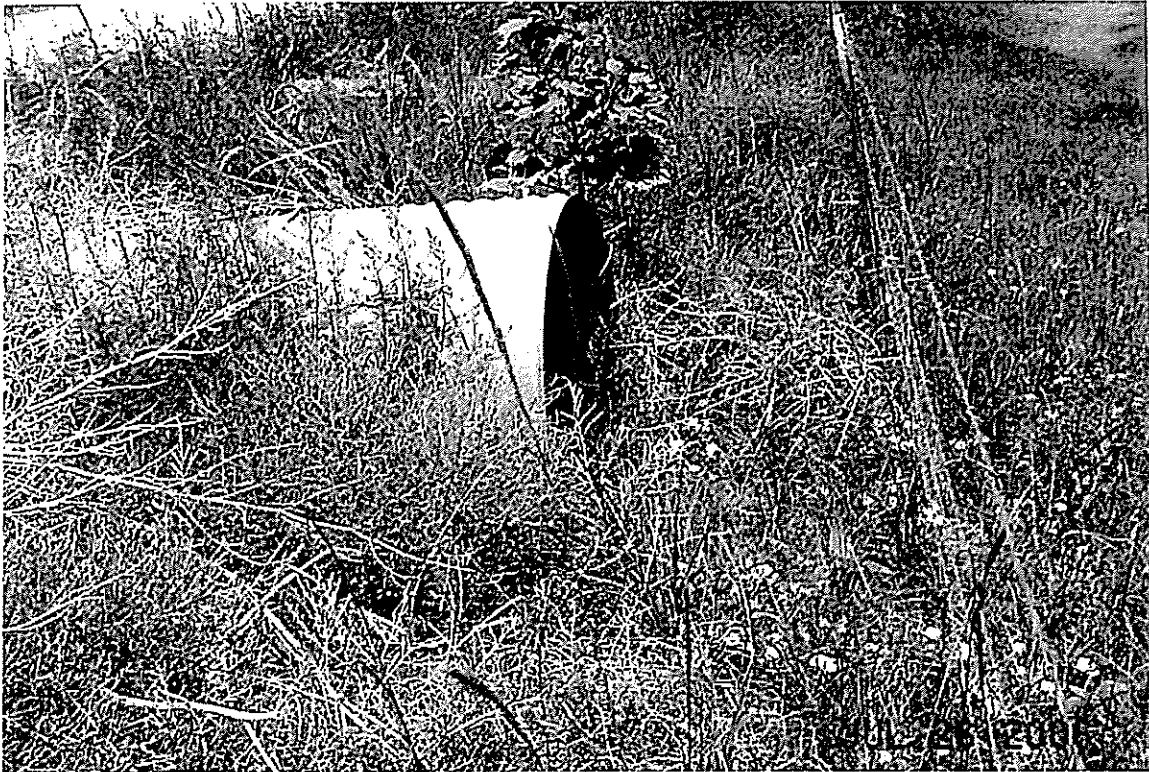
F7

Franceville Coal Mine Road, 36" CMP Inlet Channel in Good to Fair Condition.

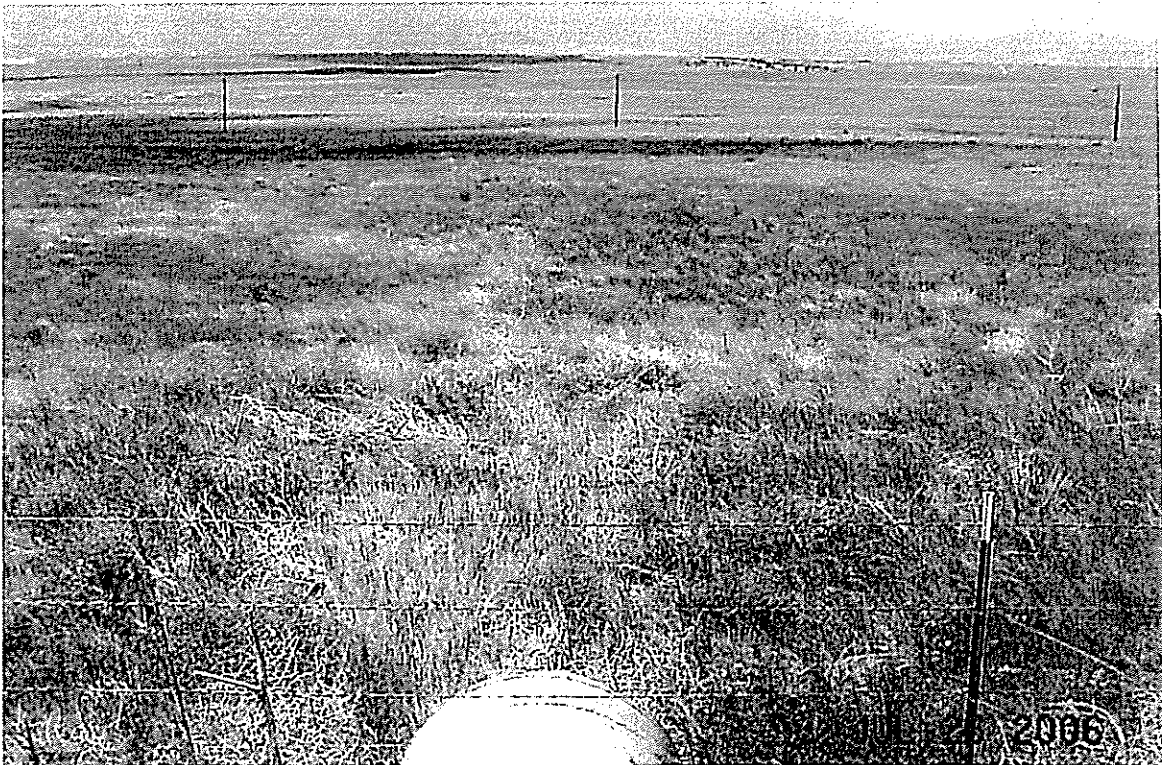
F7

Franceville Coal Mine Road, 36" CMP Inlet.

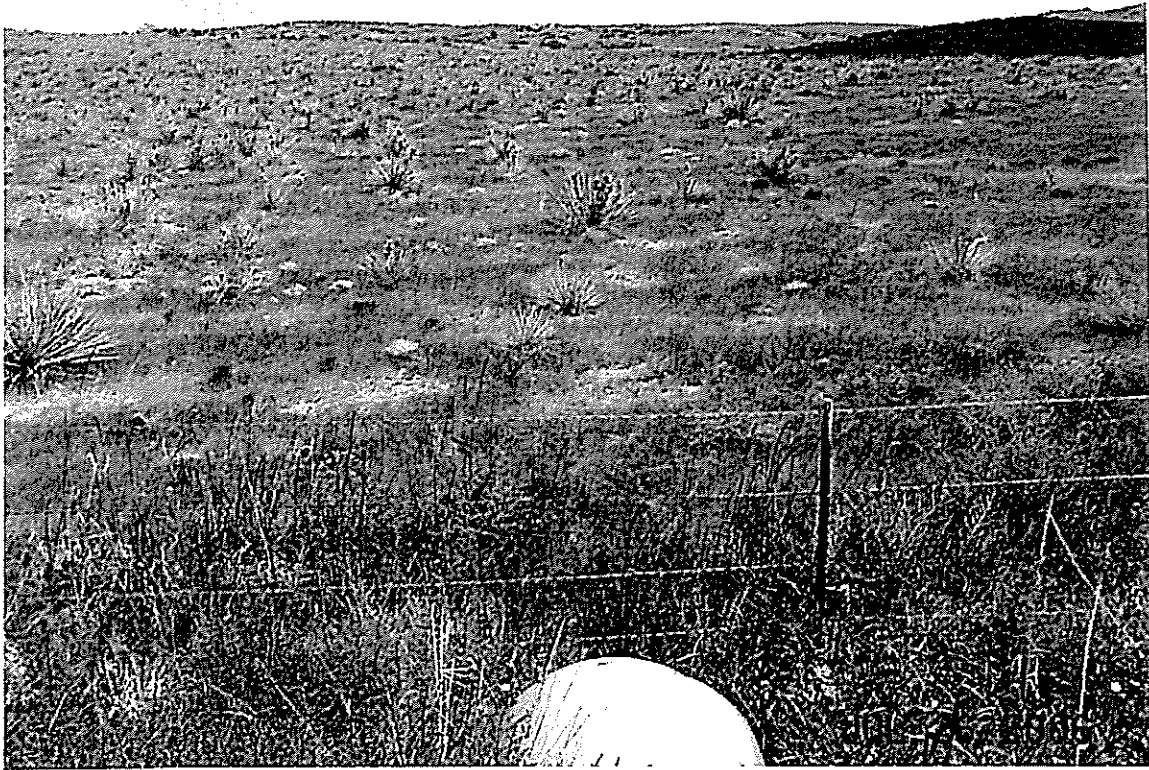
F7

Franceville Coal Mine Road, 36" CMP Outlet Channel in Good to Fair Condition.

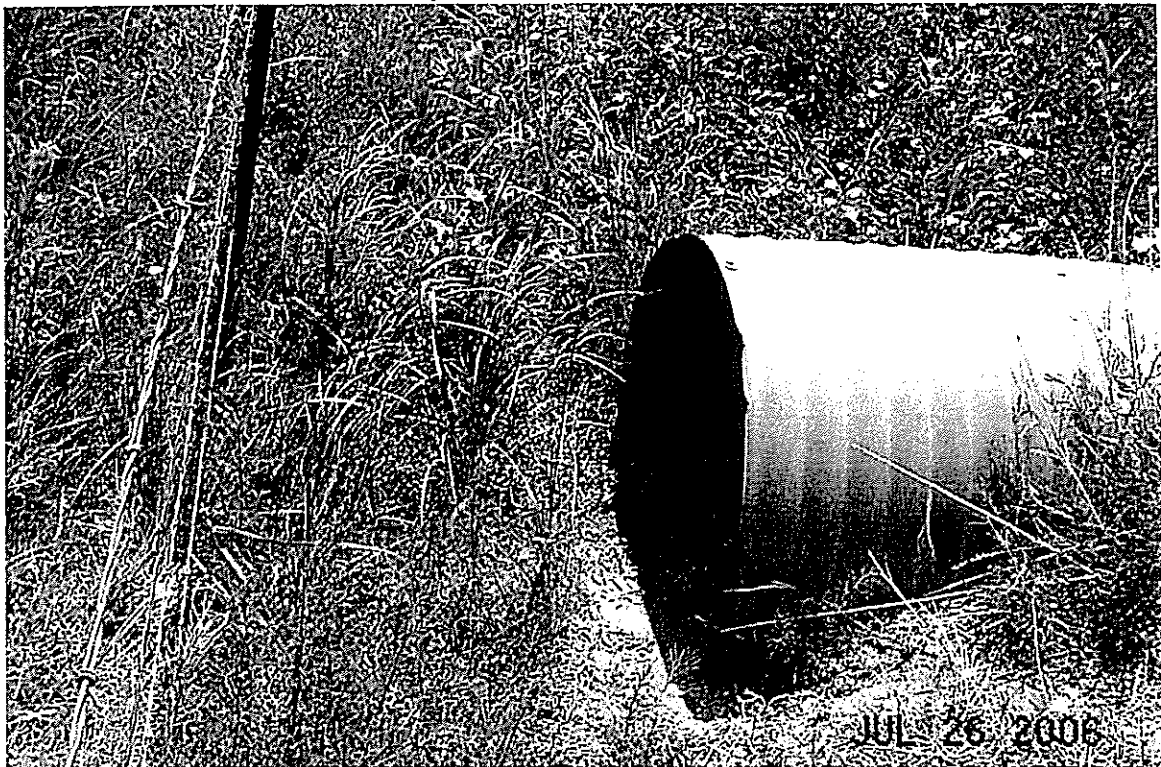
F8

Franceville Coal Mine Road, 30" CMP Inlet Channel in Good to Fair Condition.

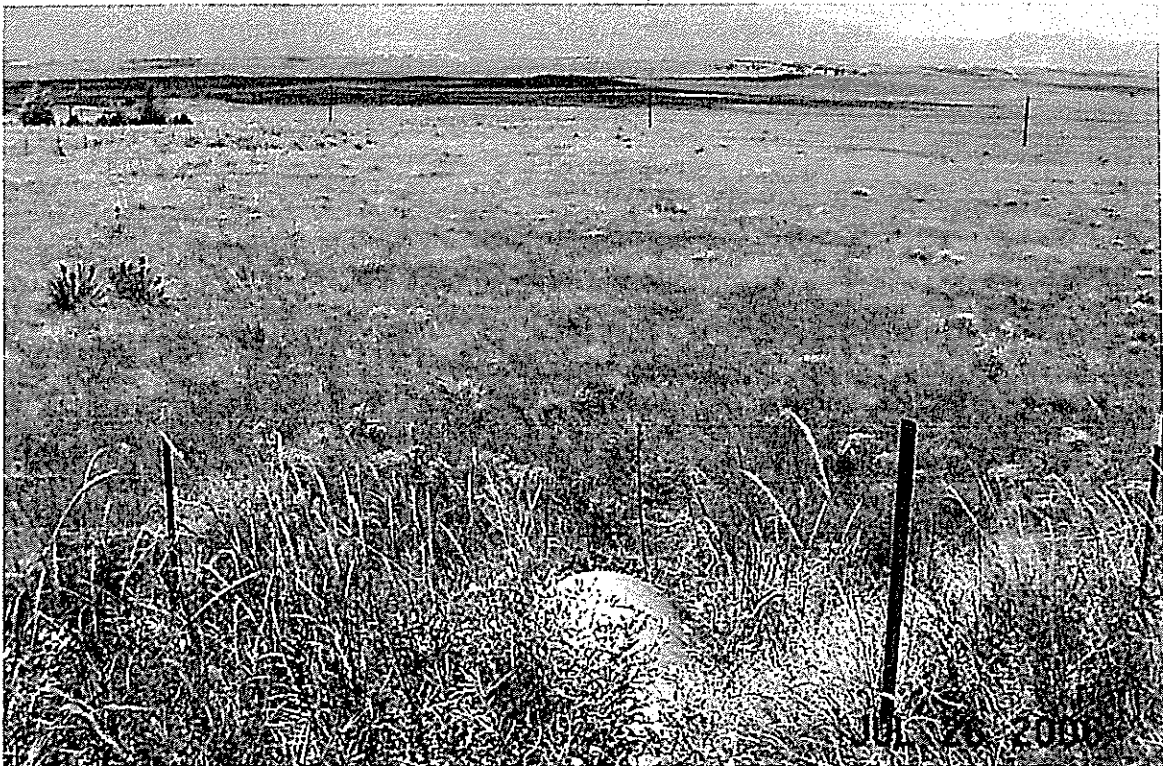
F8

Franceville Coal Mine Road, 30" CMP Outlet.

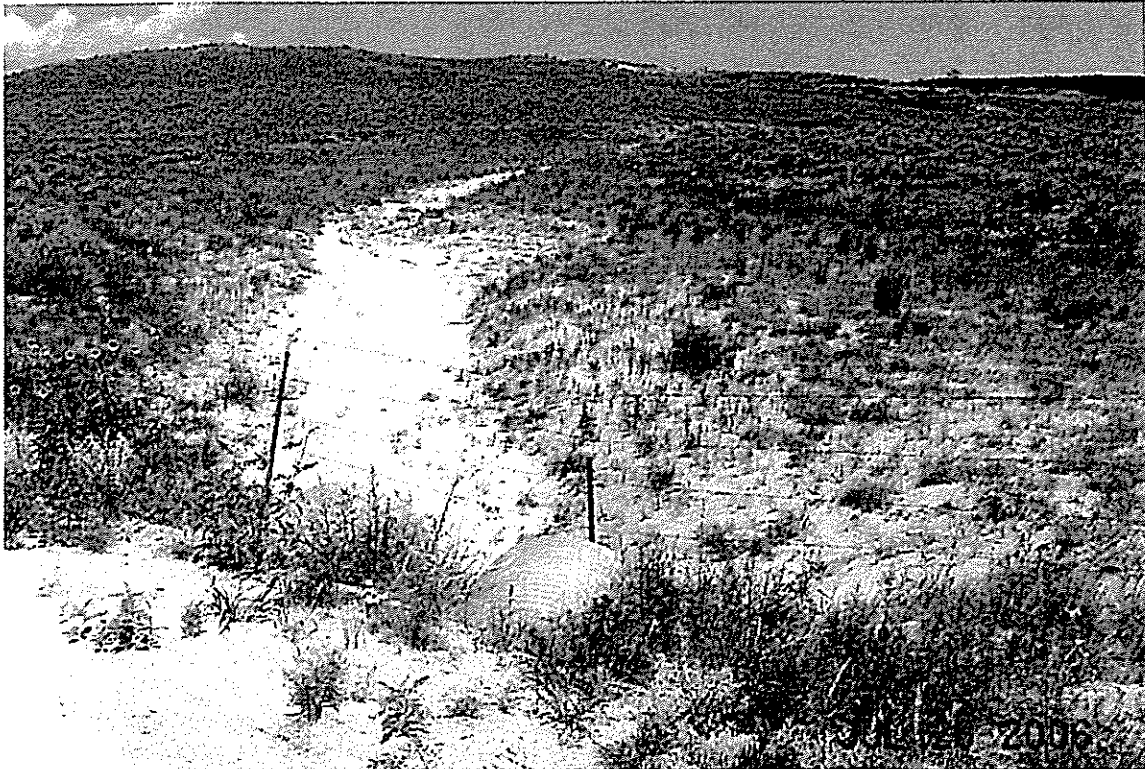
F8

Franceville Coal Mine Road, 30" CMP Outlet Channel in Good to Fair Condition.

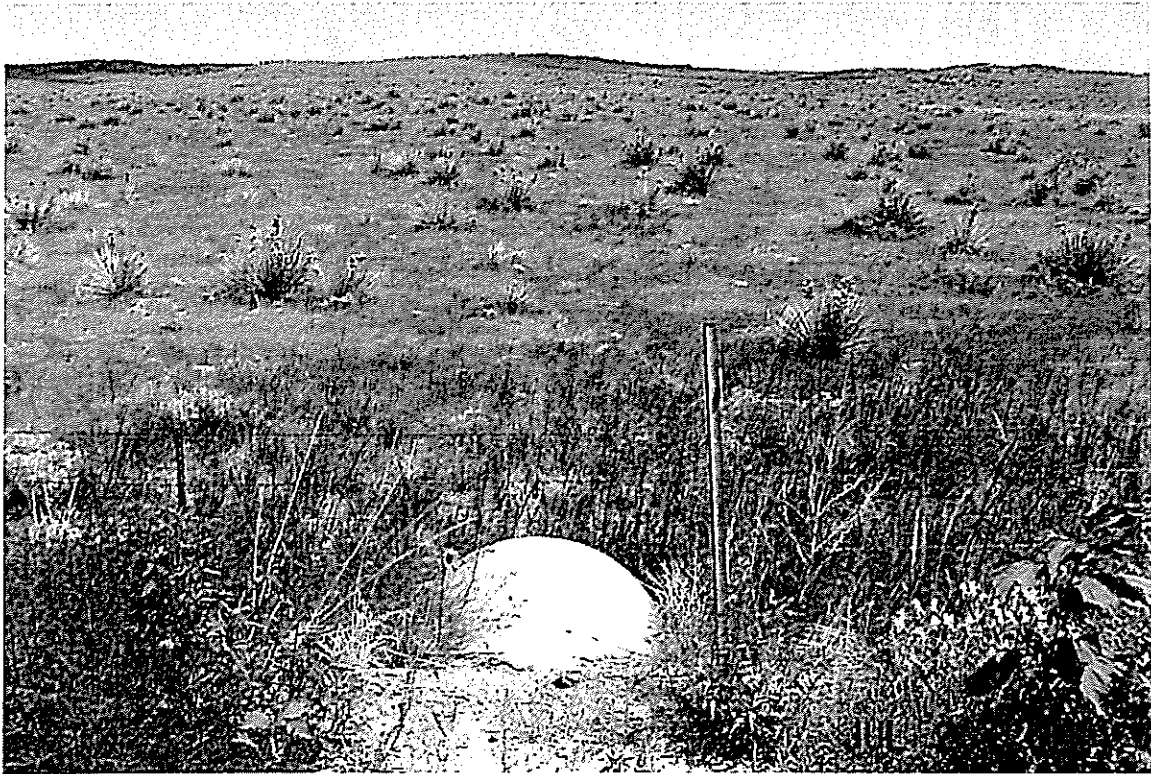
Franceville Coal Mine Road, Two 42" CMPs Outlet Channel in Fair Condition.

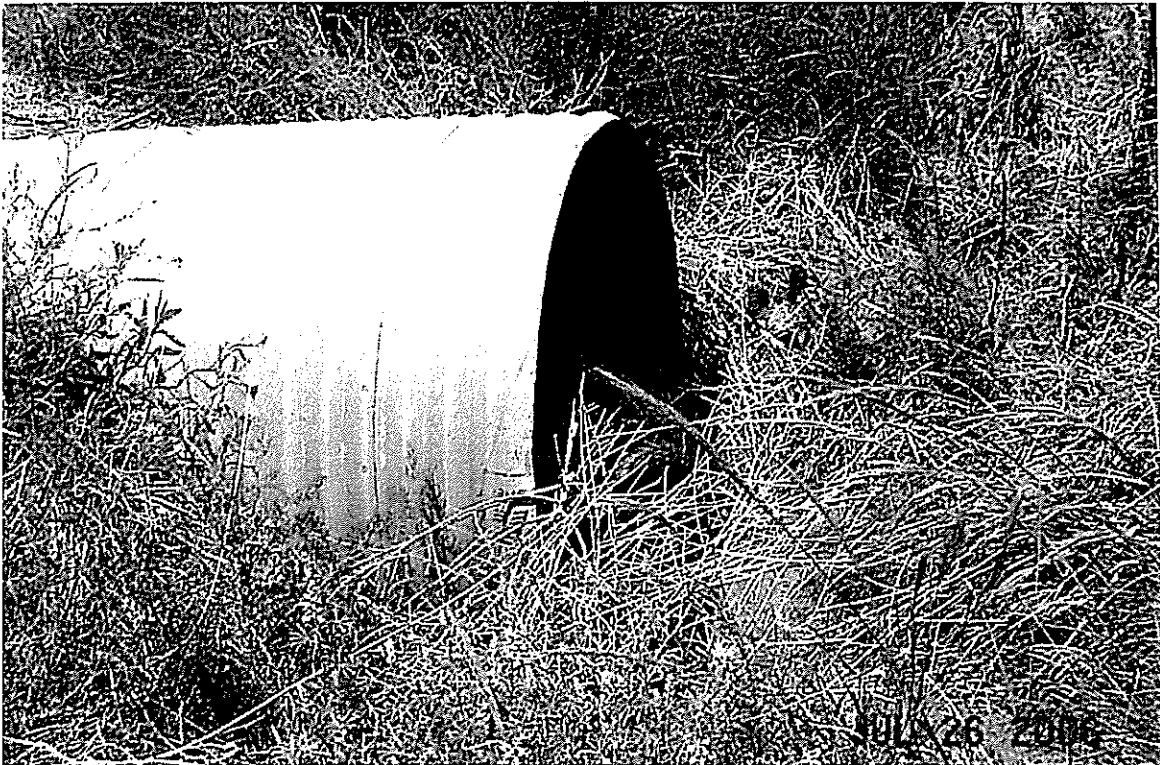
F10

Franceville Coal Mine Road, 42" CMP Inlet Channel in Good to Fair Condition.

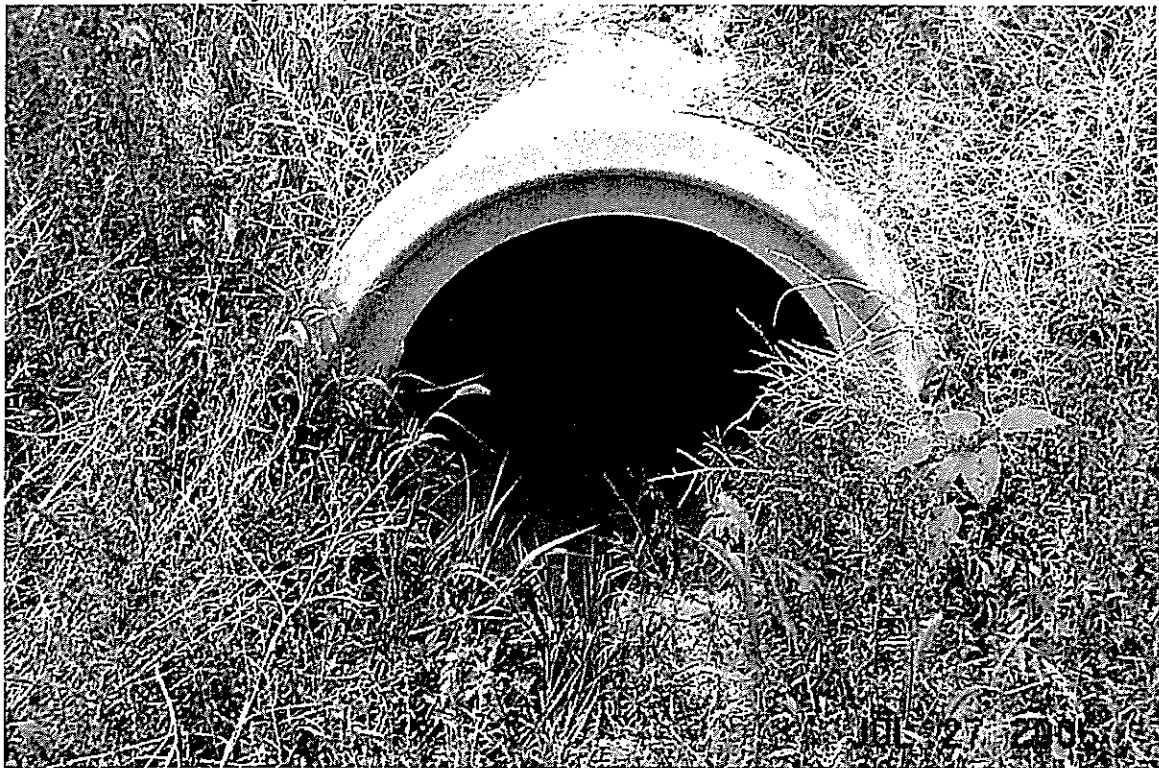
B1

Bradley Road, 36" RCP Inlet Channel in Good to Fair Condition.

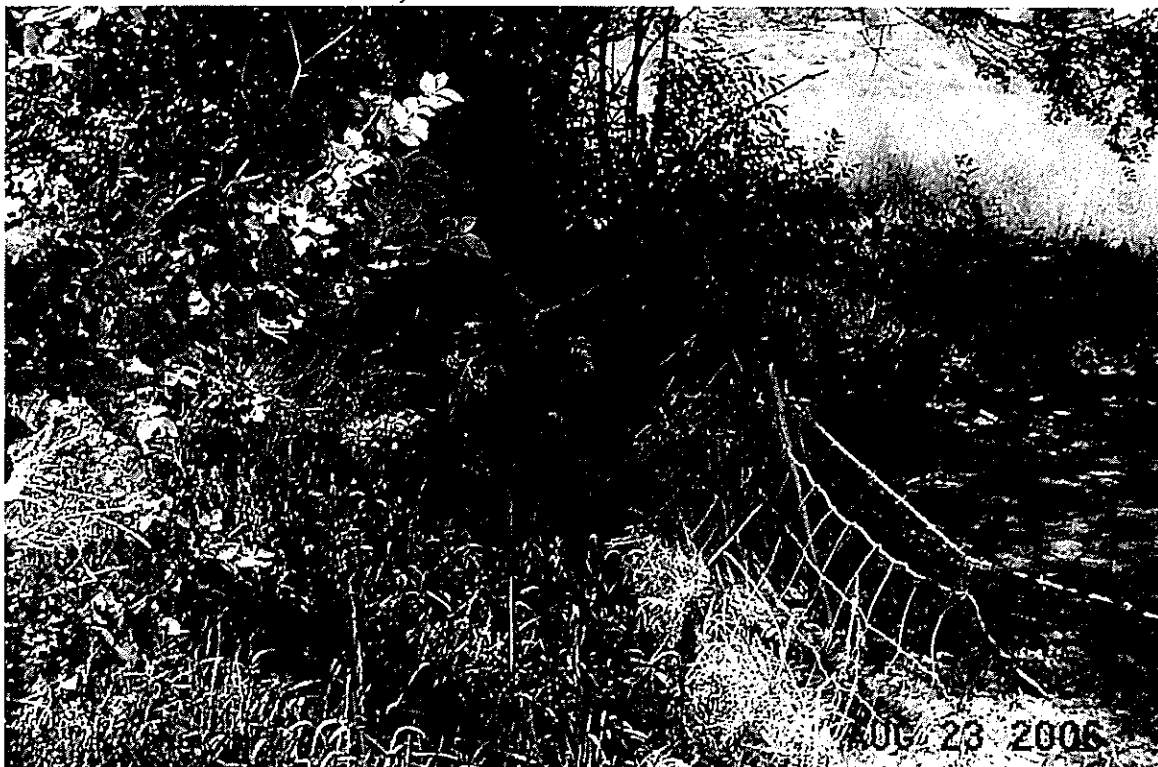
CS2

C & S Road, Two 34" w x 24" h CMPs inlet channel.

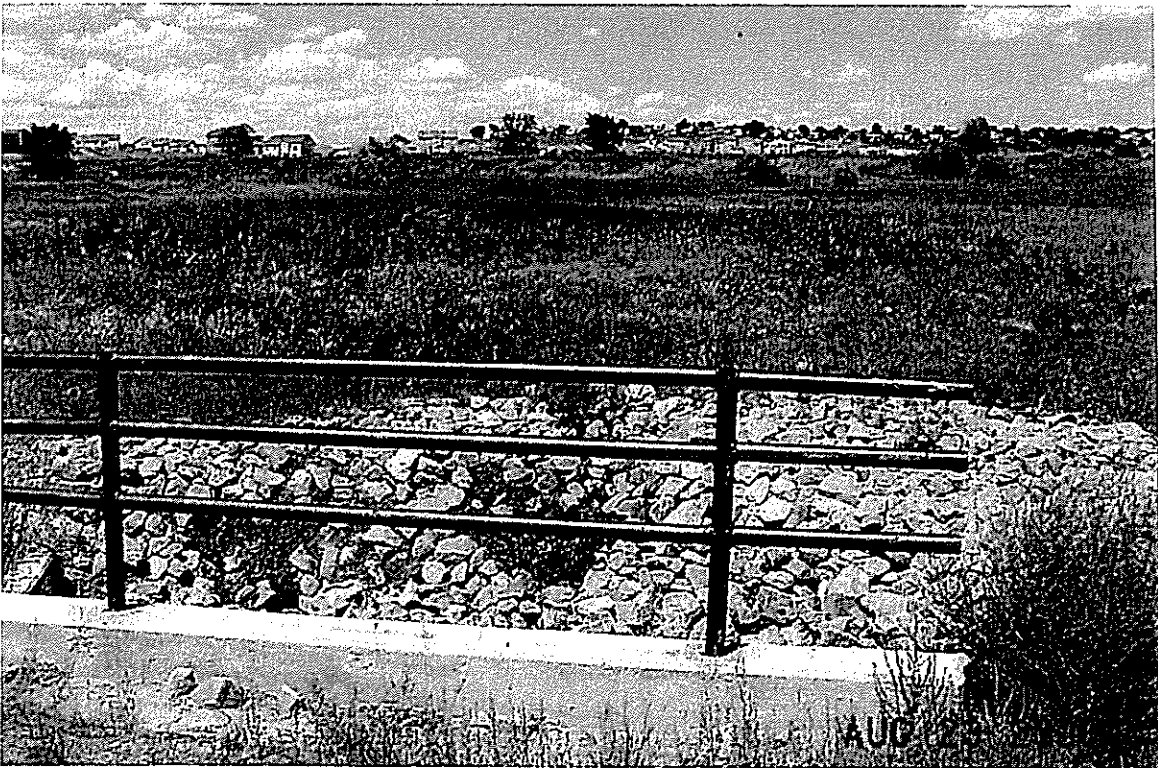
CS2

C & S Road, Two 34" w x 24" h CMPs outlets.

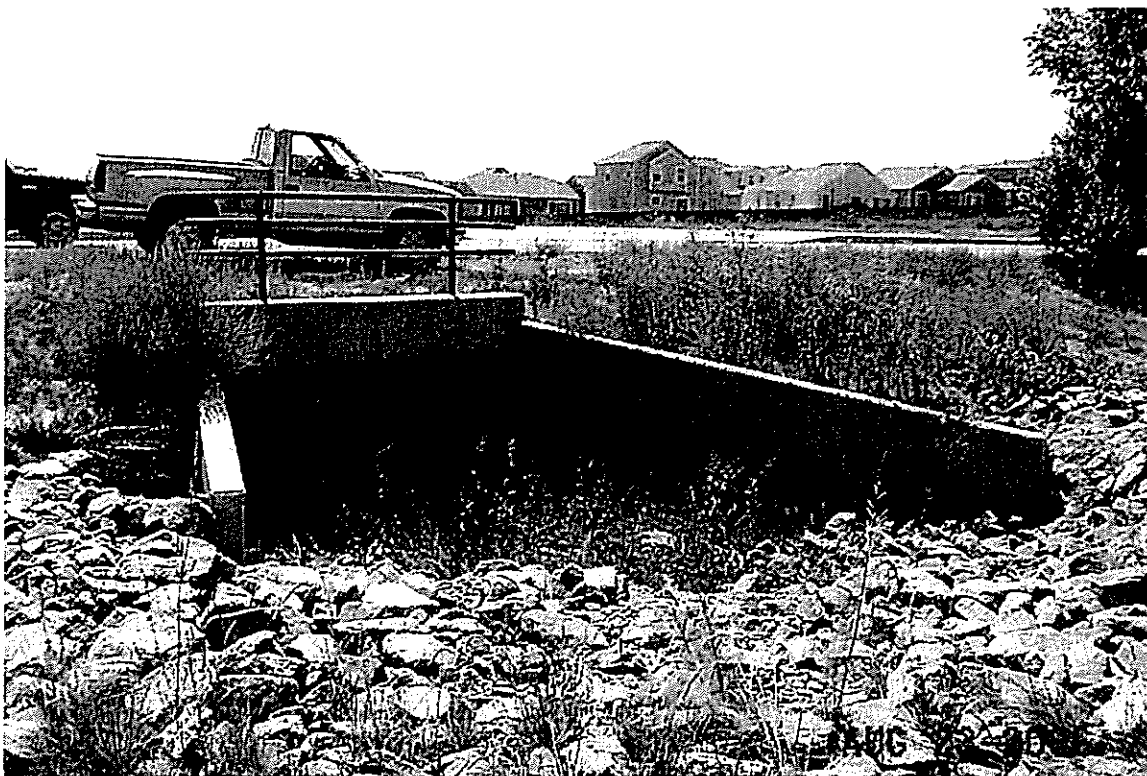
CS1

C & S Road, 12' w x 6' h concrete box culvert inlet channel.

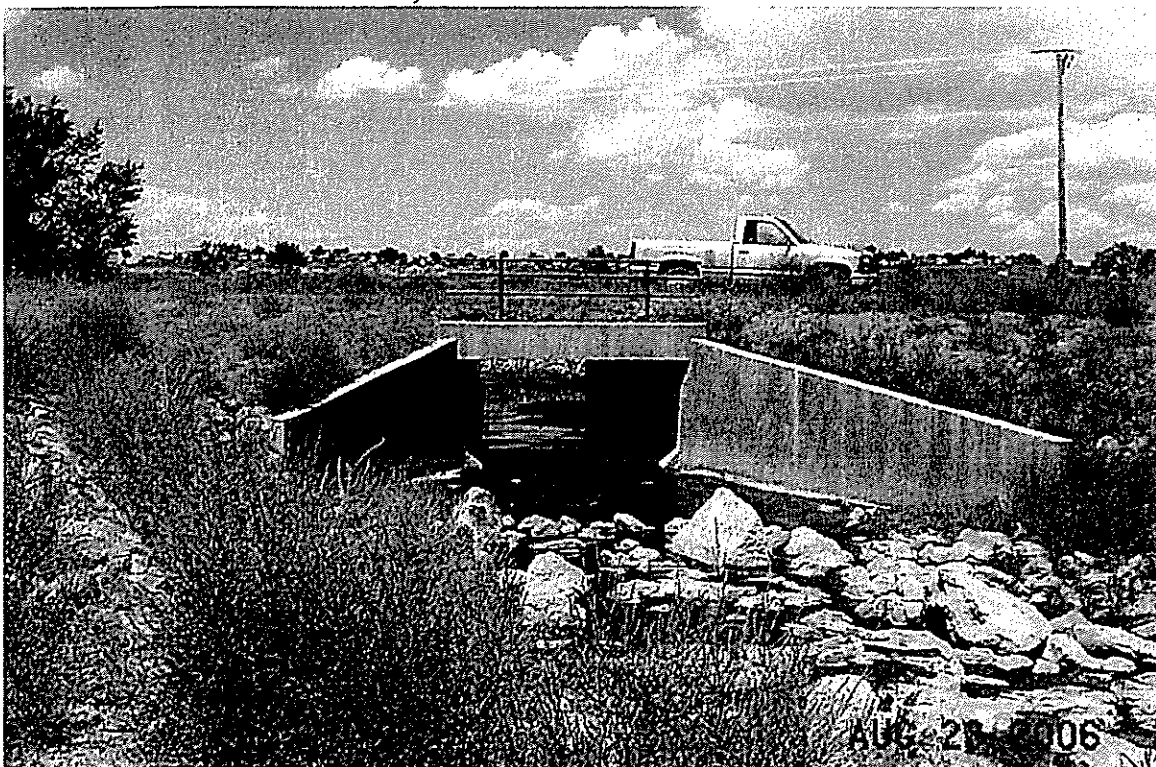
CS1

C & S Road, 12'w x 6'h concrete box culvert inlet.
