**APPENDIX D**  
**EXISTING FACILITIES**  
**Facility Summary**  
**Photographs**

Table 1 Existing Major Drainageway Structure Inventory

JIMMY CAMP CREEK DBPS  
OLD PUEBLO ROAD BRIDGE  
JIMMY CAMP CREEK  
EL PASO COUNTY, COLORADO  
BRIDGE PROFILE

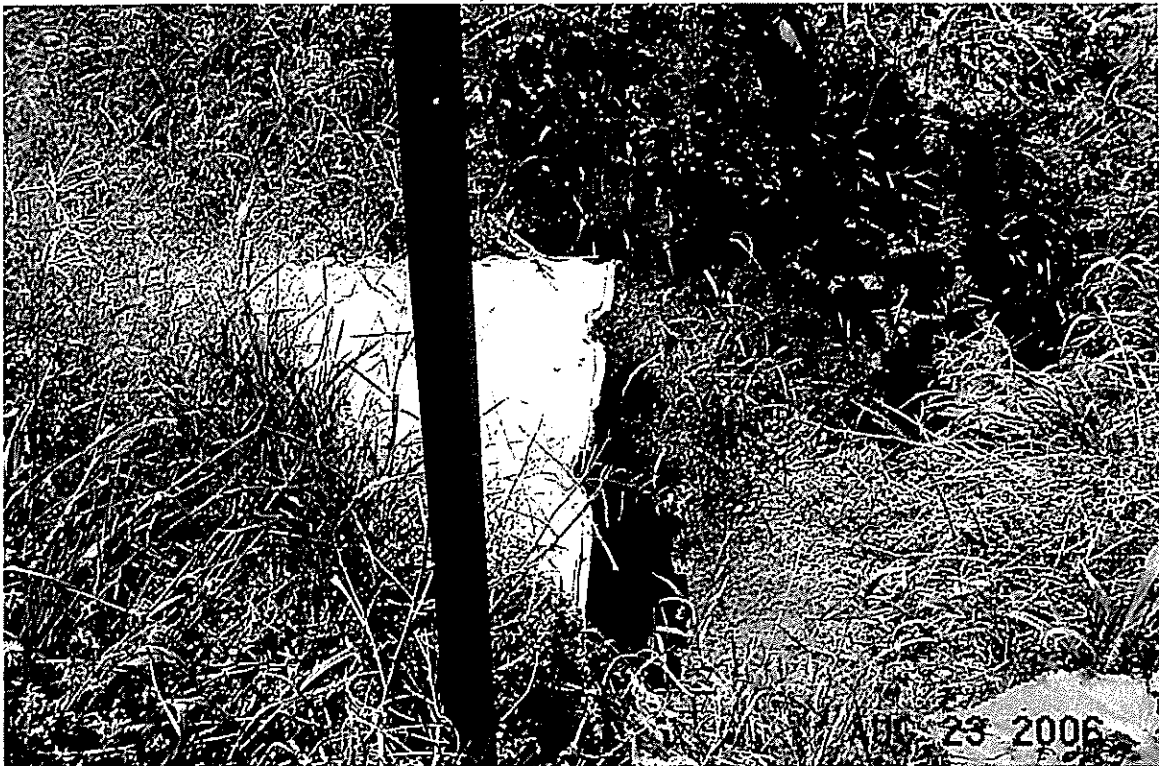
MG 4

Marksheffel Road, 40" w x 26" h CMP inlet channel.

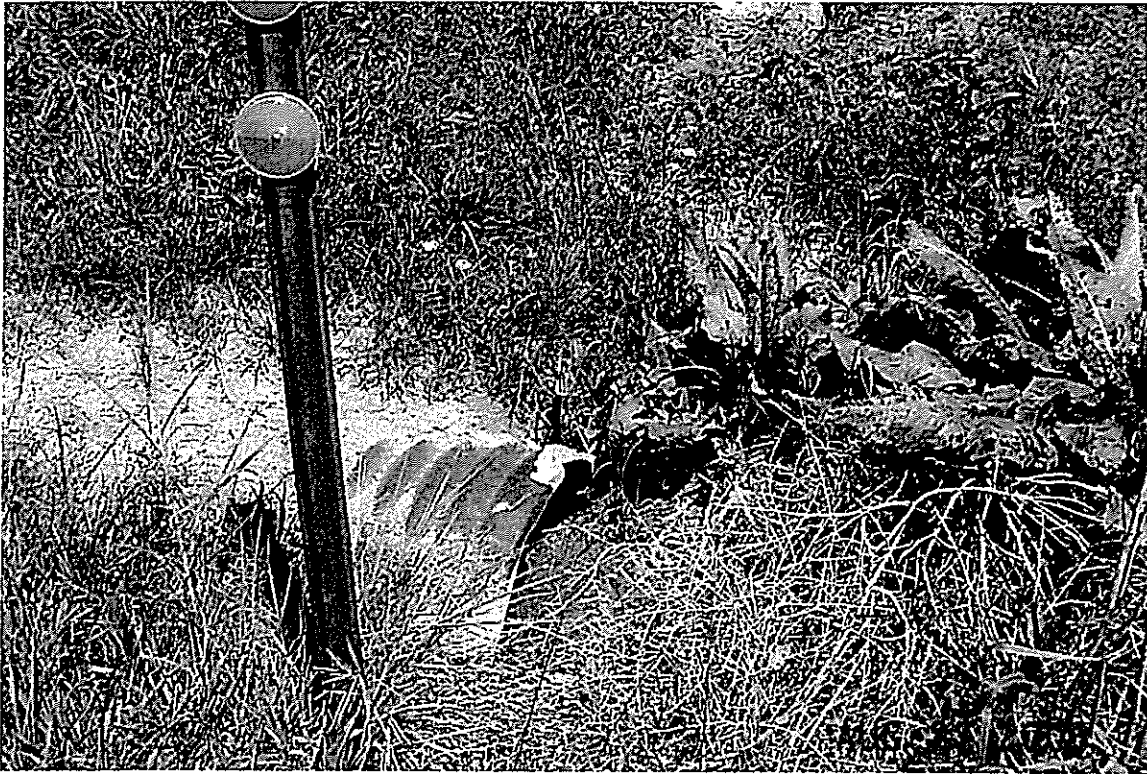
MG 4

Marksheffel Road, 40" w x 26" h CMP inlet.

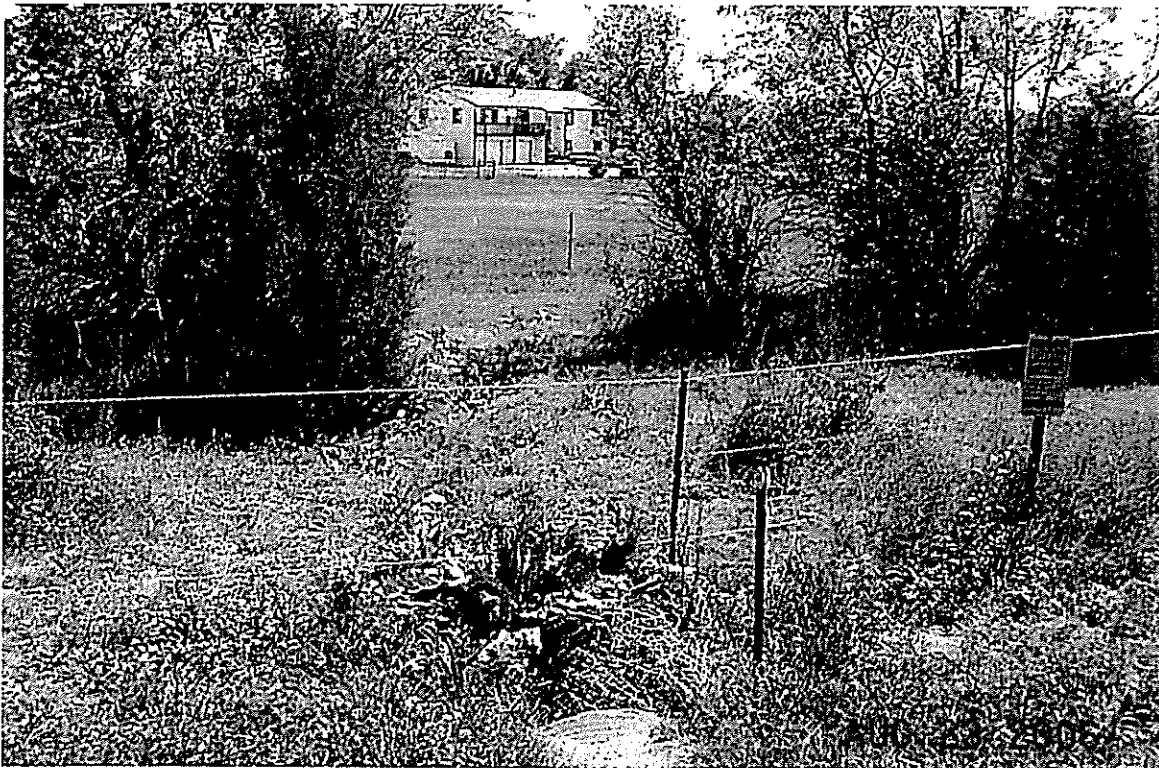
MSH

Marksheffel Road, 40" w x 26" h CMP outlet.

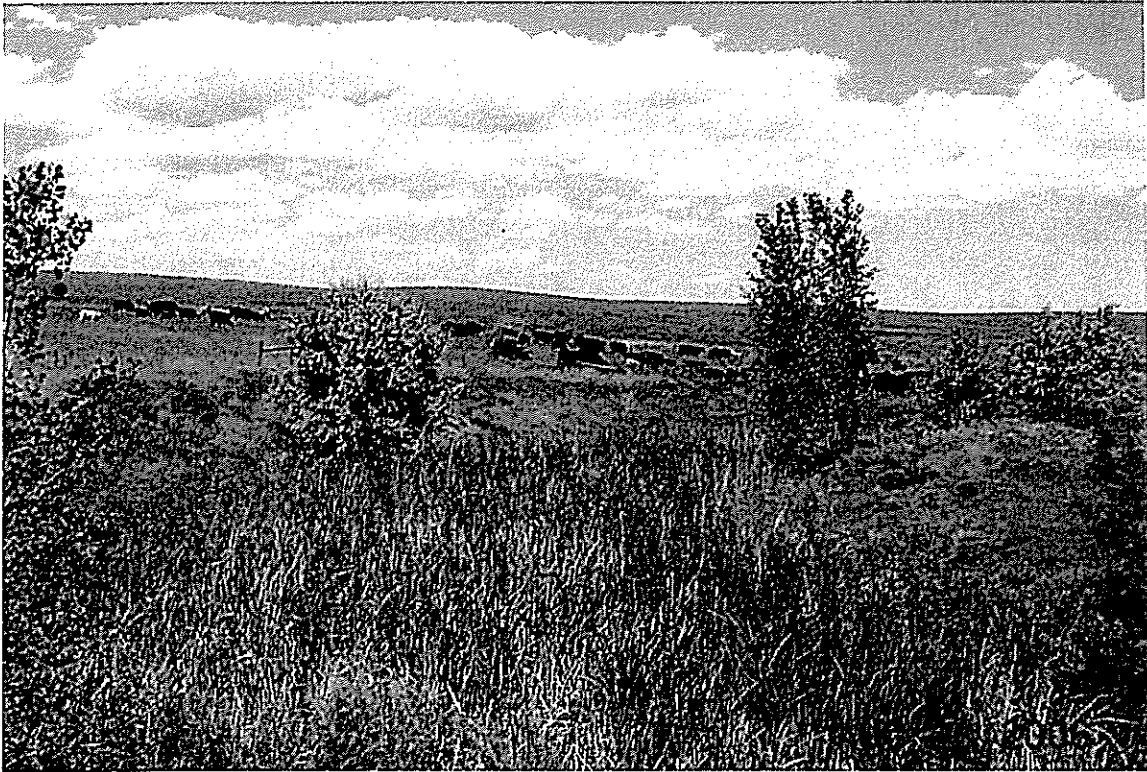
MSH

Marksheffel Road, 40" w x 26" h CMP outlet channel.

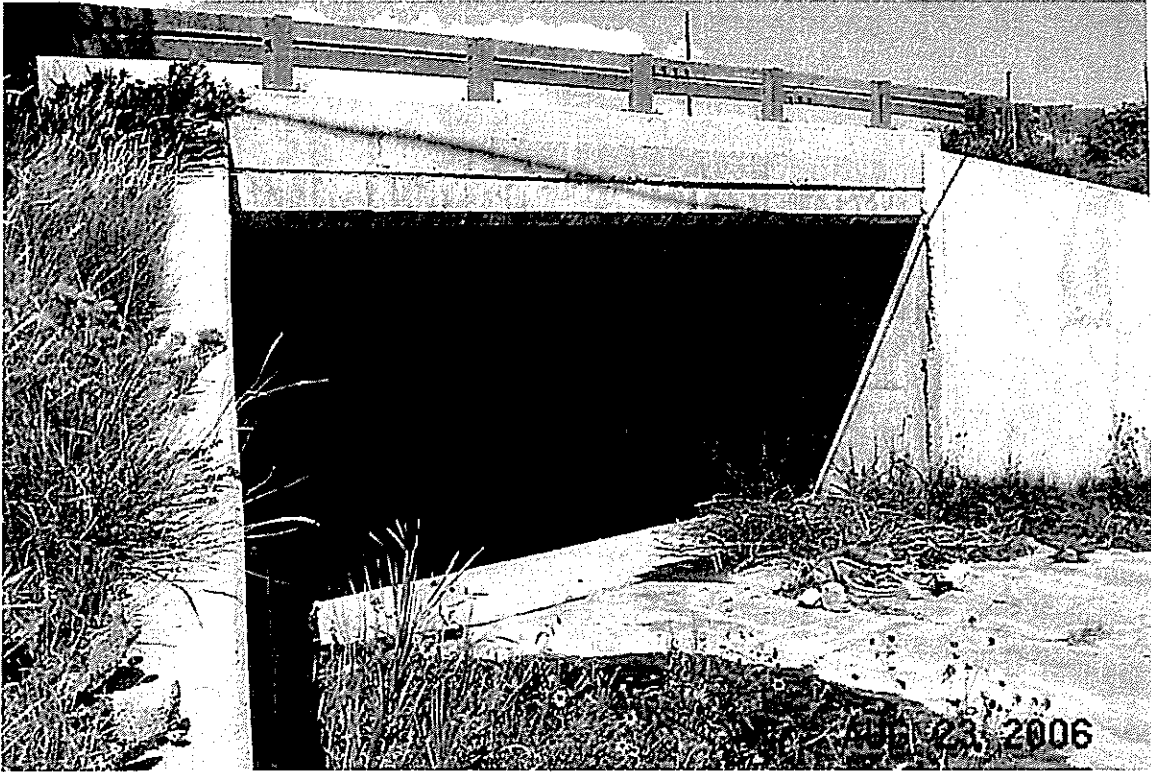
FR1

Fontaine Road, 26'w x 10'h Box Culvert inlet.

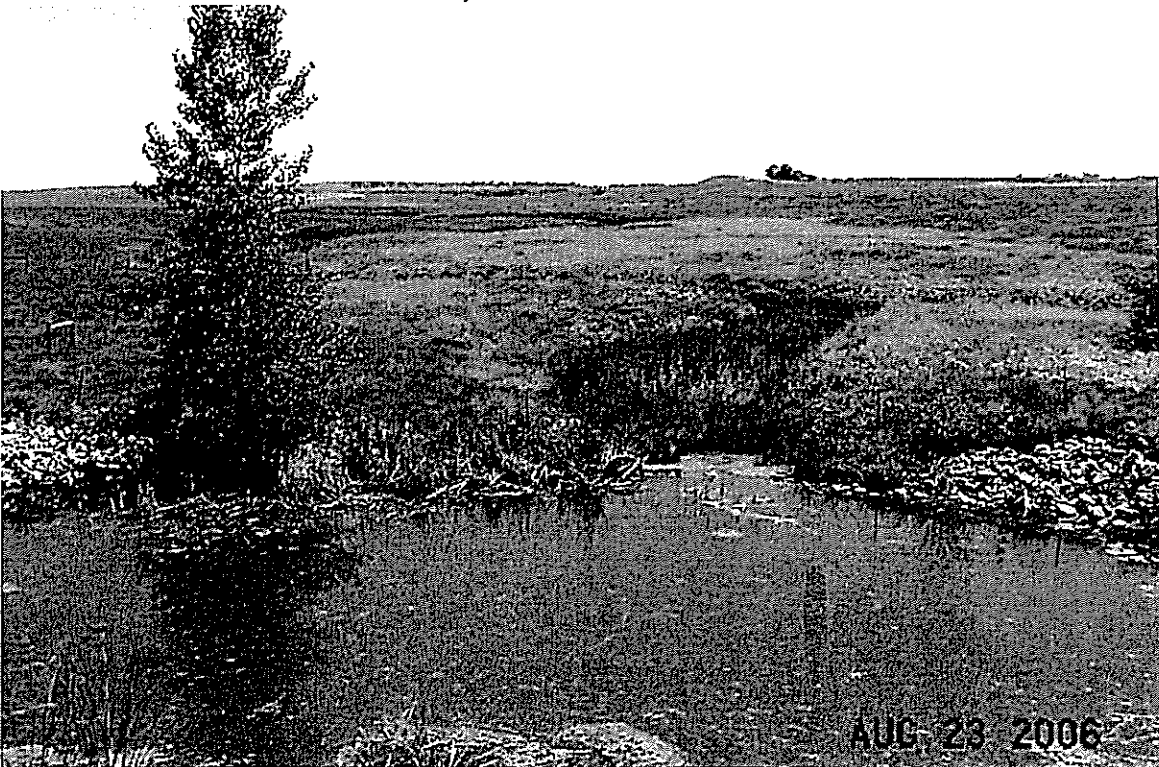
FR1

Fontaine Road, 26'w x 10'h Box Culvert outlet.

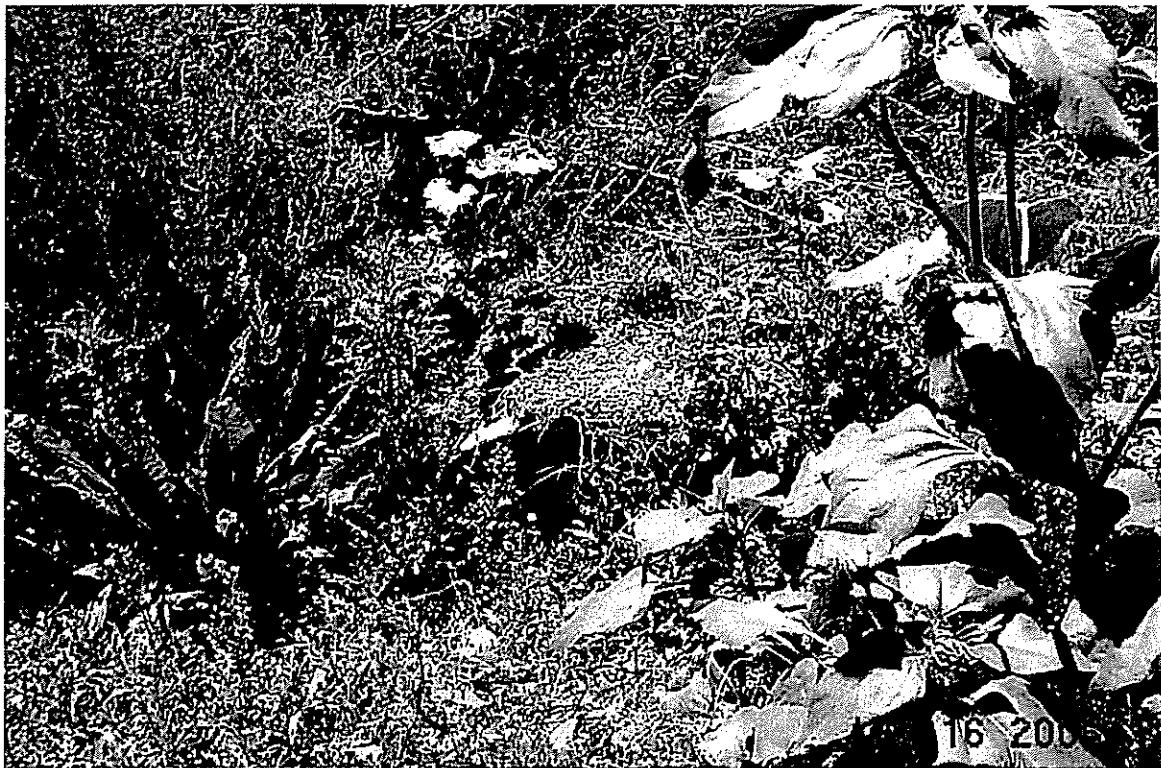
DR1

Drennan Road 24" CMP inlet Channel located northwest of Drennan Road & Marksheffel Road.

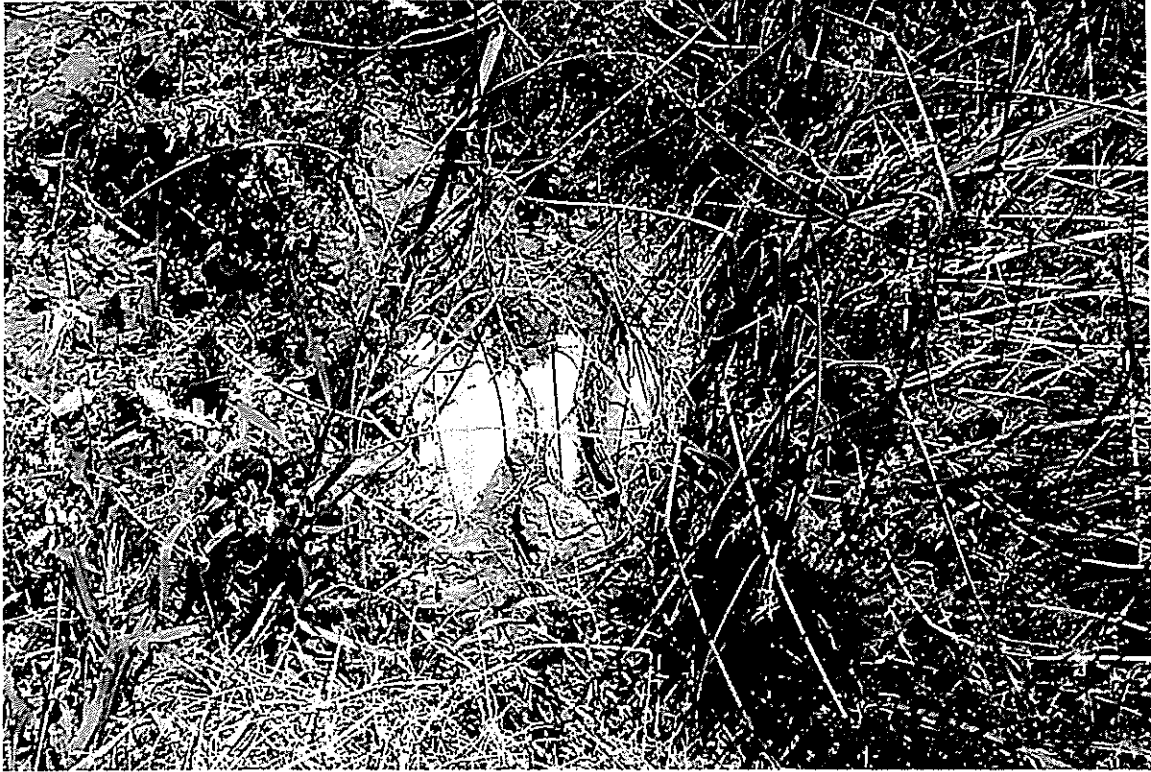
DR1

Drennan Road 24" CMP inlet located northwest of Drennan Road & Marksheffel Road.

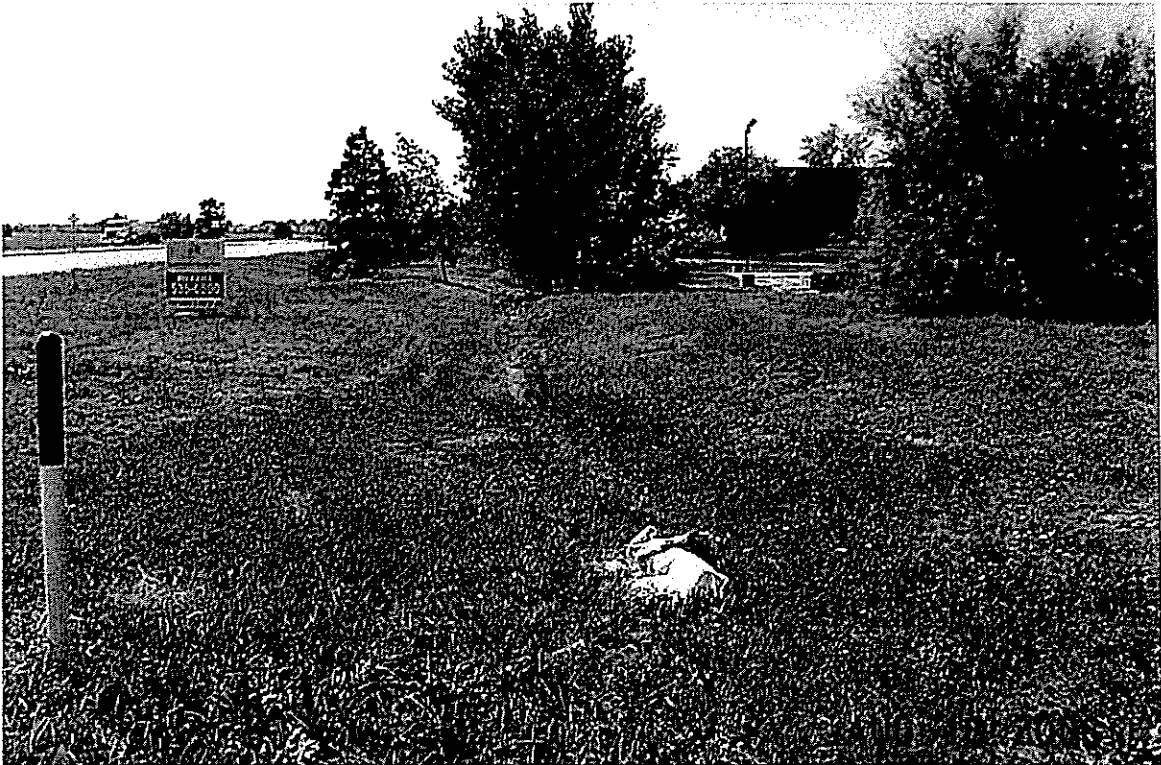
DR 1

Drennan Road 24" CMP outlet located southwest of Drennan Road & Marksheffel Road.

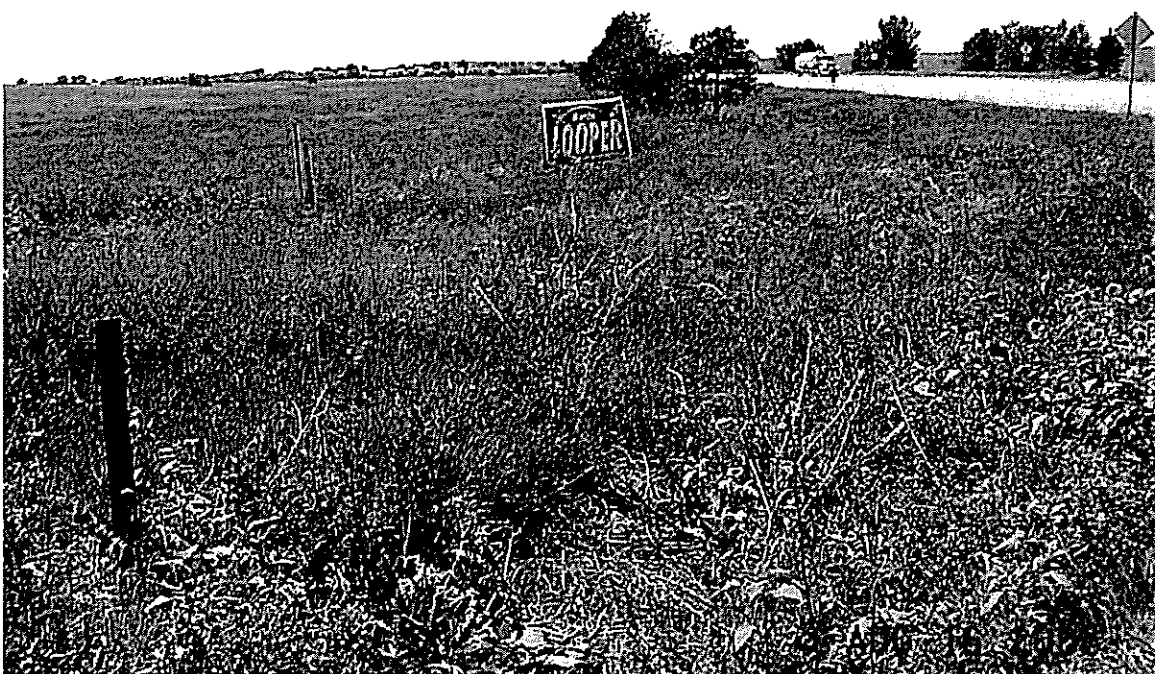
DR2

Drennan Road 18" CMP outlet located southeast of Drennan Road & Marksheffel Road.

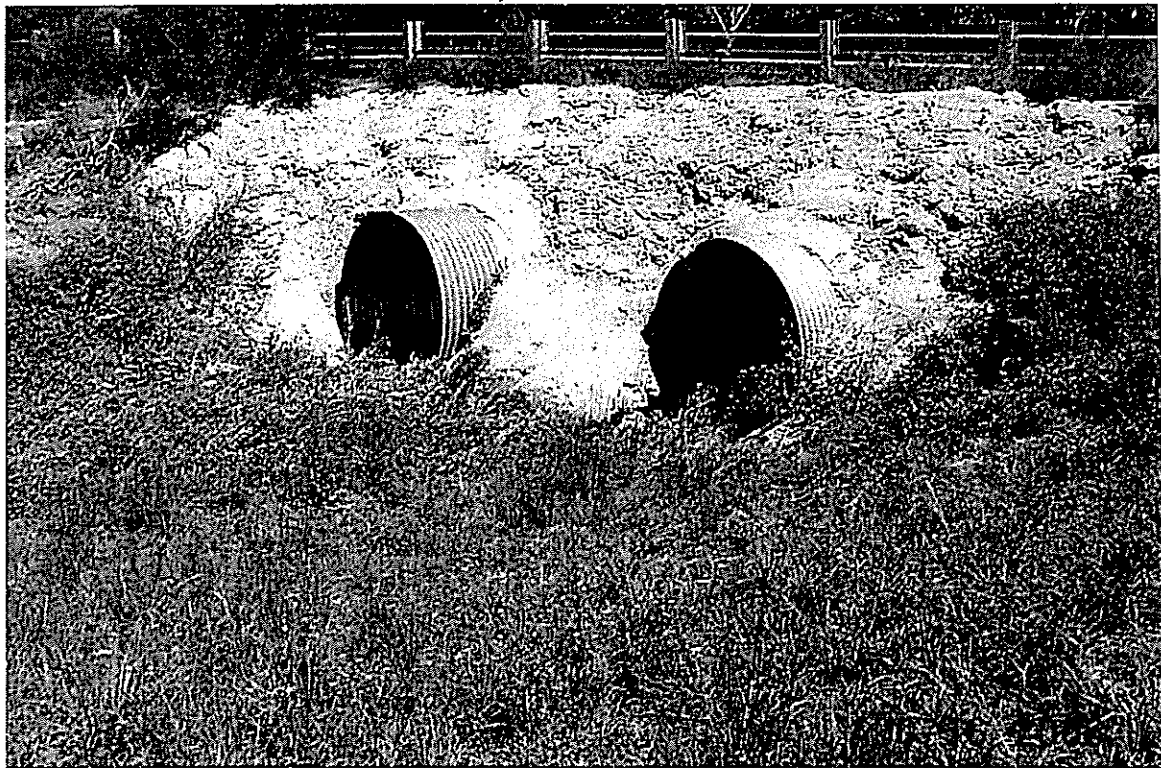
MS2

Marksheffel Road, Two 72" CMPs inlet Channel.

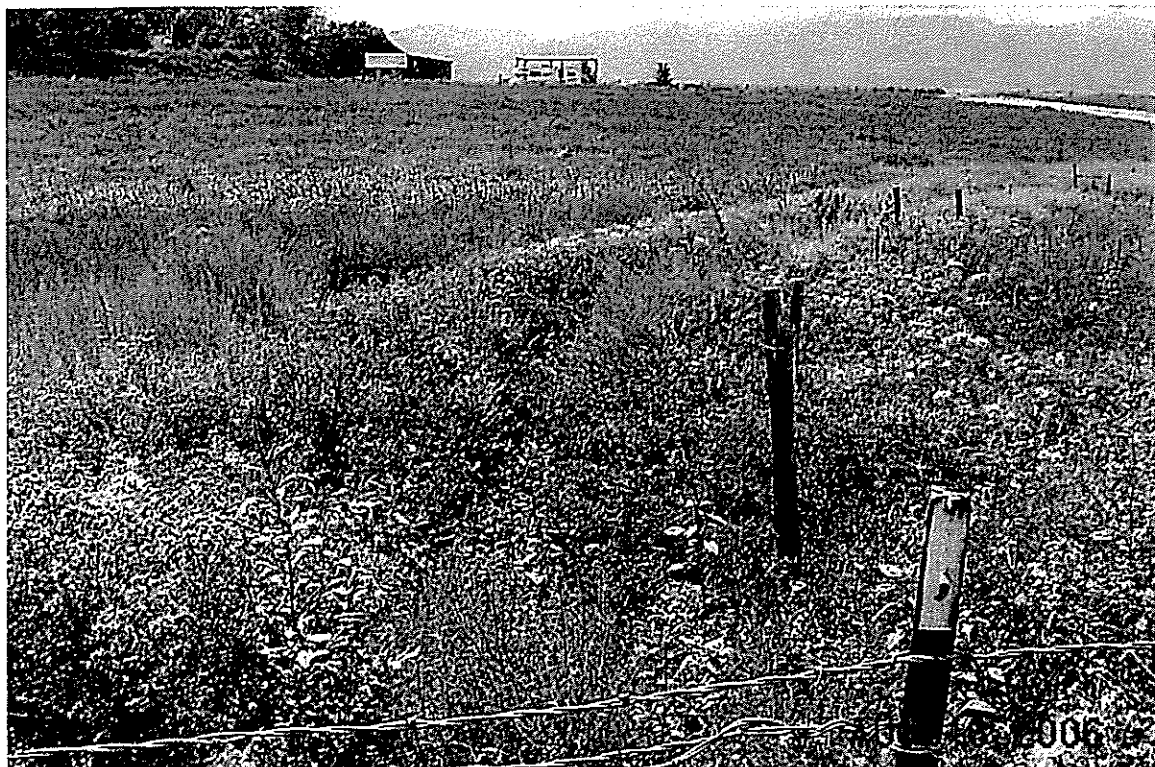
LR2

Link Road CMP.

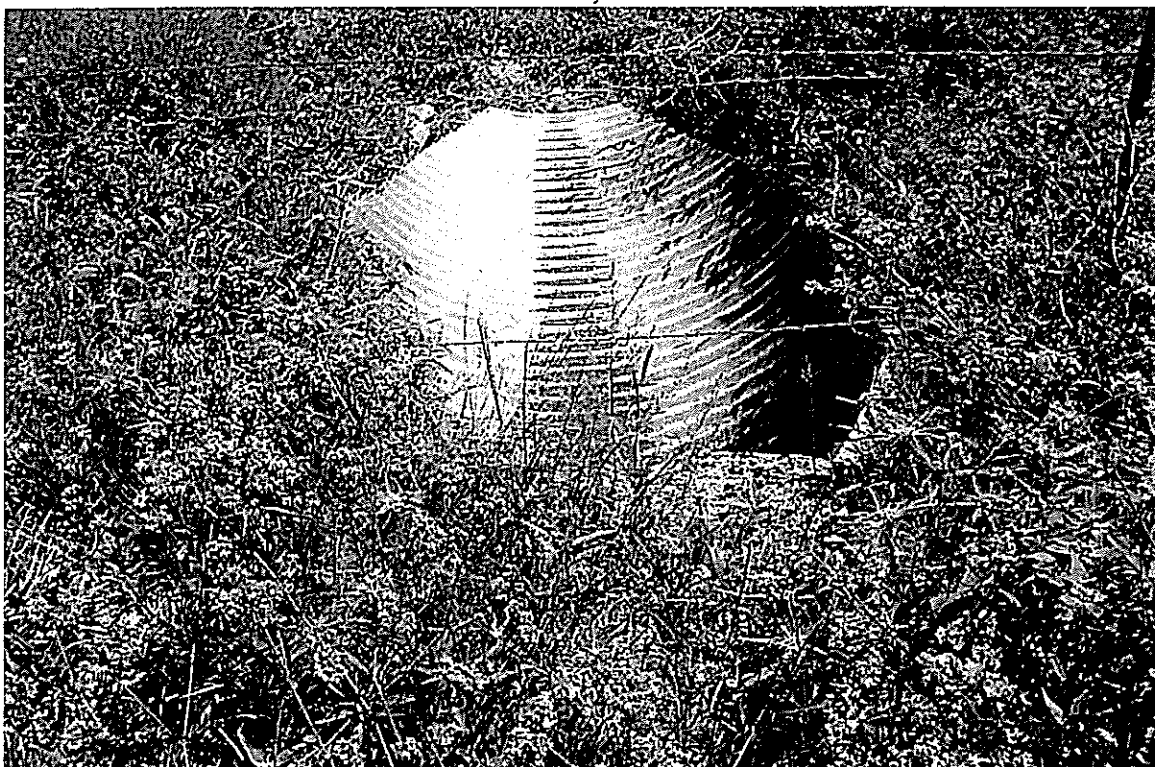
MS3

Marksheffel Road, 72" CMP inlet.

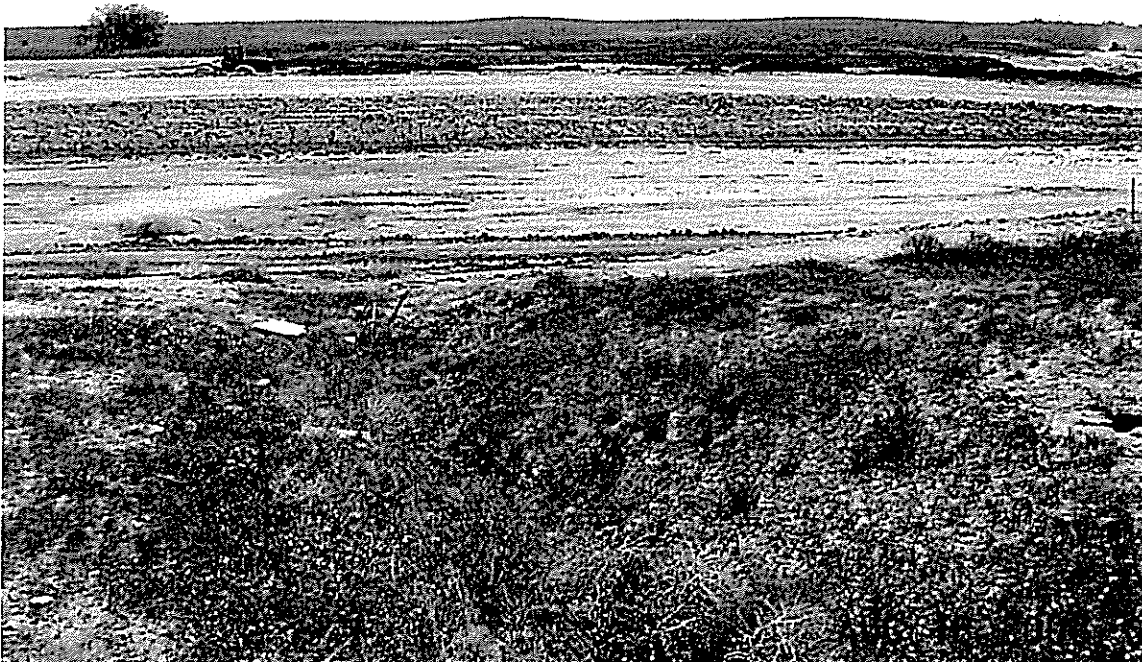
MS3

Marksheffel Road, 72" CMP outlet.

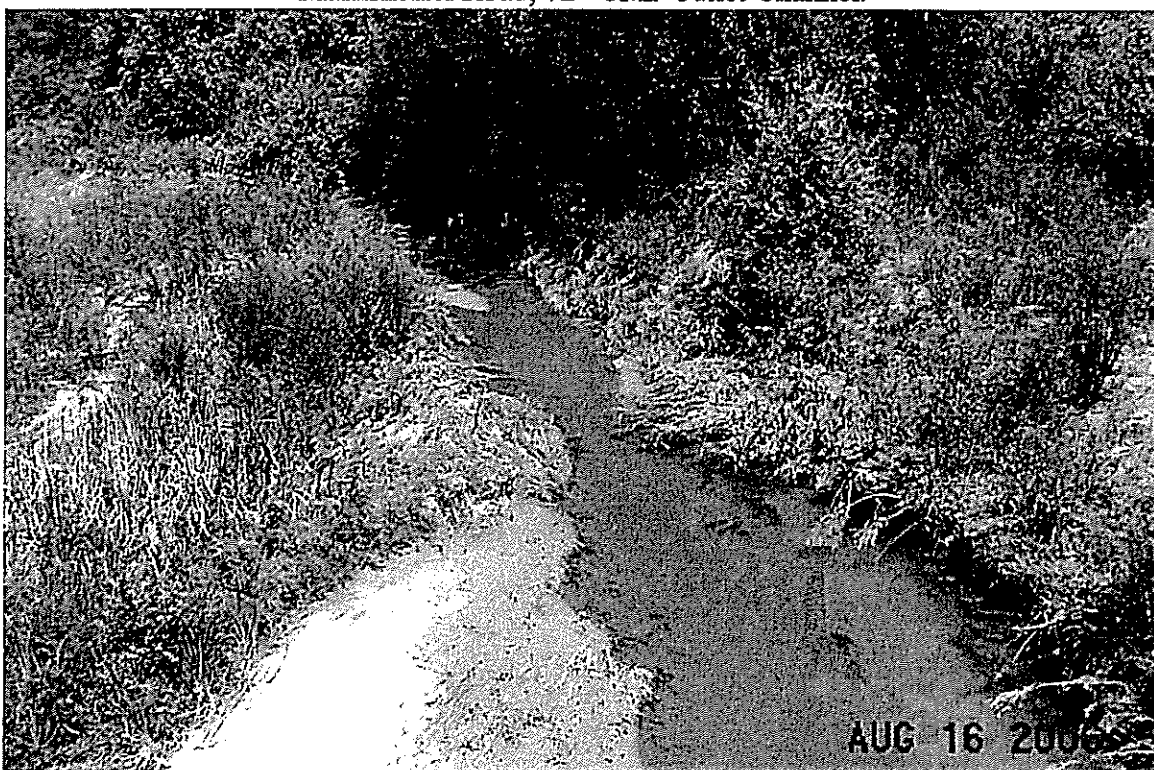
MS3

Marksheffel Road, 72" CMP outlet Channel.
